NAPA RIVER RUTHERFORD REACH RESTORATION PROJECT ANNUAL MONITORING REPORT - 2018

Reach 8, May 2018

Napa County Flood Control and Water Conservation District

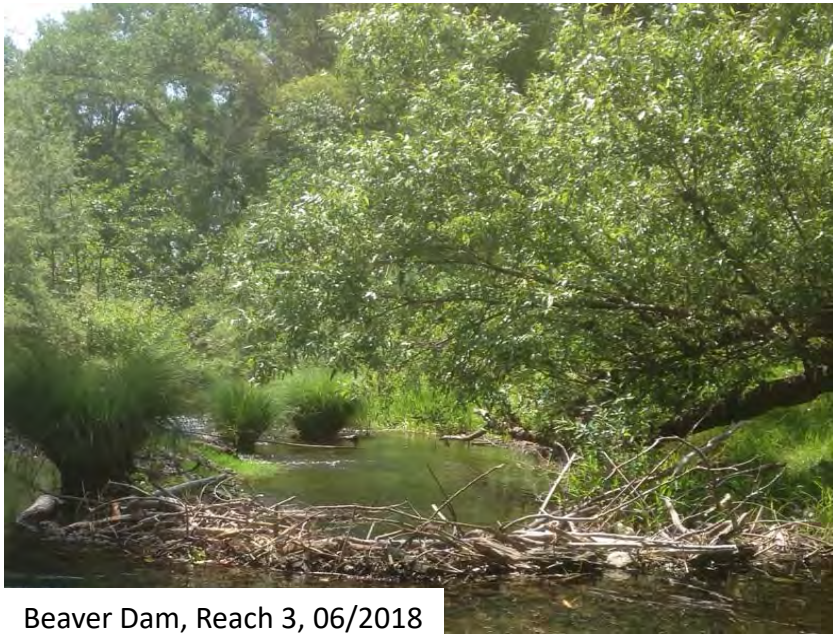
Beaver Dam, Reach 3, 06/2018

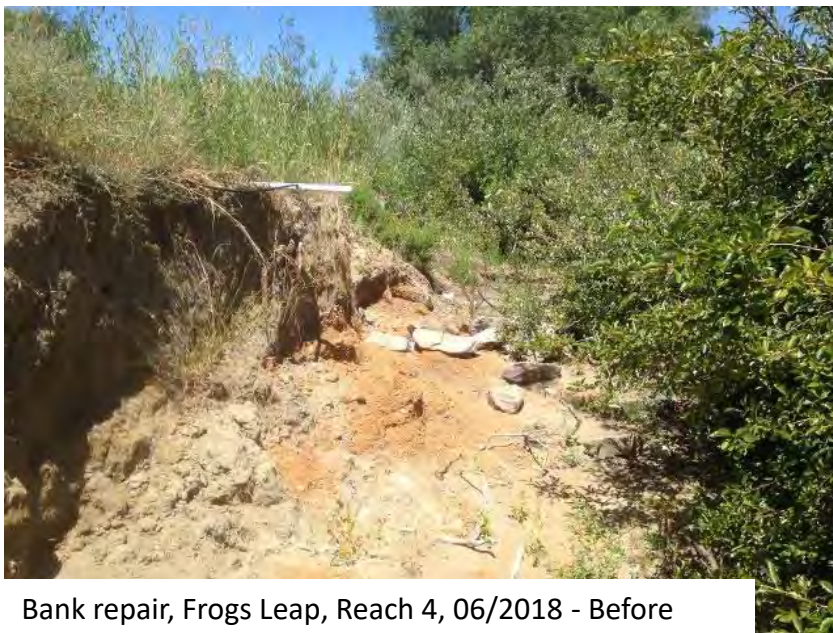
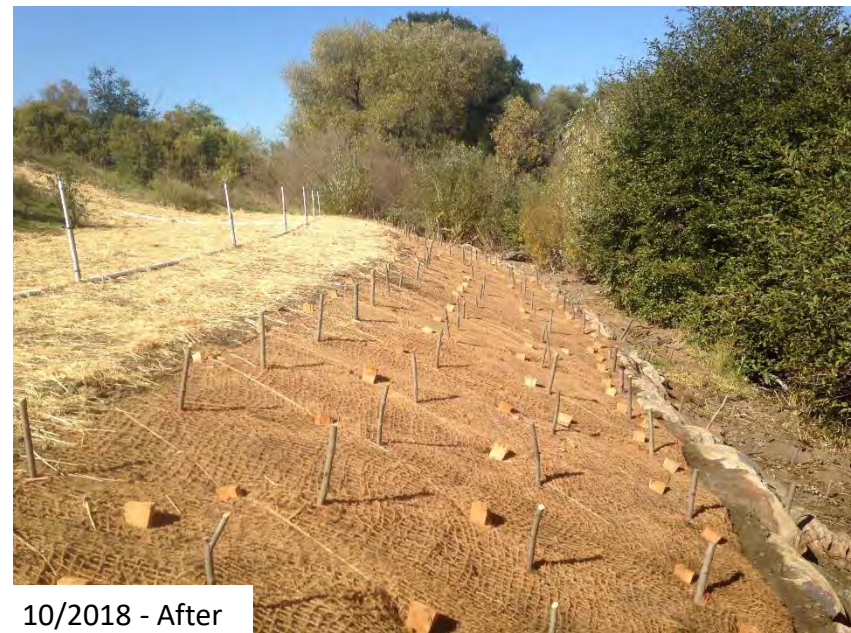
Bank repair, Frogs Leap, Reach 4, 06/2018 - Before

10/2018 - After

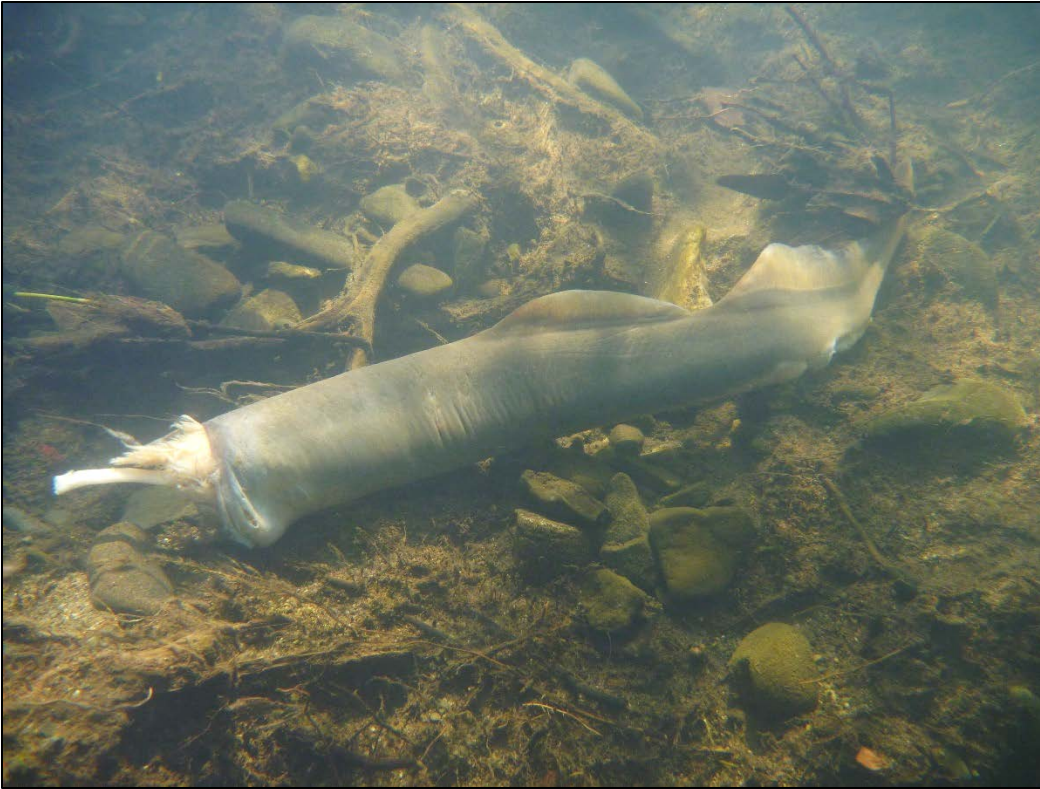
Two Pacific Lamprey carcasses were found alongside freshly-constructed spawning nests during the survey. Both carcasses had been scavenged and were half-eaten (Figure 2). Additionally, Pacific Lamprey nests were observed frequently throughout the surveyed reach, most commonly in pool tail-outs. Nest sites typically contained between 1 and 5 excavated pits, each approximately 0.5m in diameter and 0.1-0.2 m deep.

Figure 2. Scavenged Pacific Lamprey carcass.
