NAPA RIVER RUTHERFORD REACH RESTORATION PROJECT 2012 MONITORING REPORT

March 2013

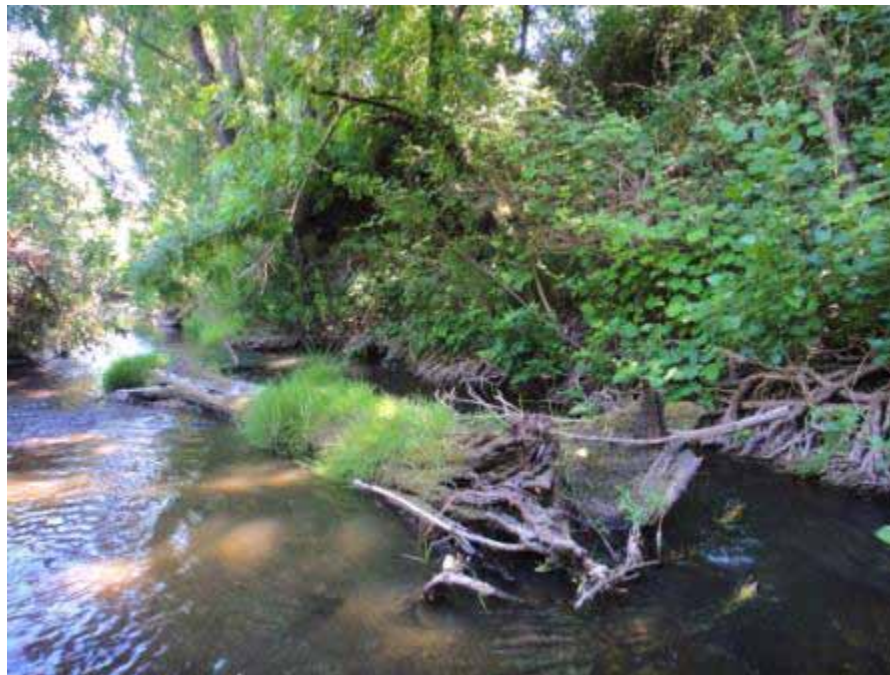
8,270 Cross Section LWD Persisting from prior to 2004 through 2012
