2019 Putah Creek Watershed Monitoring and Prevention

**Watershed Information & Conservation Council
September 26, 2019**

**Sabrina Colias
Solano County Water Agency
Associate Water Resources Specialist**

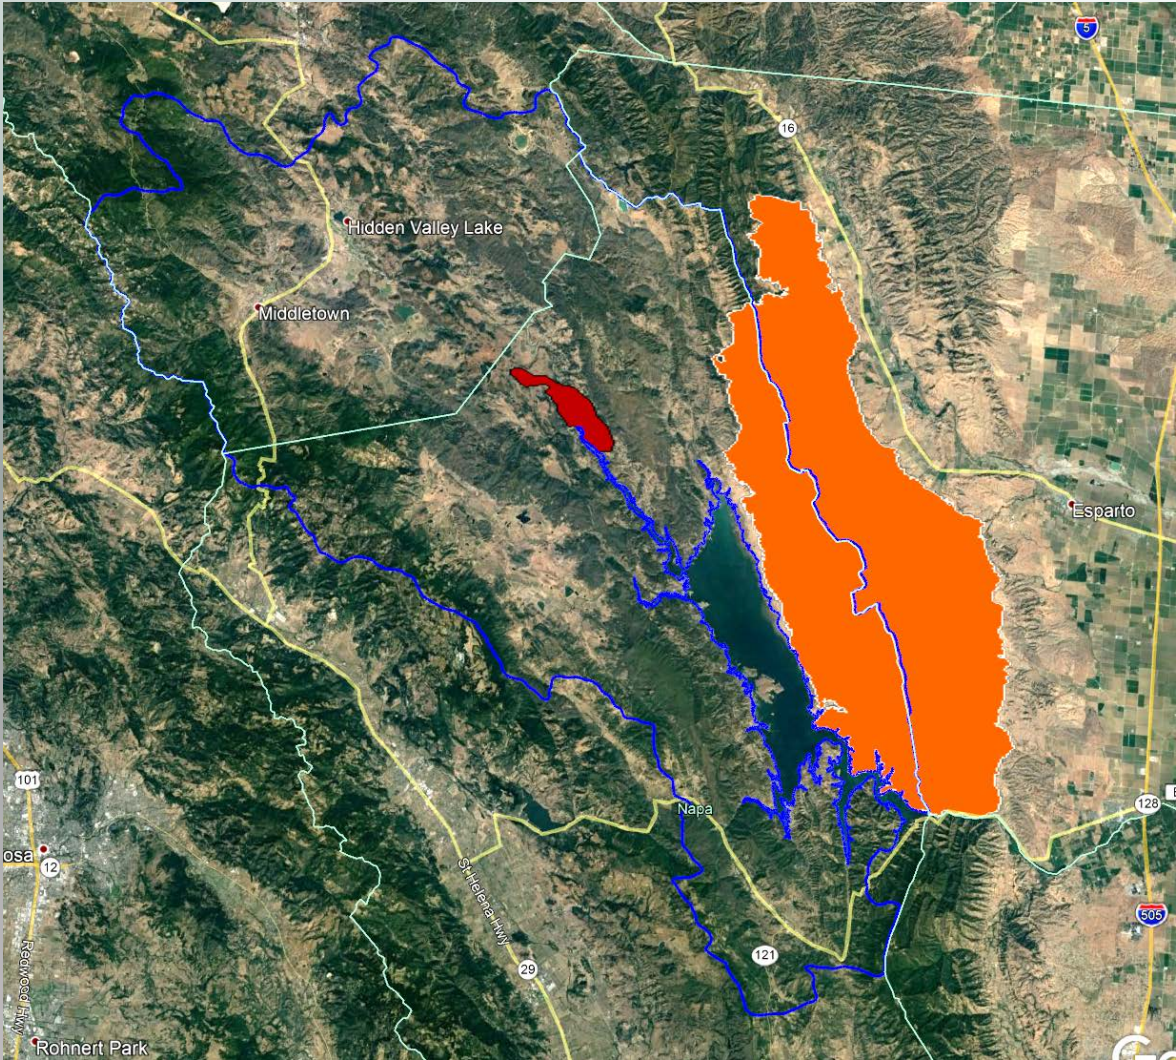
WILDFIRES IN 2018

Fire	Area (acres)
County Fire (East of Lake Berryessa)	90,288
Snell Fire (Upper Putah Creek, North of Walter Springs)	2,490

Total = 92,778 acres (145 mi²)

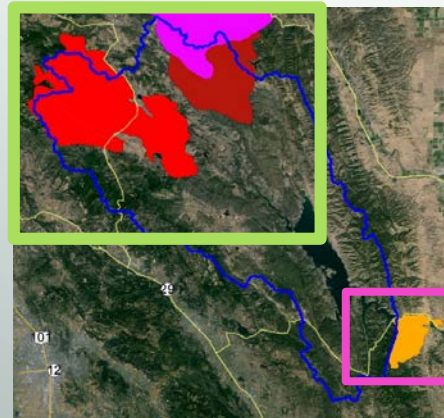
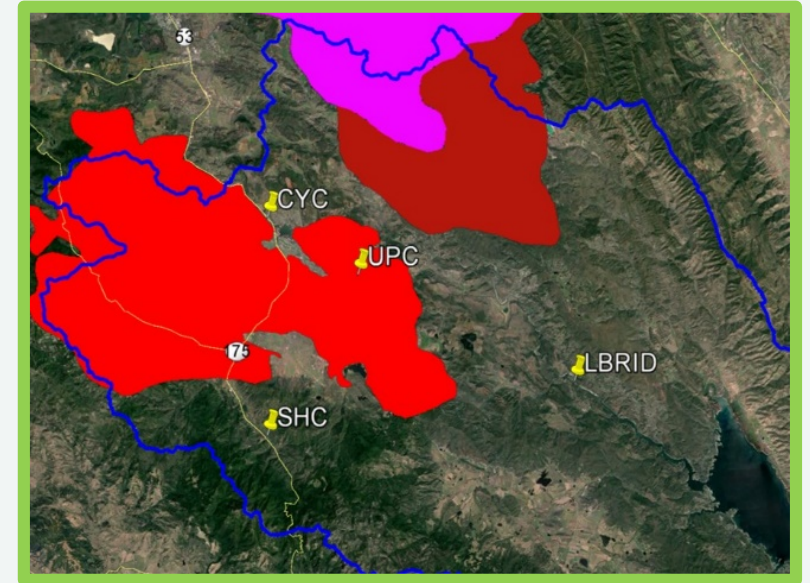
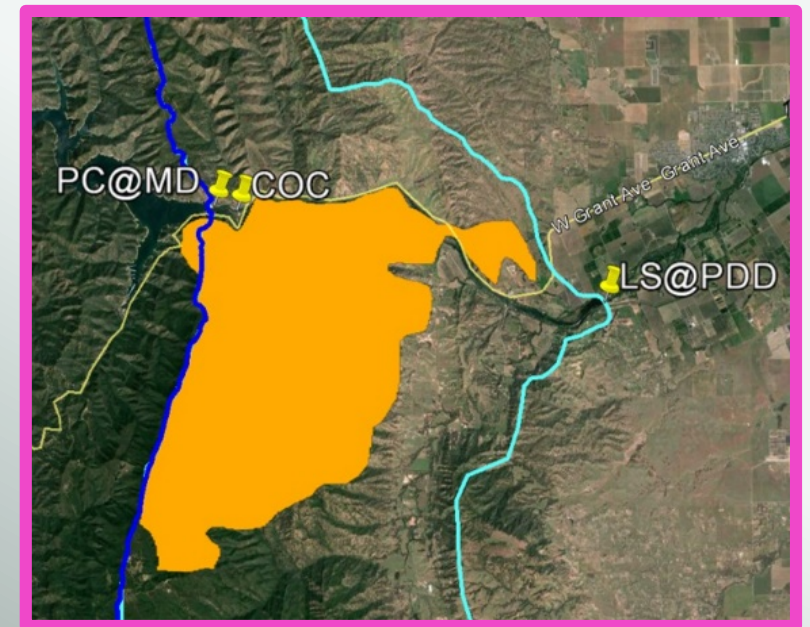
2016 SAMPLE LOCATIONS

Name	Description
SHC	St Helena Creek (Control)
CYC	Coyote Creek (Partial, Small Tributary)
UPC	Putah Creek (Upper, Sig Burn Impact)
LBRID	Putah Creek (Middle, U/S L. Berryessa)
PC@MD	Putah Creek (Lower D/S L. Berryessa)
COC	Cold Canyon Creek (U/S of Putah Ck)
LS@PDD	Lake Solano at Diversion Dam (Intake)

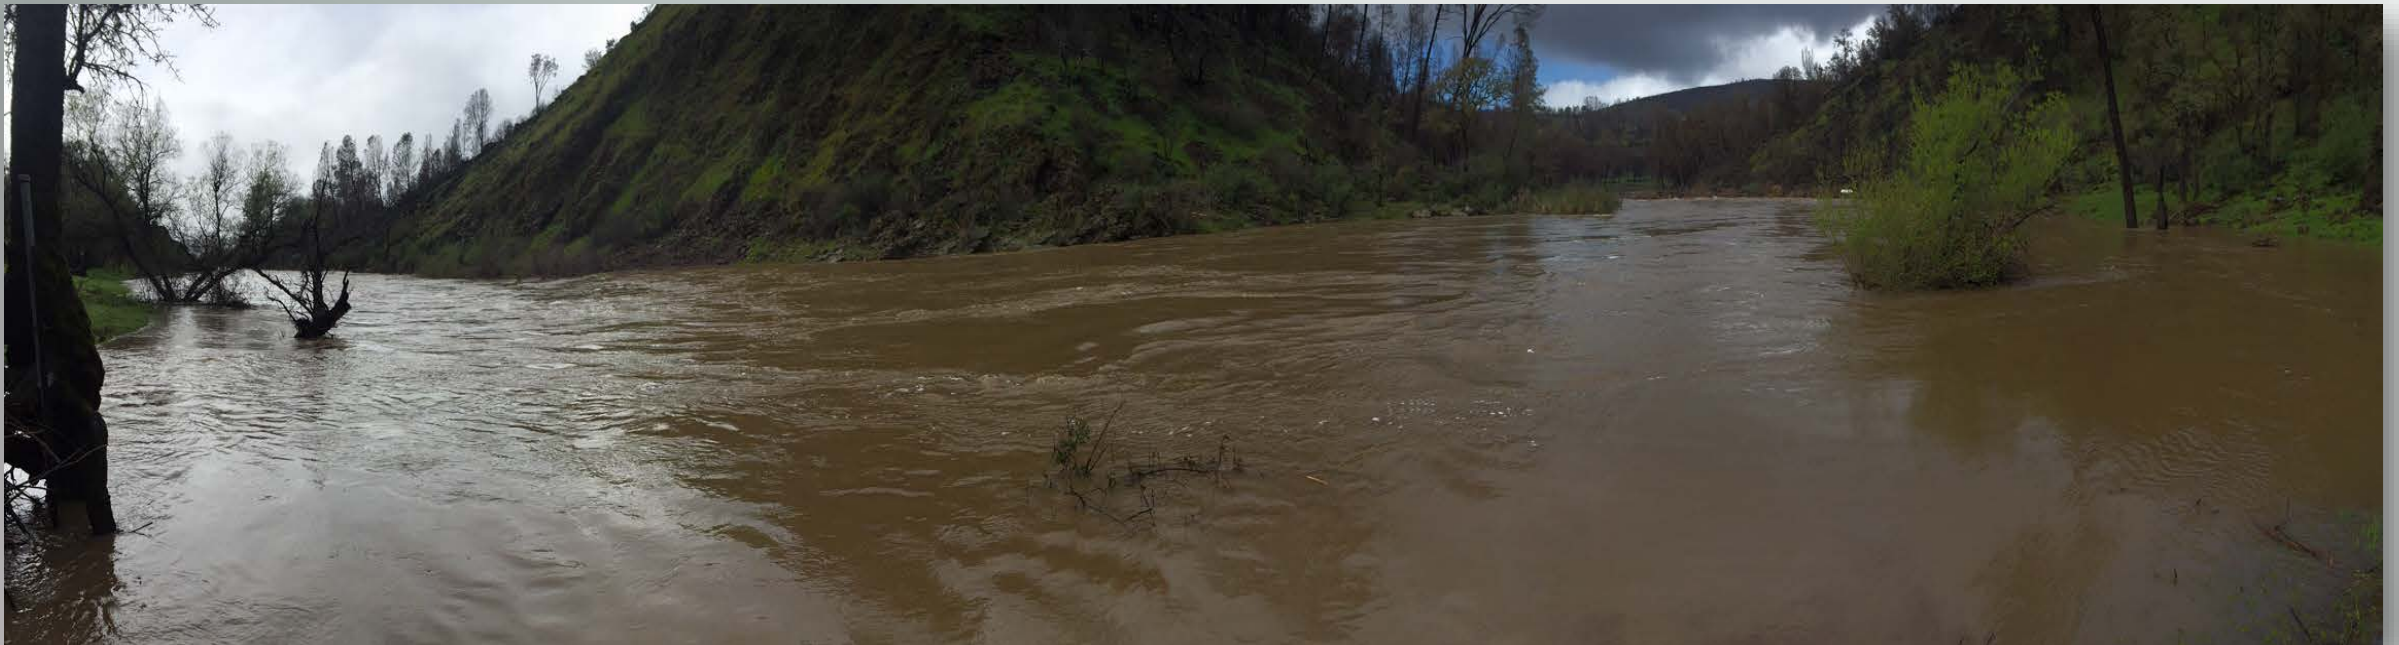
2016 KEY RESULTS

- Cold Canyon Creek (Interdam Reach) had the worst WQ
- No significant WQ degradation in Upper Putah Creek
- Upper Putah Creek has excellent WQ!
- Godzilla El Nino → Average Water Year for Putah Creek

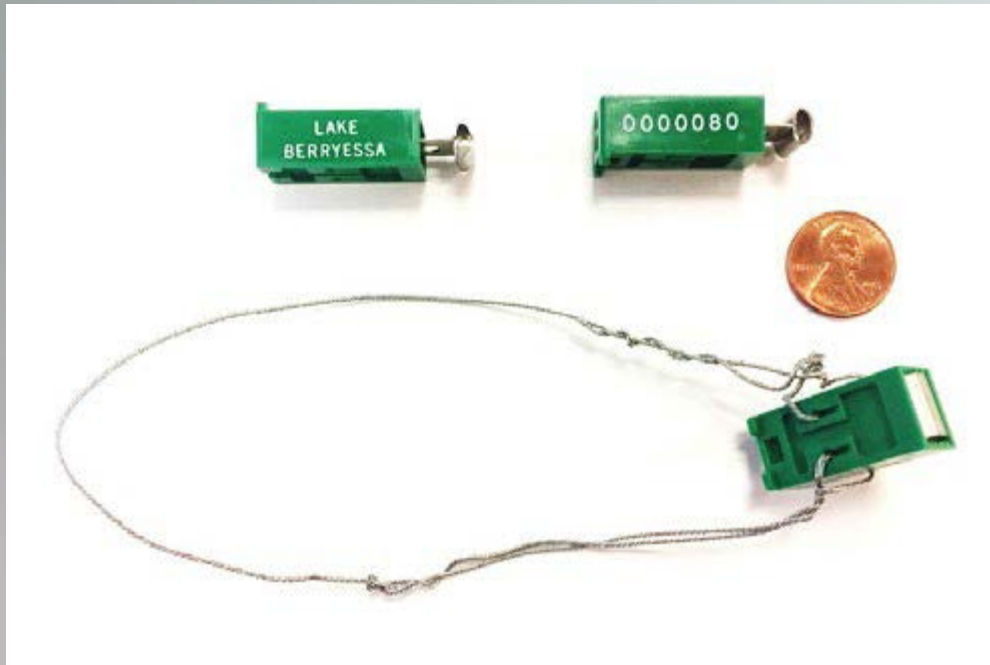
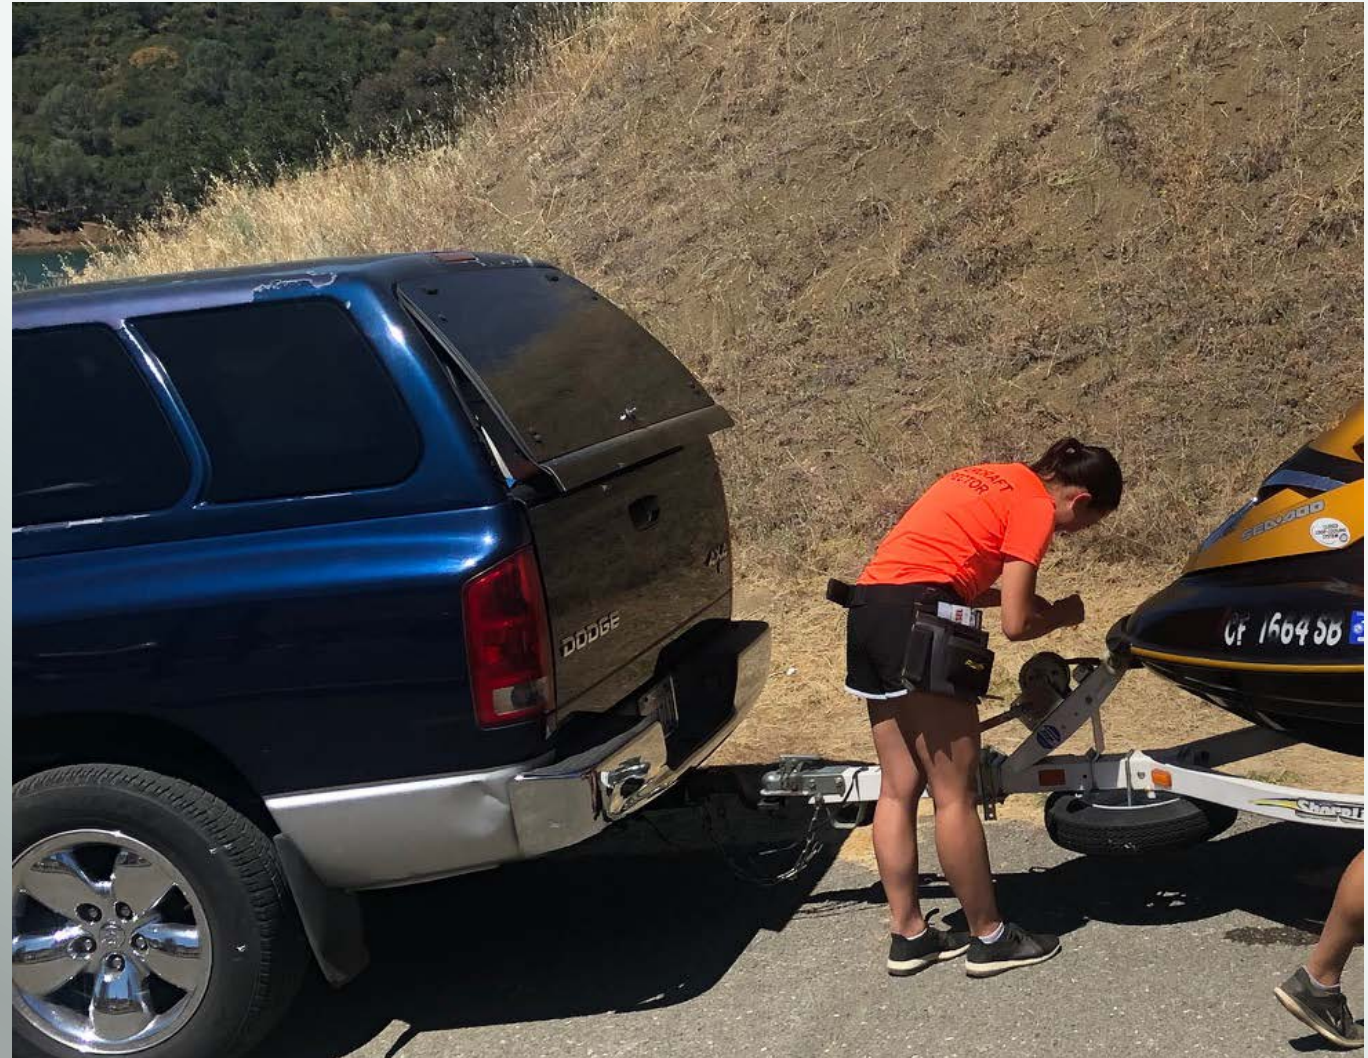
LAKE BERRYESSA - SEALS AND RECEIPTS

Right: Jasmie Installing a seal on a Jet Ski before leaving Steele Canyon Launch ramp.

Below: Example of Lake Berryessa Custom Seal (open and closed with tampered wire)

- Secure method for prevention
- Separates locals from 'Foreign' Boaters
- Speeds up Inspection process

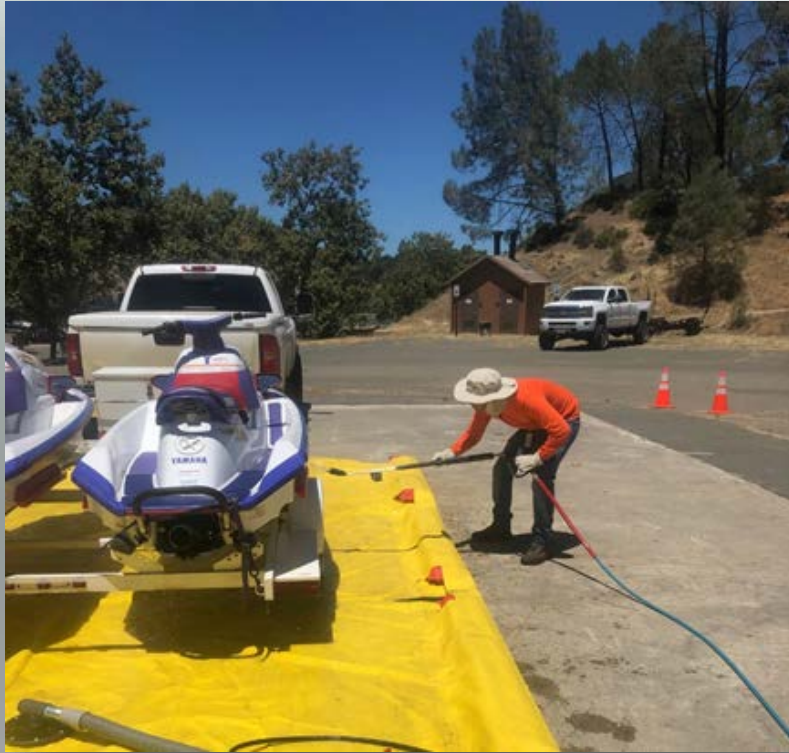
DECONTAMINATION STATION

Inspection Results:
Unverifiable Standing Water
Unknown Launch History
High Risk Boat

Sent to Decontamination:
Located at Steele Canyon Resort
Free to All Boaters

Professional Decontamination:
Exterior & Motor = 140 ° H2O
Interior & Accessories = 120° H2O
Waste Water Contained/ Recycled
