CARNEROS CREEK WATERSHED MANAGEMENT PLAN

EXISTING WATERSHED CONDITIONS

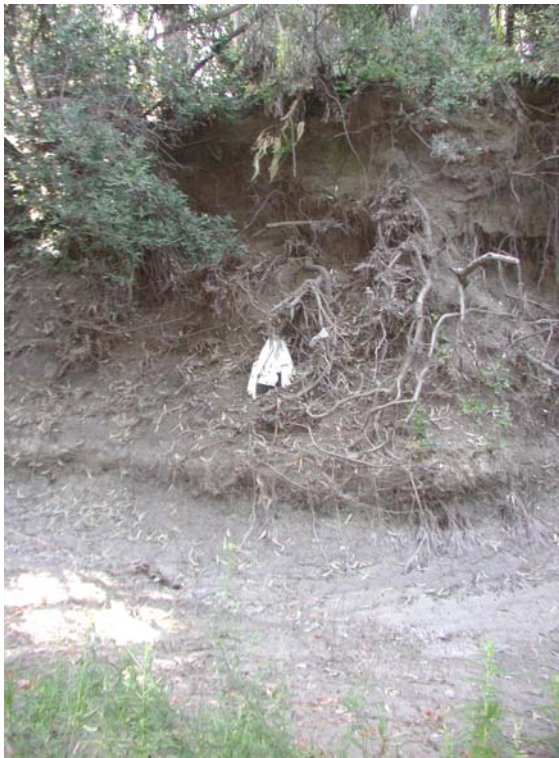
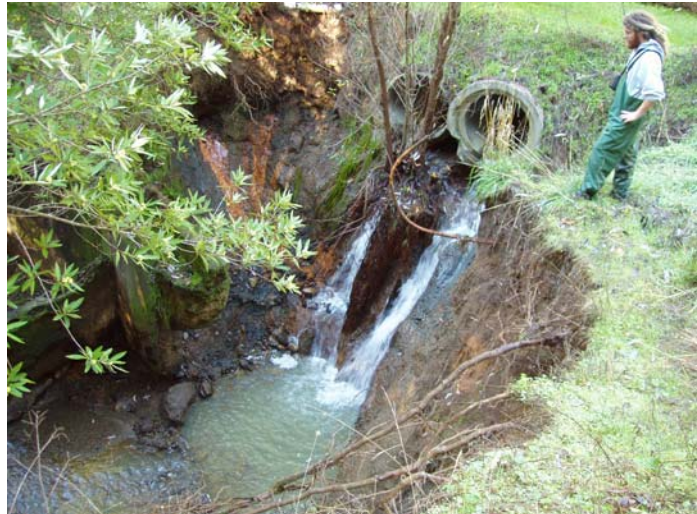
Figure 8: Examples of bank and gully erosion in the Carneros Creek watershed.

Soil erosion is a process that can take many forms including: bank erosion, gully erosion, sheet and rill erosion, and landsliding; all of which are currently occurring in the Carneros Creek watershed to varying degrees. Much of the erosion occurring on Carneros Creek is caused or aggravated by human activities. Finding solutions to minimize erosion induced by human disturbance is essential because property and soil resources are valuable and because excess erosion and the resultant sediment input to the creek can have negative impacts on channel functioning and aquatic habitat. Figure 8 shows examples of bank and gully erosion.

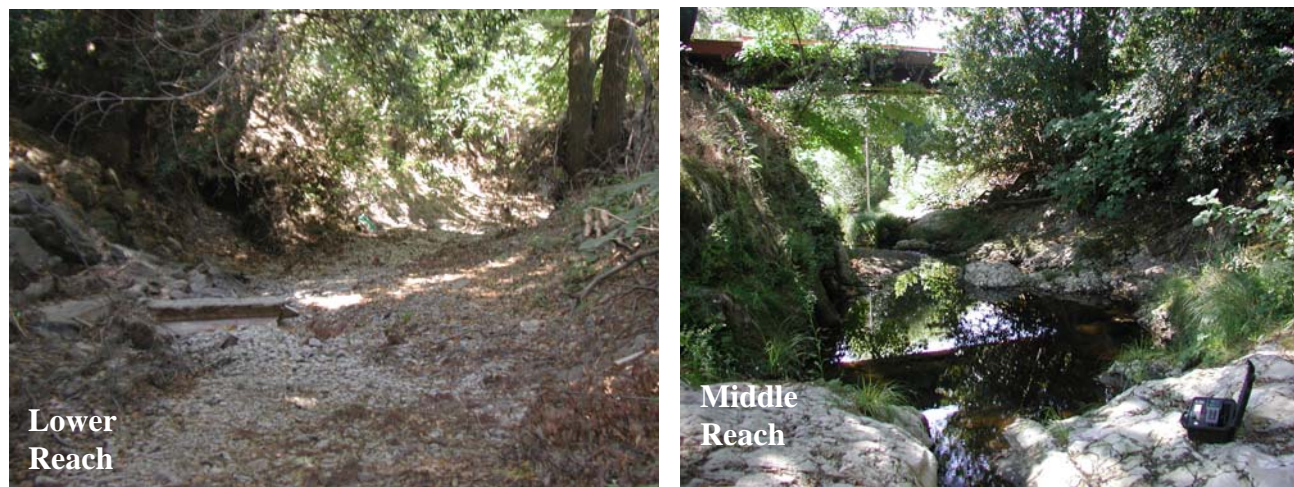
Figure 9: Images from the lower and middle reaches of Carneros Creek. July, 2004.

Precipitation is the primary source of surface water in the watershed and is driven by the natural regional flood/drought regime. Average annual precipitation in the watershed is 28 inches and it is estimated that approximately 52% of rainfall in an average year enters the creek as runoff; wetter and drier years have proportionally greater and less runoff, respectively. The rate at which the creek flows is seasonally dependent; water levels in the creek begin to rise in December and closely follow precipitation events, frequently ceasing to flow from September to November. The overall low levels of seasonal flow are likely the historical norm and are typical of many Napa region creeks. Historic stream surveys have noted lack of channel flow. However, there is evidence of recent decreases in flow. The entire channel has essentially no flow from September to November. The upper reach is completely dry throughout the summer and fall, the middle reach has perennial (year-round) surface flow that slows to a trickle in the late summer, and the lower reach contains only isolated pools, which quickly decrease in volume and quality throughout the summer. Aquatic habitat for cold-water fish is impacted by the naturally low summertime flows and exacerbated by additional decreases. Figure 9 shows an example of stream levels in the lower and middle reaches of Carneros Creek during the month of July.
