Napa River Rutherford Reach Restoration Project
Final Memorandum Report for Annual Maintenance Activities
2013 Field Season

Prepared by: Napa County Flood Control and Water Conservation District

March 2014

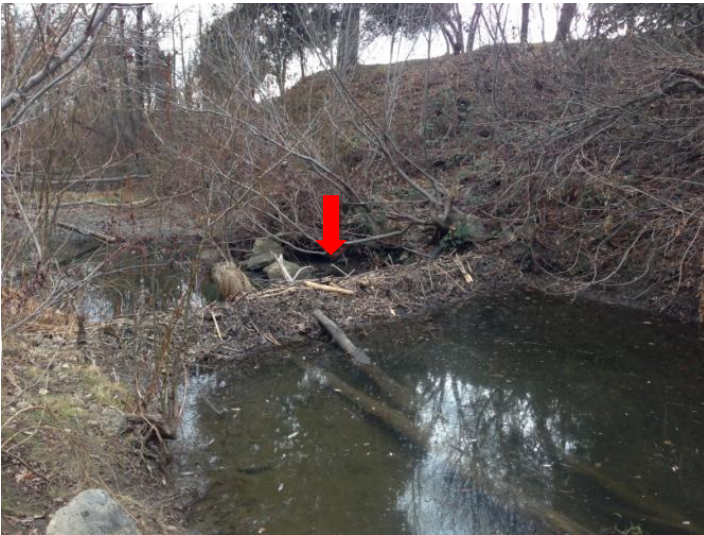
Photo 1: Beaver dam Reach 9

Additionally, an increasing amount of beaver activity (dam building, downing of large significant native trees) necessitated management measures to protect several large cottonwoods. The District wrapped tree trunks with wire mesh to protect them from beavers in order to maintain sufficient riparian canopy and bank stability; Photo 1 and 2 below. It should be noted that District staff has documented several beaver dams in the Project reach but does not view these as an issue that could cause bank erosion or localized flooding. The beaver dams are small and have completely washed away during high winter flows in every instance. During low flow, the dams impound slow water, providing cool pool habitat.
