# Oakville to Oak Knoll Restoration Project Update

**Napa River Restoration: Oakville to Oak Knoll  
Final Concept Plan**

Napa River Restoration - Oakville to Oak Knoll Reach

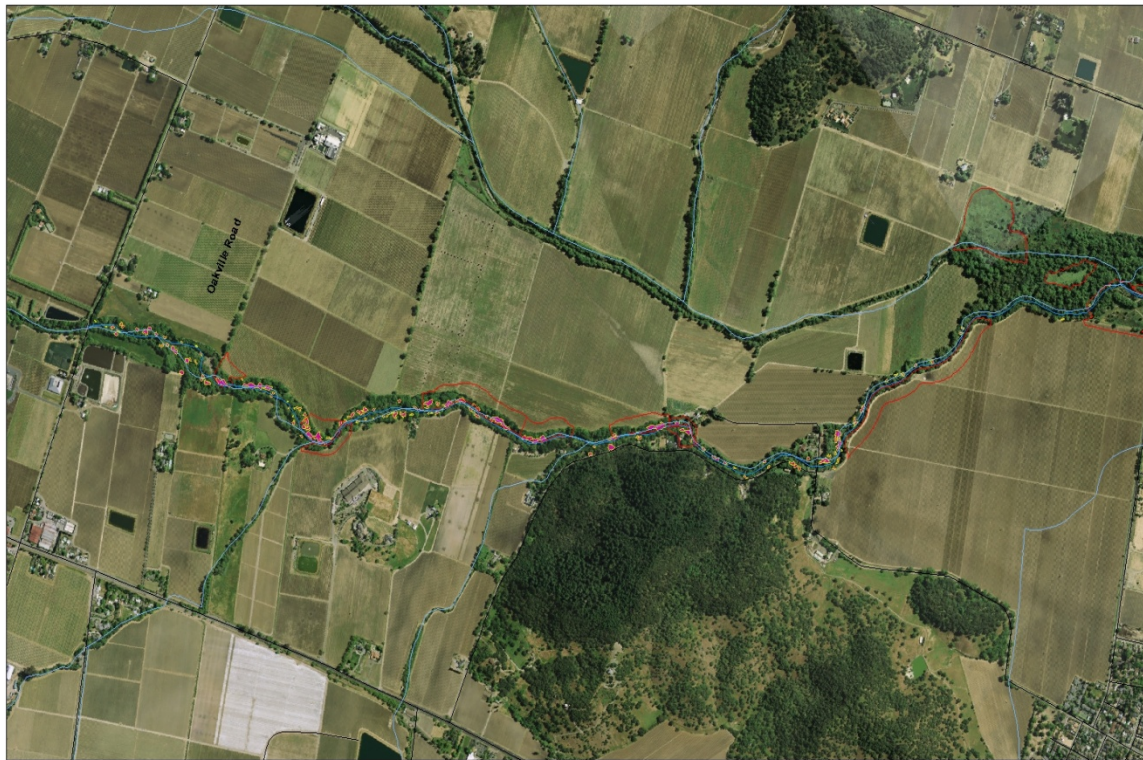
**Napa River Restoration Project**  
**Arundo Donax Management**

Arundo patch

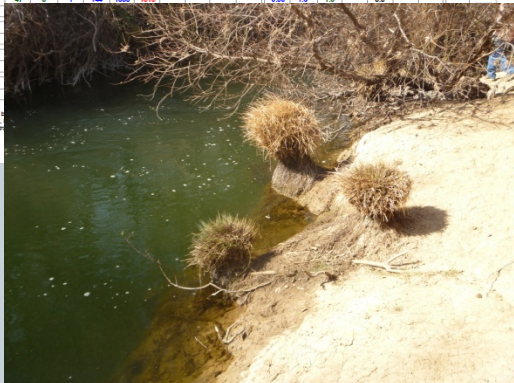
Soil FERTILITY AND MICRONUTRIENT ANALYSIS Report No: 13-045-0051  
Purchase Order:  
Date Printed: 02/28/2013  
Date Recd: 02/14/2013

Sample Description - Sample ID - Plant Name	Hor/Bed TEC	% Quil. Lime	pH	NH <sub>4</sub> -N ppm	NO <sub>3</sub> -N ppm	PO <sub>4</sub> -P ppm	K ppm	Ca ppm	Mg ppm	Cu ppm	Zn ppm	Mn ppm	Fe ppm	Saturation Extract							
														B ppm	SO <sub>4</sub> meq/L	Na meq/L	Ca meq/L	Cl meq/L	ECa dS/m	OM %	Lab No
Site Bulk #1-1 (River Channel)	20	7.8	1	0	1	86	1633	2999						0.19	0.4	2.9	1.4		0.4	0.7	20002
	202	None	0.1	0	0.8	0.4	4.2							0.4	0.3	(1.21)	1.2				
Site 1 Boring B-1-1 (1-1-11)	30	6.7	0	0	1	128	2185	2999						0.02	0.4	2.1	0.1		0.7	0.4	20003
	302	None	0.2	0	0.8	0.4	4.3							0.1	1.1	(1.21)	2.9				
Site 17 Bulk #17-1 (River Channel)	18	6.9	73	1	4	180	1924	1294						0.04	2.2	3.4	0.4		2.0	0.6	20004
	200	None	2.0	0.2	0.9	0.7	3.7							0.1	0.7	(1.09)	0.4				
Site 17 Boring B-17-4 (16-16-5)	17	7.0	12	10	0	198	1822	810						0.04	1.4	1.1	0.1		2.1	0.6	20005
	187	None	0.7	0.2	0.9	0.7	3.1							0.1	0.9	(0.76)	1.8

Site 17 Boring B-17-4 (20-5-21)	24	7.1	6	6	3	186	1997	1163						0.02	1.3	1.8	0.1		0.4	0.4	20006
	207	None	0.2	0.1	0.4	0.7	2.6							0.1	0.4	(1.13)	1.1				
Site 19 Bulk 19-2 (River Channel)	26	6.8	47	8	1	144	1638	1916						0.06	1.3	1.3	0.8				
	216	None																			
Site 19 Boring B-19-P-2 (17-17-5)	22	7.1																			
	116	None																			
Site 22 Bulk #22-2 (River Channel)	22	7.6																			
	281	None																			
Site 22 Boring B-22-1 (20-5-21)	31	7.0																			
	279	None

Sufficiency Factor (1=Deficient for average crop)  
 1=Average field moisture capacity, Major elements,  
 Zinc, Cu, Manganese & Boron by CDTA test  
 \*LOW, \*SUFFICIENT, \*HIGH

- Geology and Geotechnical Investigations
  - Geologic Mapping
  - Drilling and Sampling Borings
    - 46 borings drilled
  - Geotechnical Laboratory Testing
    - Moisture Content
    - Dry Density
    - Atterberg Limits (Plasticity Index)
    - Particle Size Distribution
    - Slaking
  - Geologic and Geotechnical Characterization
    - Soil Classification/Engineering Properties
    - Geologic Cross Sections
- Soil Sampling and Analyses
  - Soil and Plant Laboratory (Jim West)
  - Site Visits with Napa NRCS Scientists

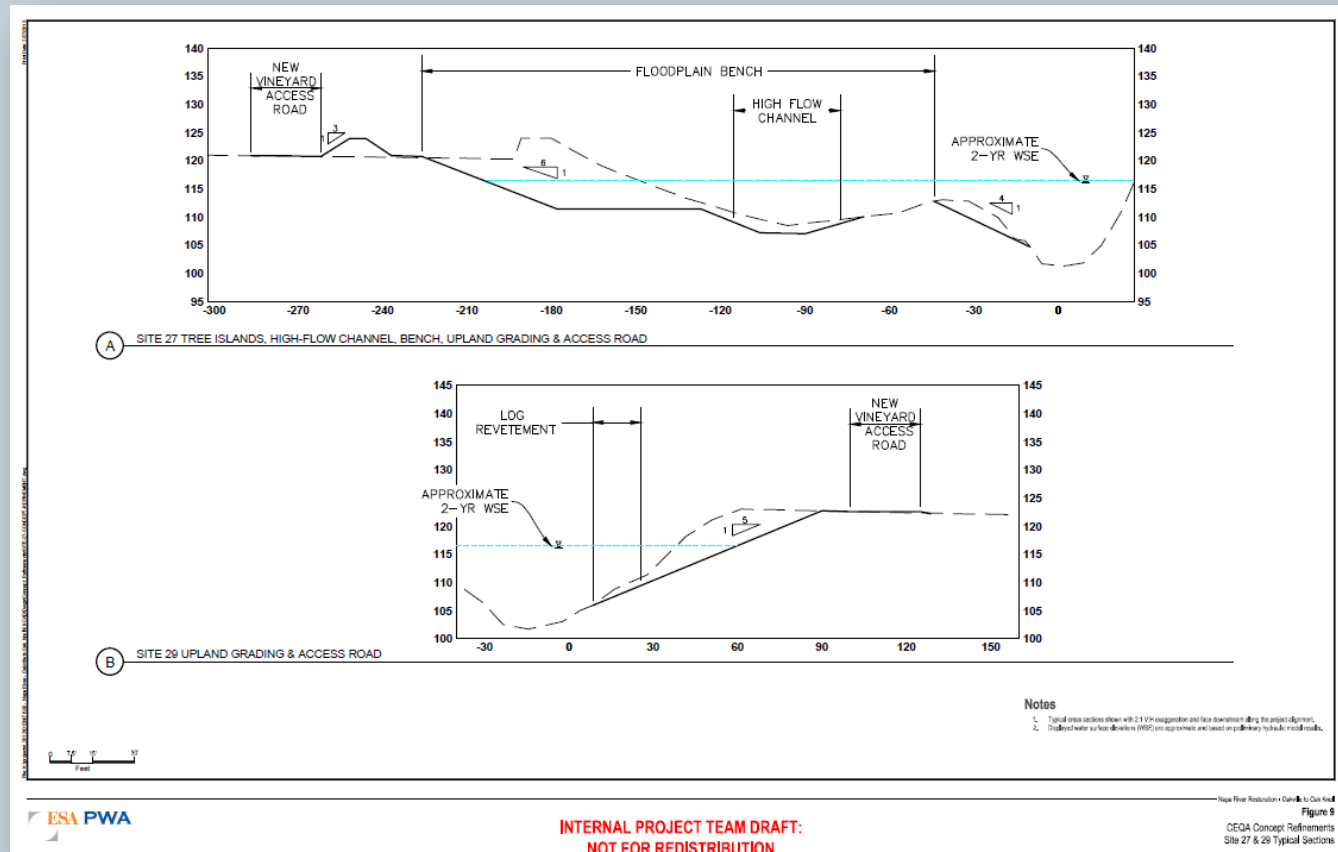
- Active Restoration
  - Vineyard and berm setback (80 to 130 feet)
    - layback oversteepened banks and revegetate
    - new vineyard access roads
  - Large wood structures for geomorphic function, bank stability and refugia
