Napa River Rutherford Reach Restoration Project Annual Stream Maintenance Survey

Napa River Rutherford Reach, June 2017

Prepared by:
Napa County Flood Control and Water Conservation District
Napa County, California

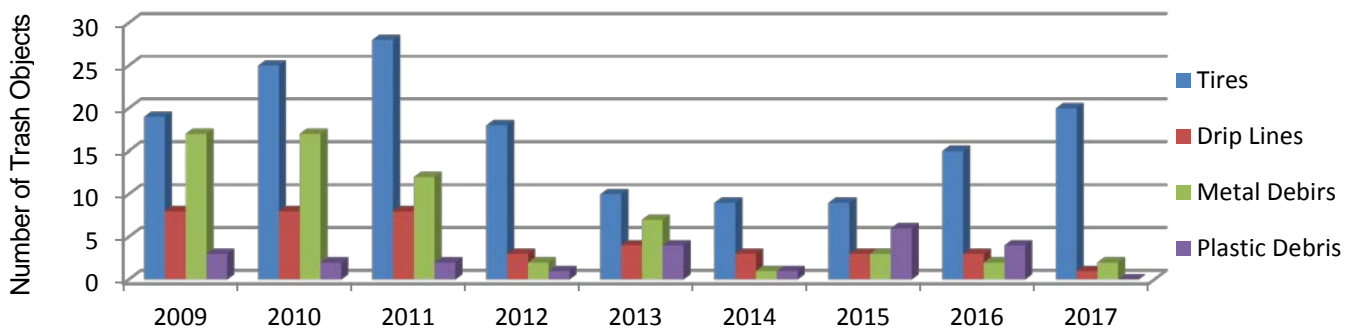
Graph 1: Trash and Debris (2009-2017)

A total of 23 significant occurrences of trash and debris were documented in the Project area. **Graph 1** illustrates the number and types of trash documented during the stream survey, including tires (**Picture 1**), drip lines, metal debris and plastic. Since surveys began in 2009, tires have consistently been the dominant trash documented in the channel. This year 20 of the 23 trash occurrences were tires. The remaining three (3) items included a lawn mower, garden hose and a computer monitor. **Figure 2** shows the location of the surveyed trash and debris.

- Removal of all trash and debris from the stream channel that can be readily accessed and accomplished with hand labor, pulley or winch assisted mechanisms,

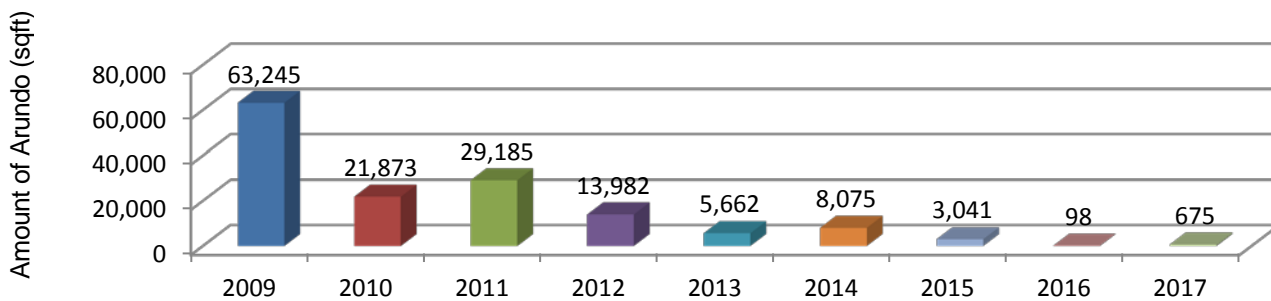
Graph 2: Arundo mapped and treated (2009-2017)

Previous and ongoing efforts to manage and remove Giant reed have been successful in significantly reducing the quantity within the Project area; **Graph 2** below depicts the decline of *Arundo* throughout the Project area since monitoring and management began in 2009. The area of Giant reed documented this year (675 sqft) was more than the previously documented in 2016 (98 sqft). This is likely do to the fact that two significant new clumps were discovered that had previously gone undetected; all areas will be treated in the fall of 2017.

- Treat large accessible patches of invasive and Pierce host vegetation with mechanical and chemical (glyphosate) methods including Himalayan blackberry, mugwort, vinca, California grape and Arundo; this task also includes appropriate re-vegetation and irrigation of treatment sites where treatment has left significant gaps in the riparian under story canopy,

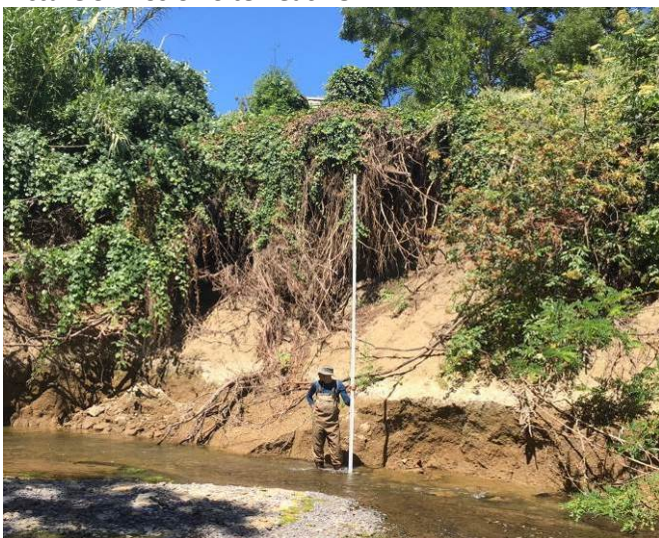
Picture 3: Erosion Site Reach 8

Three areas of significant bank erosion (**Picture 3**) were documented during the survey; the District intends to address/stabilize 2 of the 3 erosion sites utilizing a combination of bio-technical methods during the fall of 2017. The remaining erosion site on Reach 8 is beyond the funding means and scope of services of the MAD; however the District is currently in contact with the landowner at this site to jointly work towards a solution to repair the area in a manner that is consistent with the goals of the Project. See **Table 3** for the location and details of the proposed bank stabilization work to be conducted.

- Repair and stabilize exposed stream bank erosion areas as proposed in Table 3,
- Conducted annual summer mowing of non-native grasses/broadleaf’s on constructed flood plain benches as needed,

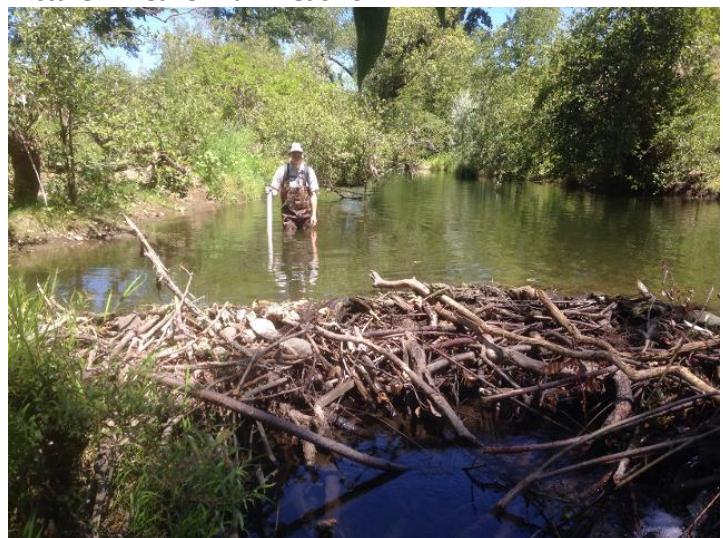
Picture 4: Beaver Dam Reach 3

Previous surveys documented significant levels of beaver activity (dam building, downing of trees) within the Project reach of the Napa River; in 2016 for instance the District documented thirteen active beaver dams. However, it appears that high stream flows from the 2016/2017 winter not only removed all beaver dams documented last year but only two (**Picture 4**) were noted during this year’s Survey. In general, the District does not consider beaver dams to be an issue that would cause bank erosion or localized flooding; the dams are small relative to the river channel and typically wash away each winter (as demonstrated this past winter). During the low flow season, the dams impound slow water, providing cool, pool habitat for aquatic wildlife. However, if a particular dam does appear to present a hazard the District will manage the area appropriately by thinning out the structural wood of the dam to allow for sufficient flow and debris conveyance.

- Coordinate with County Roads Department to remove LWD jam at base of Rutherford Cross Road Bridge,
- Continue to protect large riparian trees with hardware cloth in areas that are in close proximity of active beaver dams,

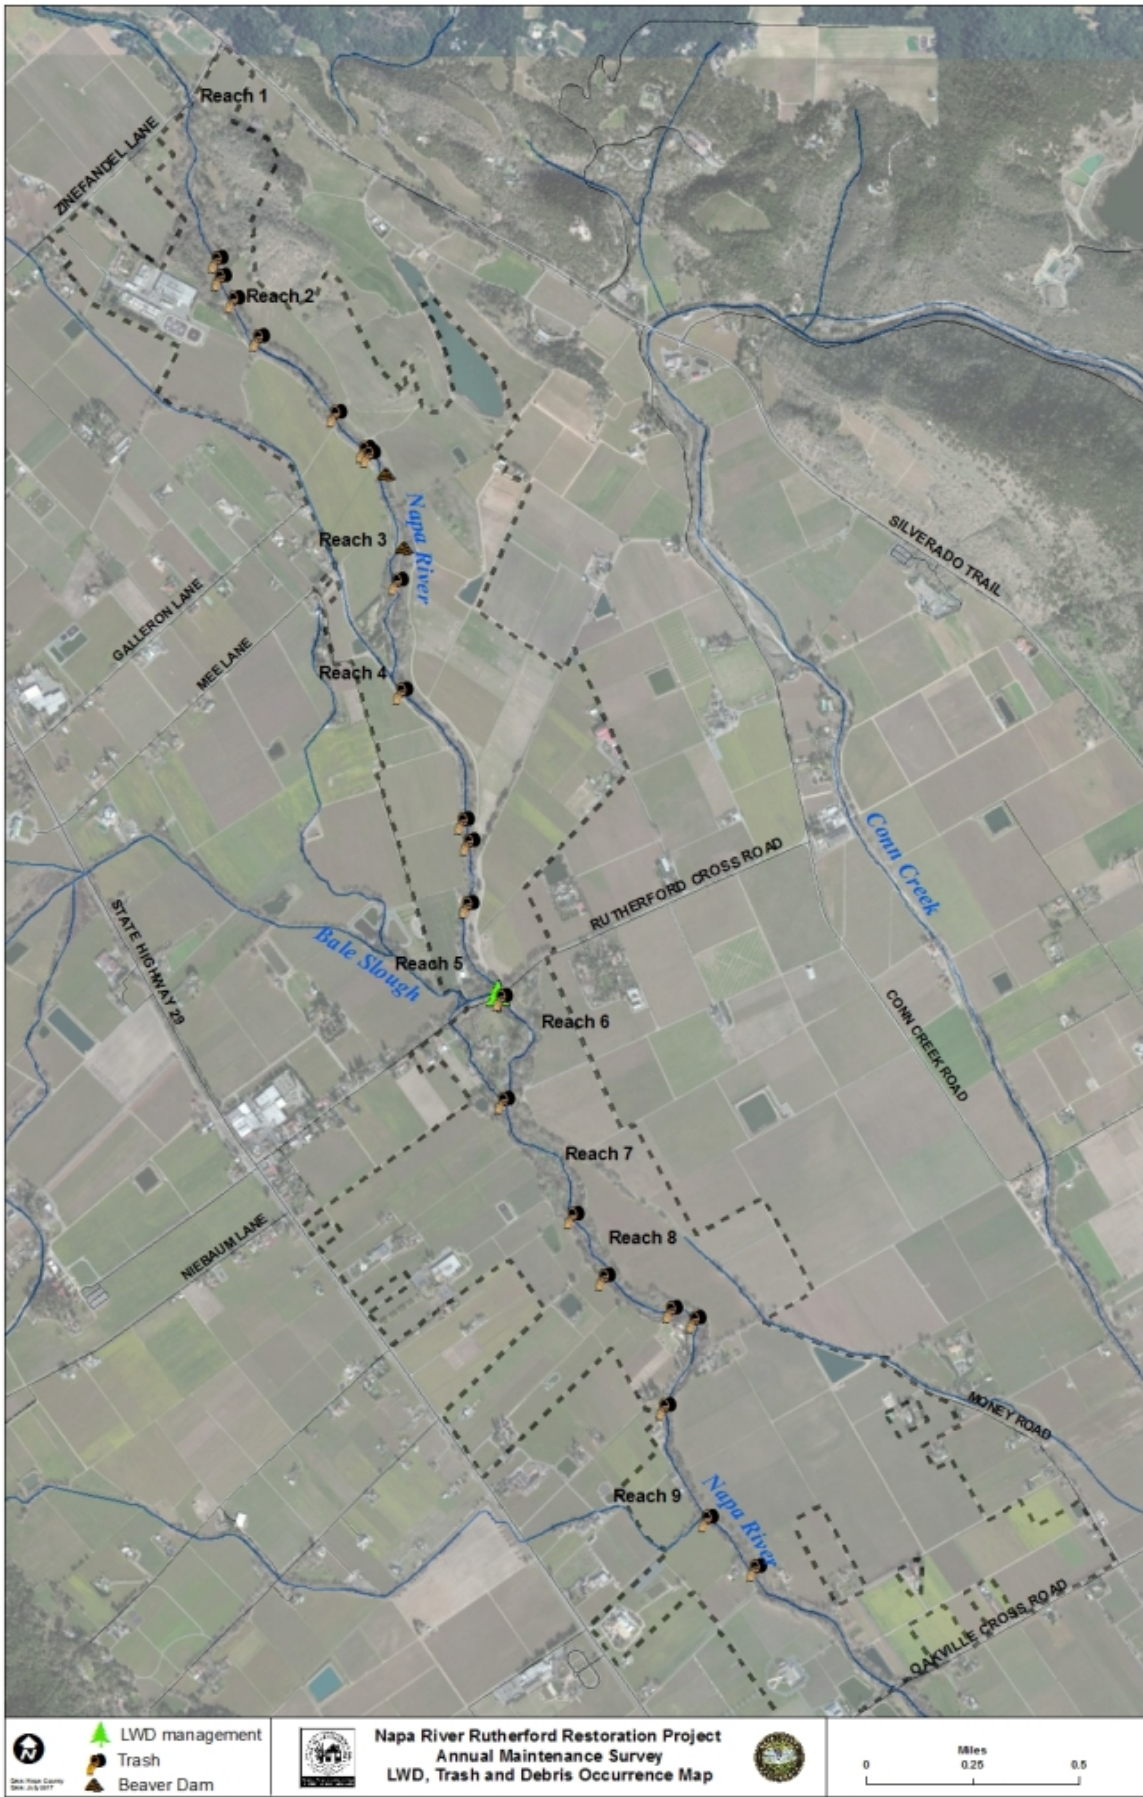
Figure 2: LWD, Trash and Debris Map

Only 1 LWD occurrence in reach 4 (**Figure 2**) was identified during the Survey that was consider significant enough to require management actions. However, the LWD jam is located at the base of Rutherford Cross Road Bridge, a County owned structure, and thus the MAD will not be responsible for maintenance at this site. District staff has contacted the County Roads Department in order to have County roads crew members address this issue.
