# Measure A Lake Berryessa Watershed Improvement Program

Christopher Silke, P.E.  
Engineering Manager  
Department of Public Works

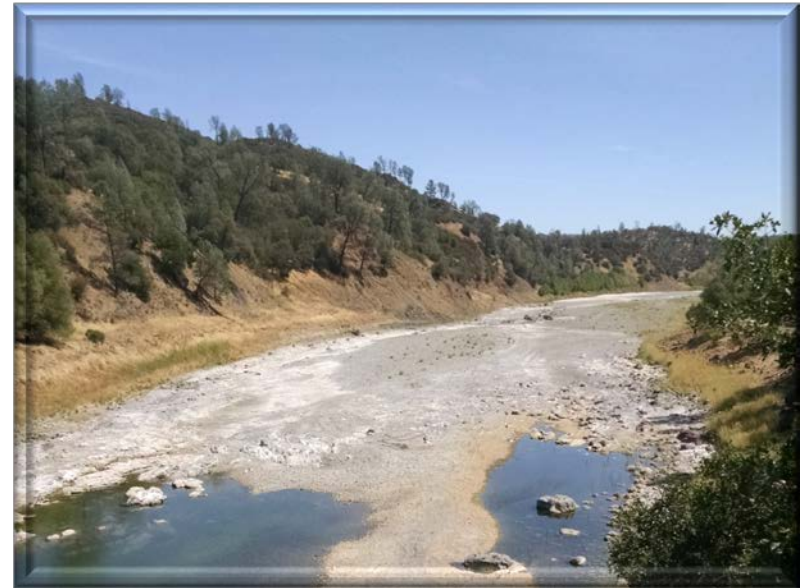
*Didymo* – August 2015

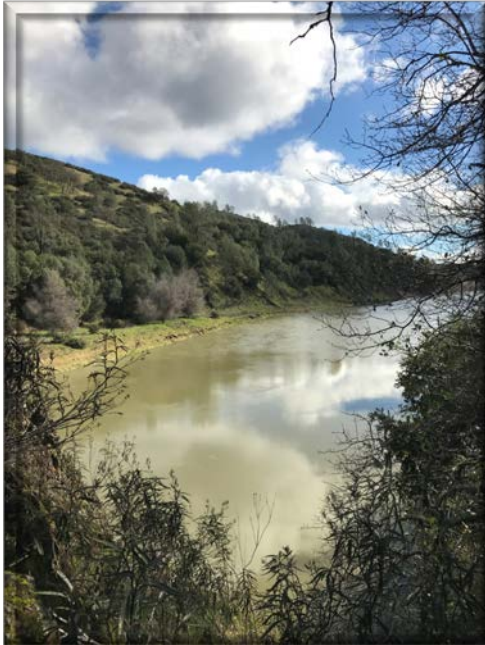
High Turbidity – January 2017

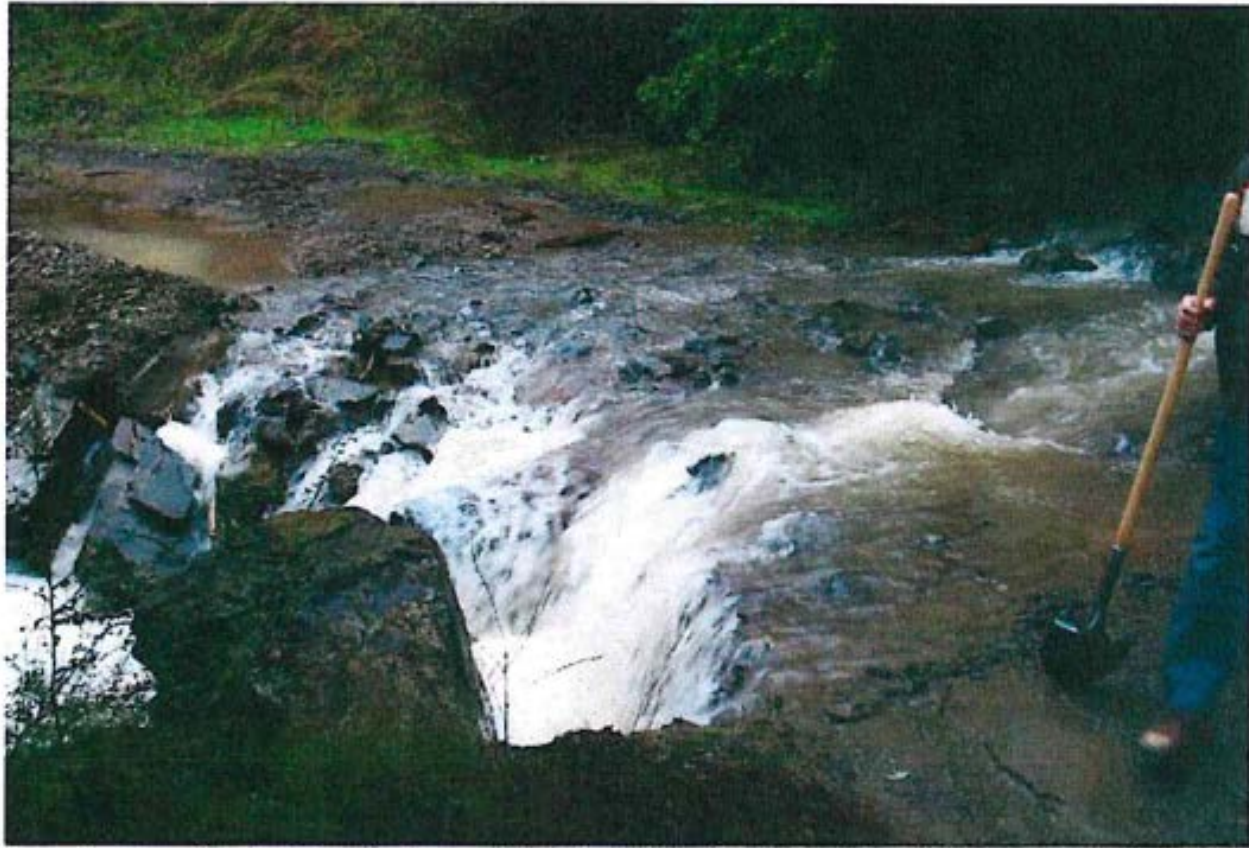
**Figure 1. Overloaded and plugged culvert leads to localized flooding and erosion.**

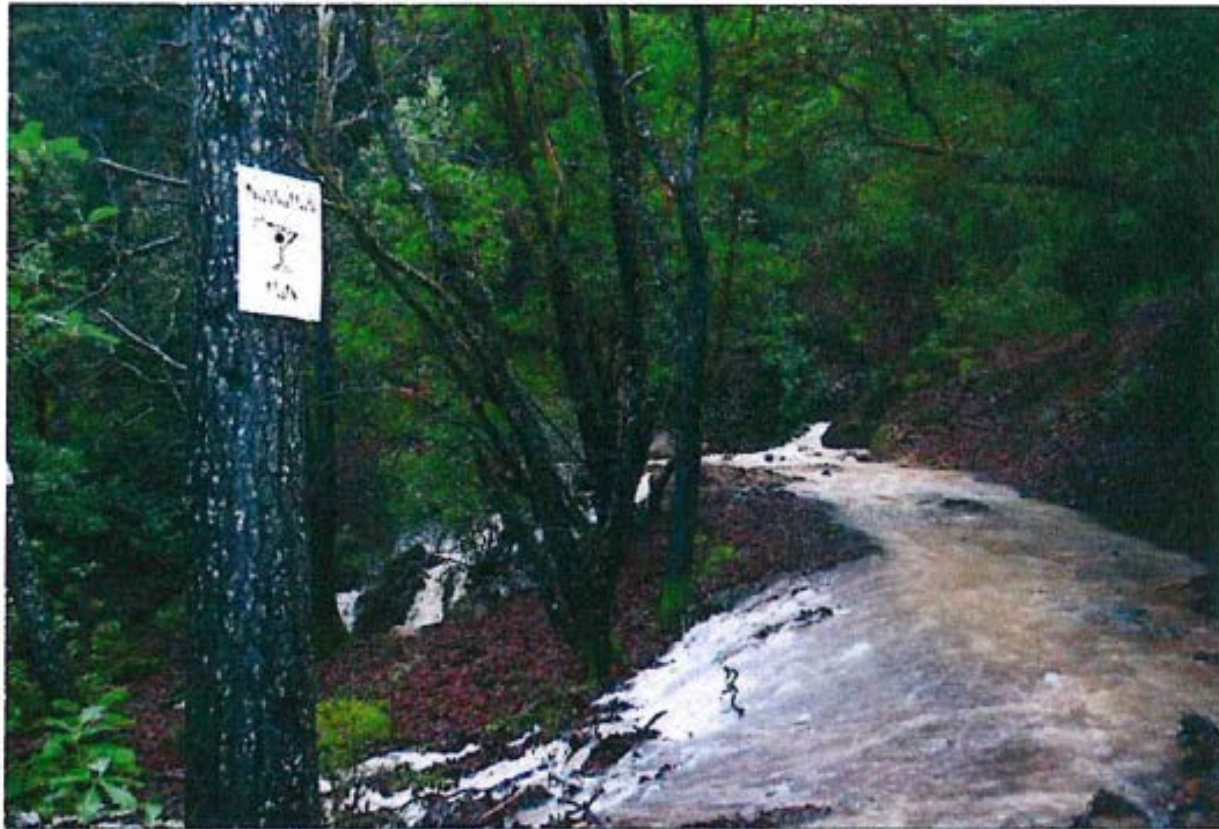
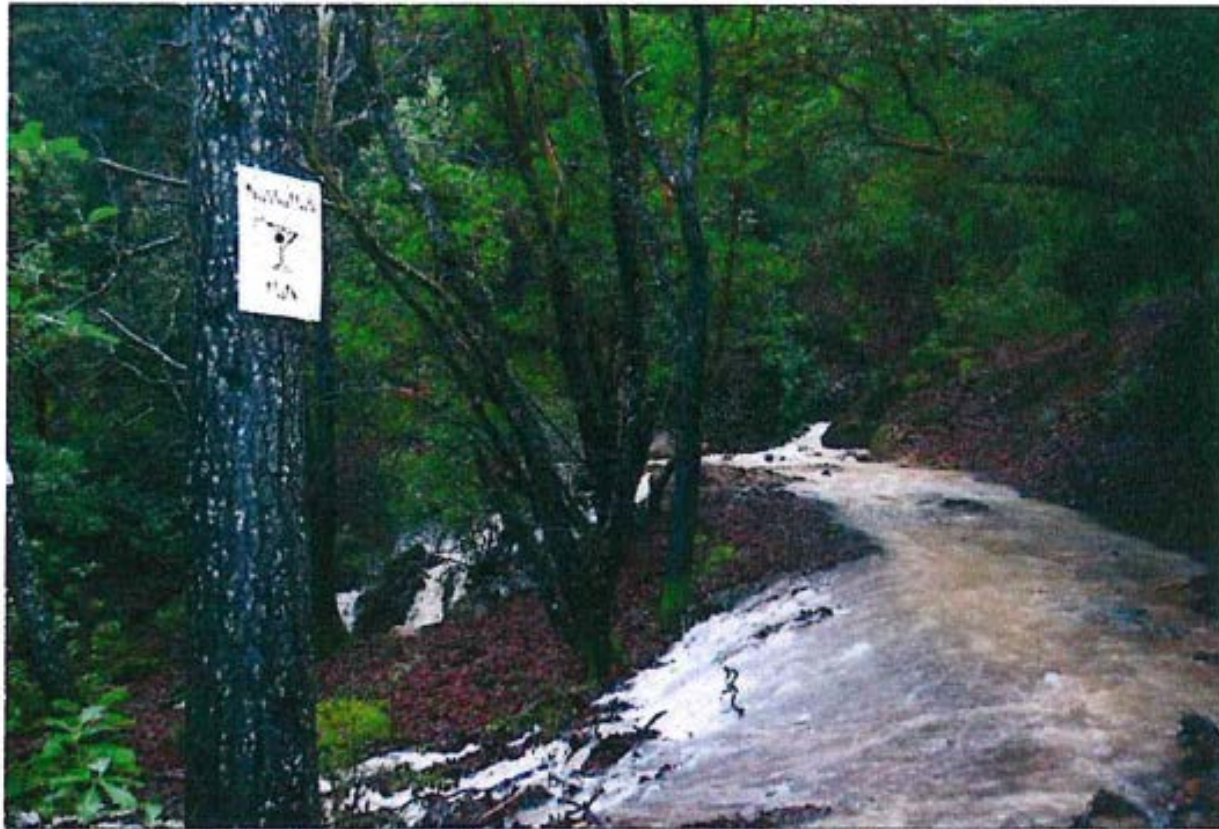
**Figure 2. Roadway completely flooded and eroding downslope.**

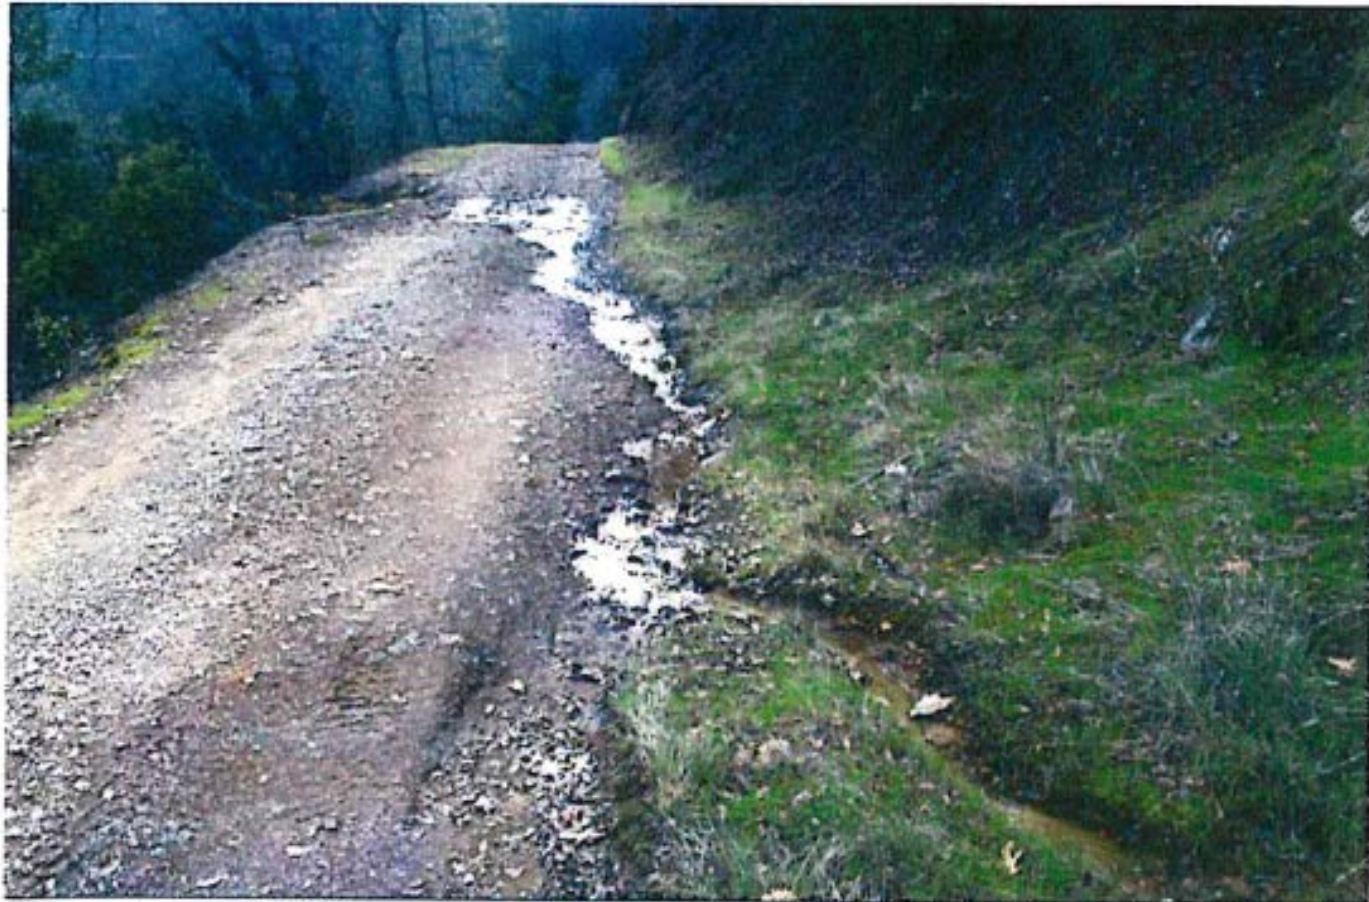
**Figure 3. Minor water way from own ditch and erodes roadway.**

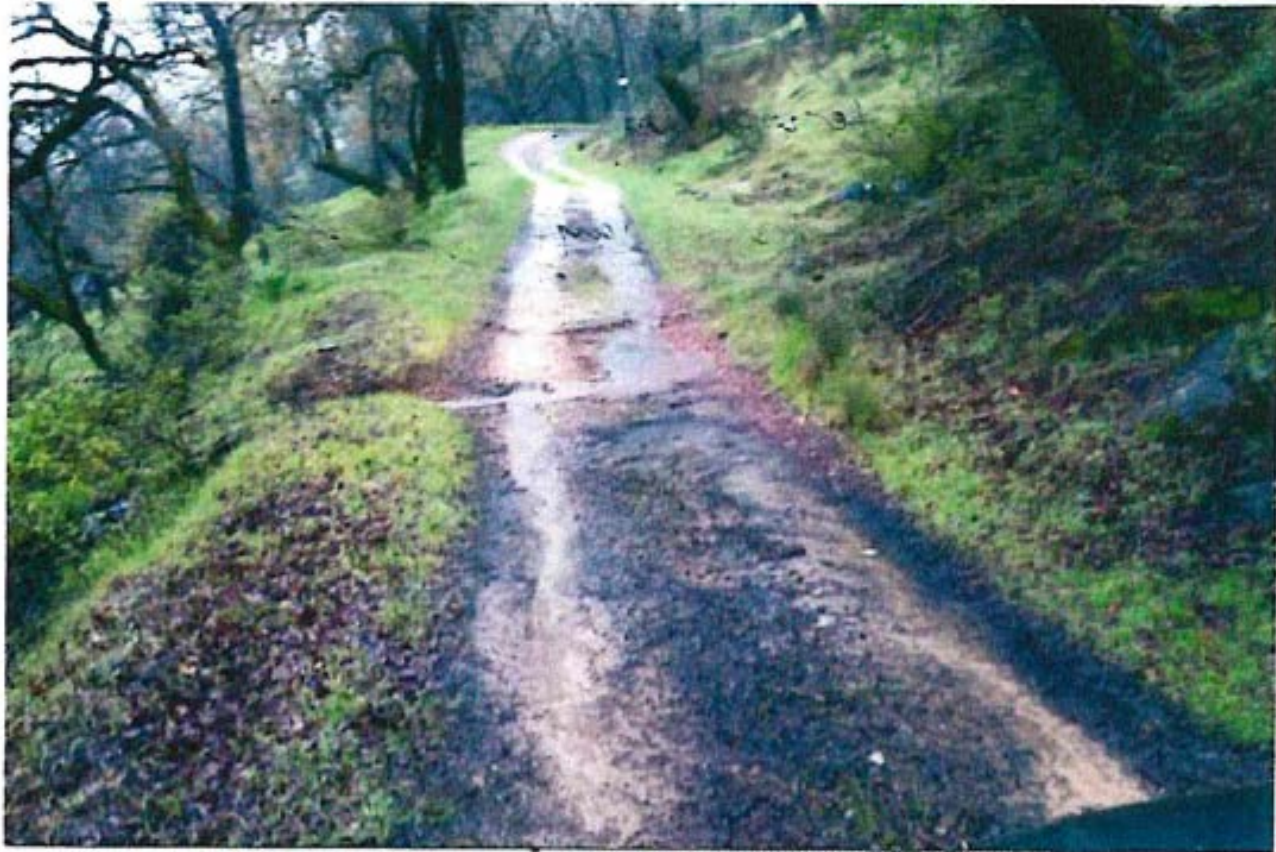
**Figure 4. Tire tracks become ditches during rain event.**

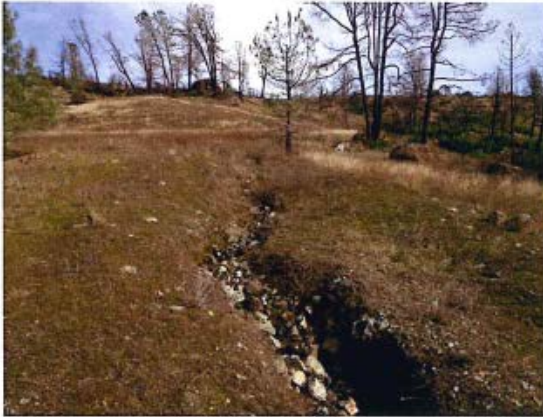
Site 1. Erosion in a serpentine meadow caused by an abandoned road. At the top of the photo the road crosses a transverse ridge diverting water from the background sub-watershed into this one.

- Abandoned Road – 1 km Extensive Soil Loss
- Insert Water Bars
- Build Rock Structures
- Largely Handwork
- Original Drainage Channels
- Place Indigenous Meadow Grasses

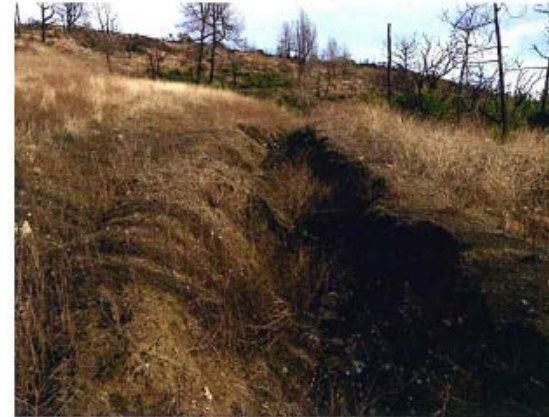
Site 1. Moving upslope towards the diversion point. This channel should not require armoring once water is redirected to its historic flow within sub-watersheds.

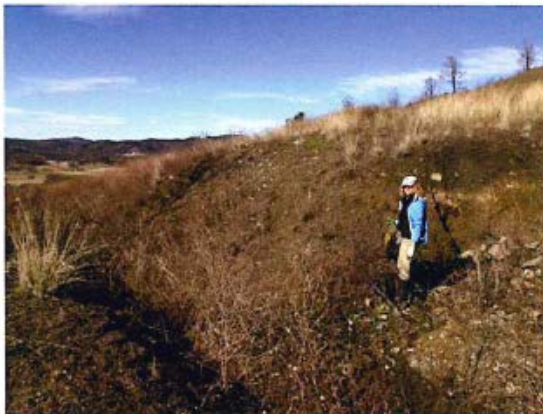
Site 1. The diversion point where the road crosses a transverse ridge and diverts flow from the foreground to the background.

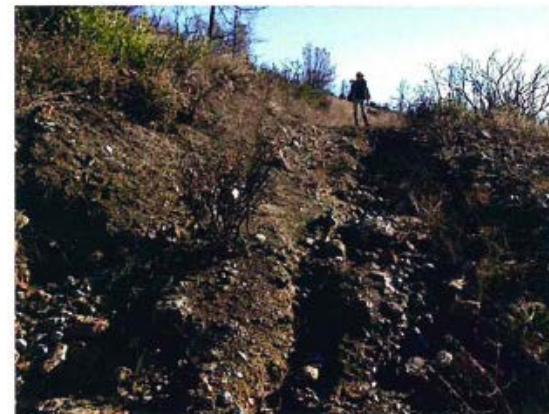
Site 1. One of numerous places along the site 1 road cut where water bars will be built to restore historic drainage patterns.

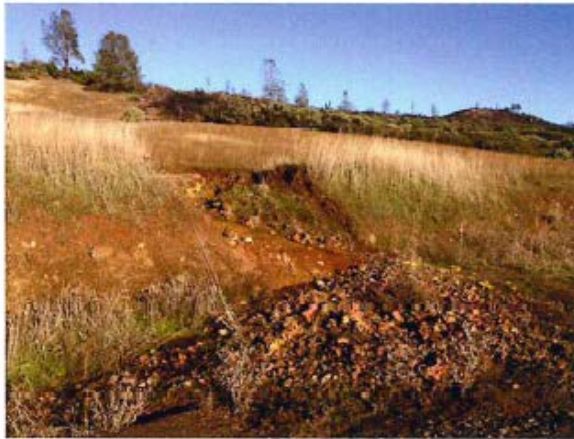
Site 2. A failed drainage ditch from an old pipeline right of way. Similar to site 1, the ditch diverts water from the background sub-watershed into the foreground.

- Failed Drainage Structure
- Abandoned Mine Pipeline ROW
- Multiple Deep Head Cuts
- Reconfigure Drainage to Historic Pathway
- Sediment Retention – “Zuni Bowls”
- Perennial Plant Plugs

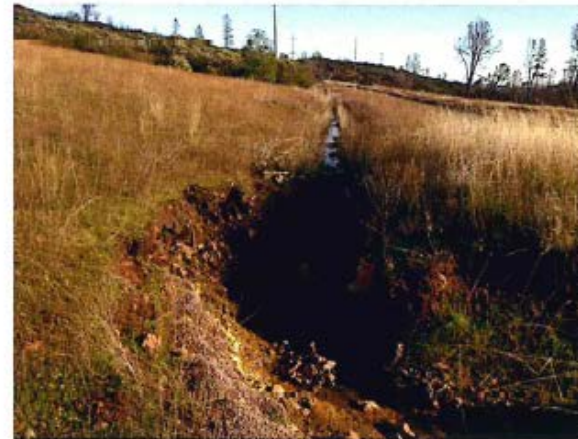
Site 2. The failed ditch has initiated a head cut that threatens serious erosion of this serpentine meadow.

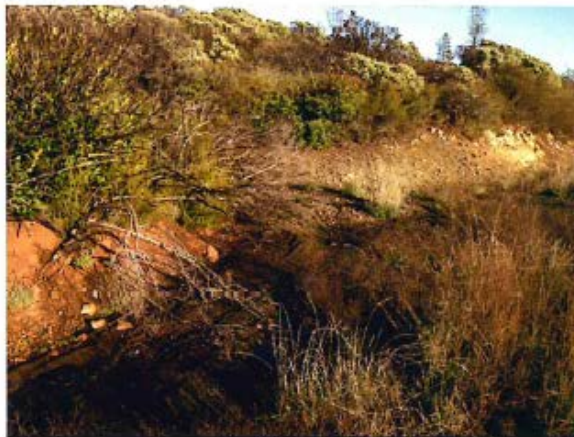
Site 2. The diversion point. Water will be redirected from the ditch, across the right-of-way, into its historic drainage.

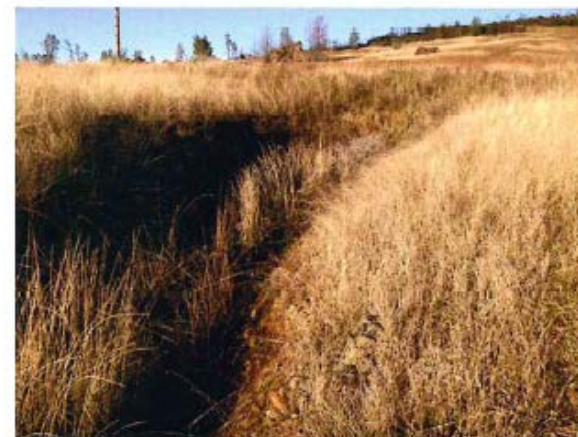
Site 2. Further downstream of the the failed ditch. Restoring historic drainage patterns will prevent further downcutting here.
