NAPA RIVER RUTHERFORD REACH RESTORATION PROJECT 2012 MONITORING REPORT

March 2013

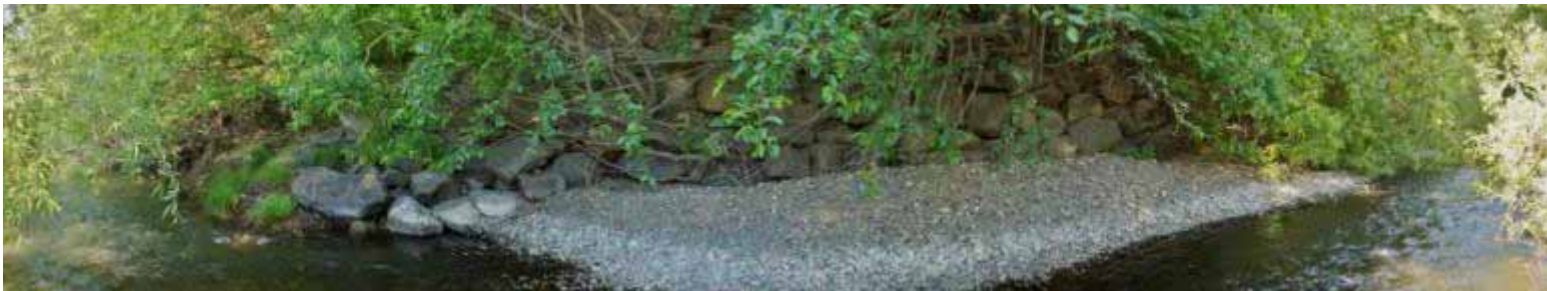
16,200-16,300 New Gravel Bar 2011

The widening of the channel at restoration sites appears to be a contributing factor to the formation of bars, the coarsening of the channel, and the reduction of fines in the gravel bars in restored reaches. Comparison of pebble counts taken at monitoring cross sections in 2009 and 2011 pre- and post- construction of Phase 2: Reach 3 in 2010 demonstrate that a new gravel bar formed at river station 16,300 on the east bank opposite Carpy-Conolly Bench 5. The gravel bar that was sampled in 2009 at station 16,422 prior to construction of Carpy-Conolly Bench 4, constructed from east bank river stations 16,725-16,475, and Carpy-Conolly Bench 5, constructed from east bank river stations 16,350-16,100, no longer existed in 2011. It is likely that the widening of the channel at Bench 5 slowed velocities sufficiently to cause the gravel that was mobilized from the bar between the two benches 122 feet upstream, where the channel width was unchanged, to deposit as a new bar.

Sampling of the new downstream bar in 2011, which set up on the opposite west bank, shows that the median grain size increased from D50=16mm to D50=32mm, and the D84 increased from 32mm to 45mm following the 2011 peak flow event of 7,330 cfs. Significantly, not only did the gravel bed coarsen from 2009, but the percentage of fines in the new bar decreased from 17% to 1% of the sample. The reduction of fines in the gravel might be attributed to the fact that sand and finer sediments can now escape the incised low flow channel and deposit on the restored benches at relatively low flows (less than a 10 year recurrence interval). The sandbar, which accumulated on the new east bank Carpy-Conolly Bench 5, provides further evidence of this hypothesis that instream bench creation in serving to reduce the percent of fines in spawning gravel.

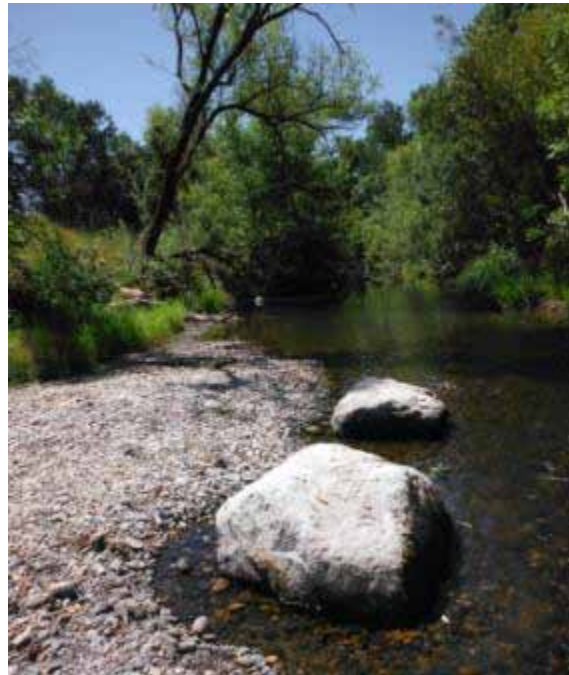
13,050 Bar Post-East Bank Bench Construction 2012

A new gravel bar also formed at station 13,050 on the east bank in 2012 following construction of Phase 3: Reach 4 East Bank Honig Bench 13 between stations 13,150-12,725 in 2011. The gravel in the bar was coarser and contained a lower percentage of fines than the gravel which existed previously in the glide that existed in the reach prior to restoration of the bench. Following the peak flow event of 7,330 in 2011, comparison of pebble counts from 2010 and 2011 show a coarsening of the bar at station 13,050, with an increase in the D50 from 11mm to 22mm, and an

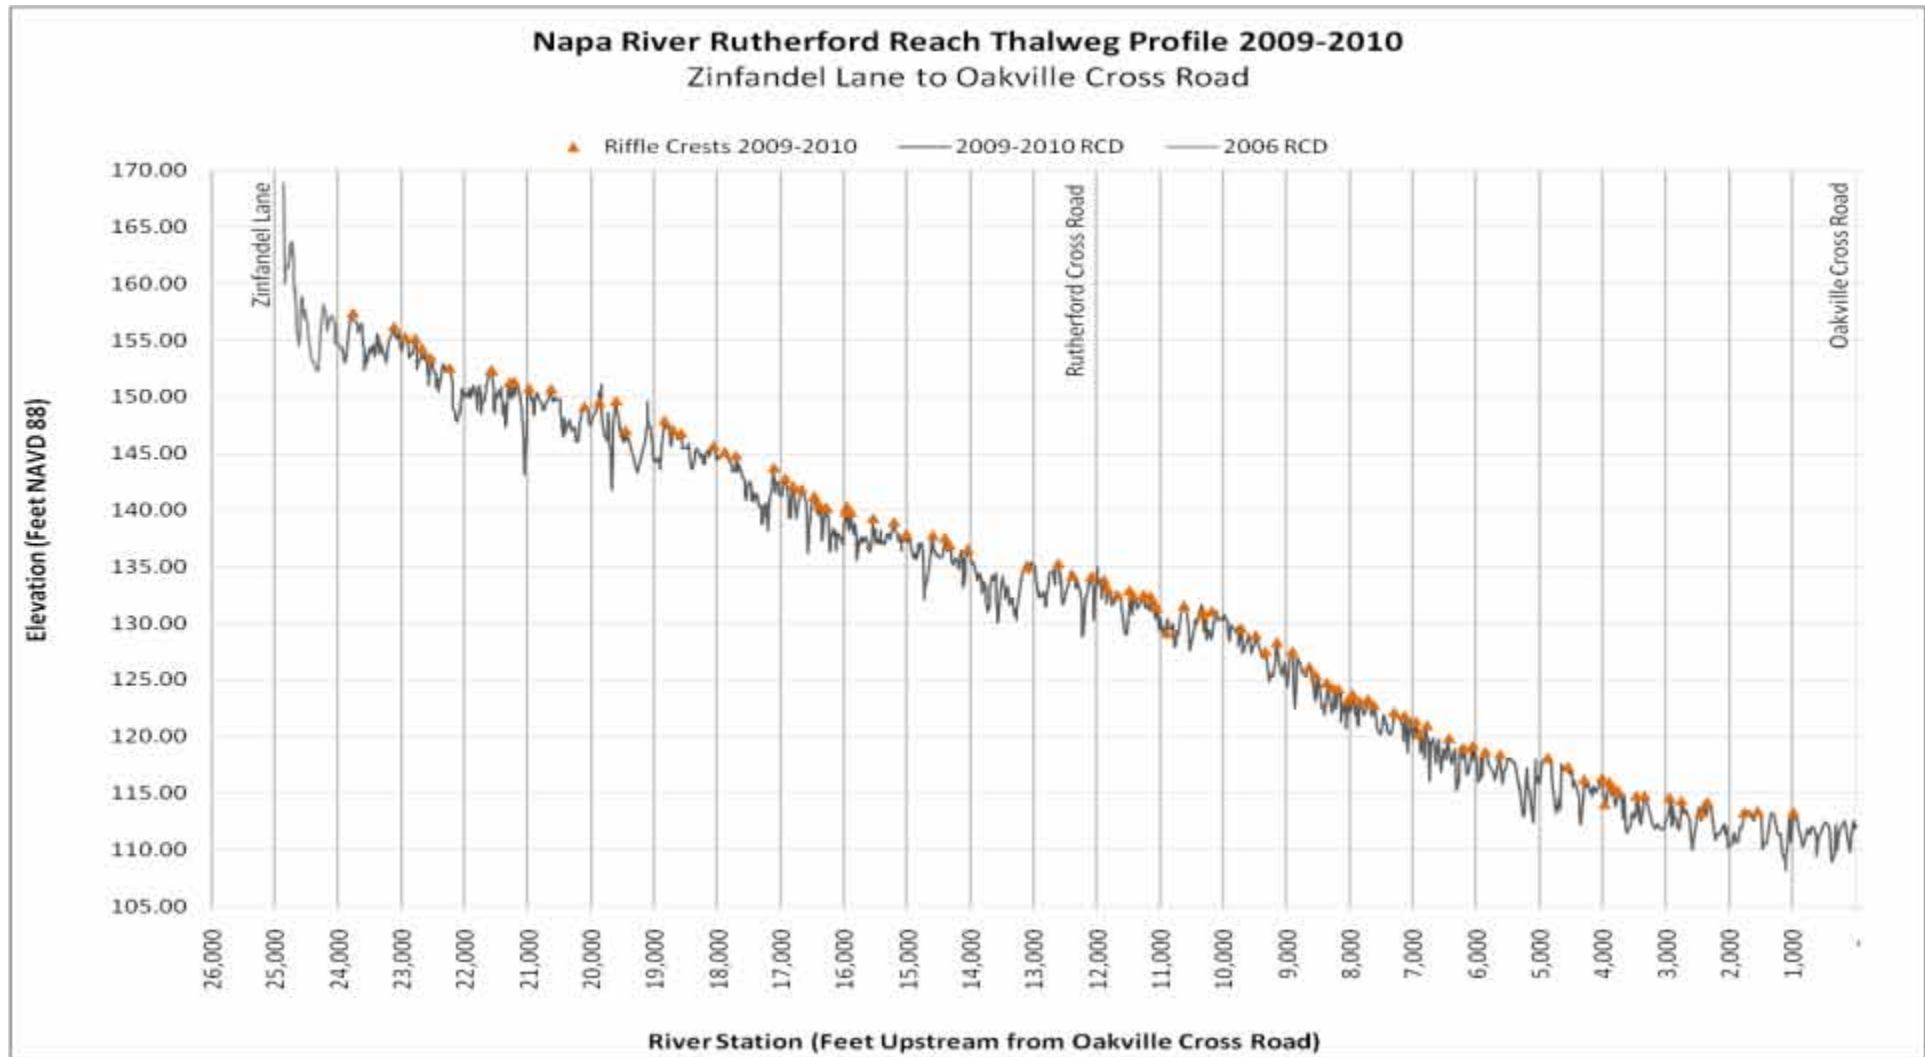
Bar and Riffle Crest Distribution 2009-2012

The performance standard for the project is a 30% increase in riffle length or riffle frequency in treated locations. The 2009-2010 survey constitutes the baseline against which to evaluate progress towards meeting the standard. During the long profile surveys conducted in 2009-2010, 101 riffle crests were mapped throughout the Rutherford Reach. A 30% increase in riffle frequency would equal 131 riffle crests, or an increase in density from 21 riffle crests per mile for the Rutherford Reach to 27 riffle crests per mile, following the completion of the 4.5 mile project, and at least one channel forming 5 year recurrence interval event.

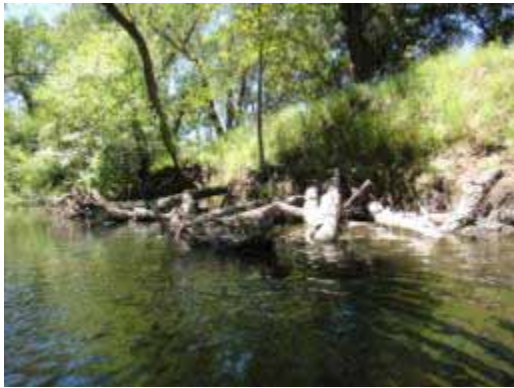
21,850 Toe Log

4 of 11 2010 Installations 2 of 12 2011 Installations					Summer Refugia			Hydraulic Constriction (Feeding Lane)			Pool Scour		
River Station	Year Installed	Installation	Restoration Label	Configuration	2010	2011	2012	2010	2011	2012	2010	2011	2012
21,850	2010	Toe Log	WD-21850-R	Jam > 10	-	X	X	-	X	X	-	X	X
21,670	2010	Spider Log	WD-21670-L	Accumulation 2 < 9	-	X	X	-	X	X	-	X	X
17,225	2010	Root Wad	WD-17225-R	Single > 18"	-	X	X	-	X	X	-	X	X
16,125	2010	Root Wad	WD-16125-L	Single > 18"	-	X	X	-	X	X	-	X	X
13,590	2011	Low Profile Log	WD-13590-L	Single > 18"	-	-	X	-	-	X	-	-	X
12,420	2011	Root Wad	WD-12420-L	Accumulation 2 < 9	-	-	X	-	-	X	-	-	X

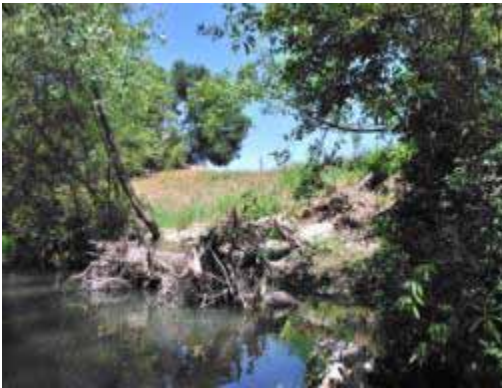
12,420 Root Wad

Cluster		cluster than the surrounding currents. No salmonids were observed around this feature during the snorkel survey. All boulders were covered heavily with filamentous algae.
WD-12410-L	12410	Root Wad	Low-flow	This rootwad appears to provide good refuge habitat during low to moderate flows. A deep scour hole has developed immediately around the feature, and water velocities measured just downstream of the rootwad were significantly lower than the surrounding currents. During the snorkel survey, no salmonids were present around this feature, but several other native fish species were observed.
WD-12600-L	12600	Root Wad	Low-flow	This rootwad is located at the left edge of a deep (>4 feet) pool and creates a slow backwater habitat. No fish were observed around this feature during the snorkel survey.
WD-12780-L	12780	Root Wad	Low-flow	This rootwad appears to provide good refuge habitat during low to moderate flows. A distinct scour hole has developed immediately around the feature, and a sand deposit was observed just downstream of the rootwad. During the snorkel survey, no salmonids were present around this feature, but several other native fish species were observed.

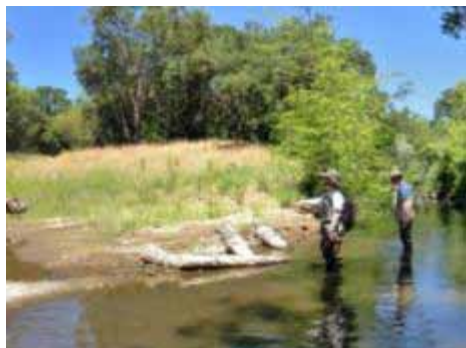
7 of 11 2010 Installations 2 of 12 2011 Installations					Summer Refugia			Winter Refugia			Hydraulic Constriction (Feeding Lane)			Pool Scour			Bank Stability		
River Station	Year Installed	Installation	Restoration Label	Configuration	2010	2011	2012	2010	2011	2012	2010	2011	2012	2010	2011	2012	2010	2011	2012
22,000	2010	Spider Log	WD-22000-R	Accumulation 2 < 9	-			-			-			-			-	X	X
21,900	2010	Spider Log	WD-21900-L	Single > 18"	-			-			-			-			-	X	X
19,475	2010	Toe Log	WD-19475-R	Single > 18"	-	X		-			-	X		-			-		
18,250	2010	Boulder Cluster	BC-18250-M	Boulder Cluster	-			-	X		-			-	X		-		X
17,700	2010	Root Wad	WD-17700-R	Single > 18"	-			-			-			-			-	X	X
17,425	2010	Root Wad	WD-17425-R	Single > 18"	-	X		-			-			-			-	X	
16,900	2010	Root Wad	WD-16900-R	Single > 18"	-			-	X		-			-			-	X	X
12,990	2011	Low Profile Log	WD-12990-L	Single > 18"	-	-		-	-		-	-		-	-		-	-	X
12,800	2011	Root Wad	WD-12800-L	Accumulation 2 < 9	-	-		-	-		-	-	X	-	-		-	-

22,000 Spider Log at Alcove
