NAPA RIVER RUTHERFORD REACH RESTORATION PROJECT ANNUAL MONITORING REPORT- 2014

Prepared April 2015 by:

Napa County Flood Control and Water Conservation District
804 First Street
Napa, California, 94559
Contact: Jeremy Sarrow
(707) 259-8204

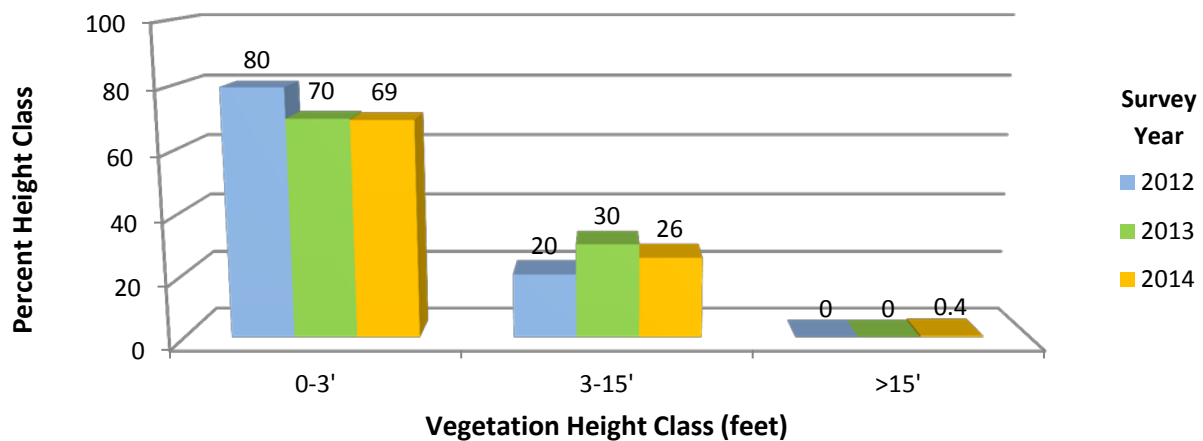
Chart 3: Average height class herbaceous and woody vegetation for line transect surveys (2012-2014)

Chart 3, below, presents the average percent for a given height class for each transect line surveyed from 2012 through 2014. Approximately 69% of the vegetation measured in 2014 at a given transect ranged between 0 and 3 feet tall while approximately 26% of the vegetation measured in 2014 ranged between 3 and 15 feet in height. In 2014 several trees (cottonwoods) measured along a transect (CAY2) in reach 3 were 15 feet in height or greater providing data for the next height class and documenting maturation of the over story canopy within Project restoration areas. This represents a milestone in the average vegetation height measured from previous survey years and is indicative of successful plant establishment providing mature riparian habitat within the Project. Representative photos of the sites are shown in **Appendix B**.

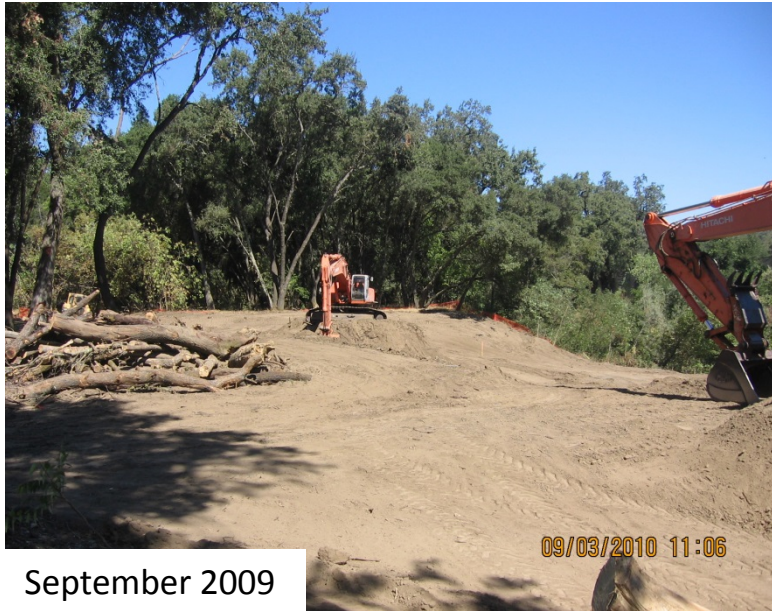
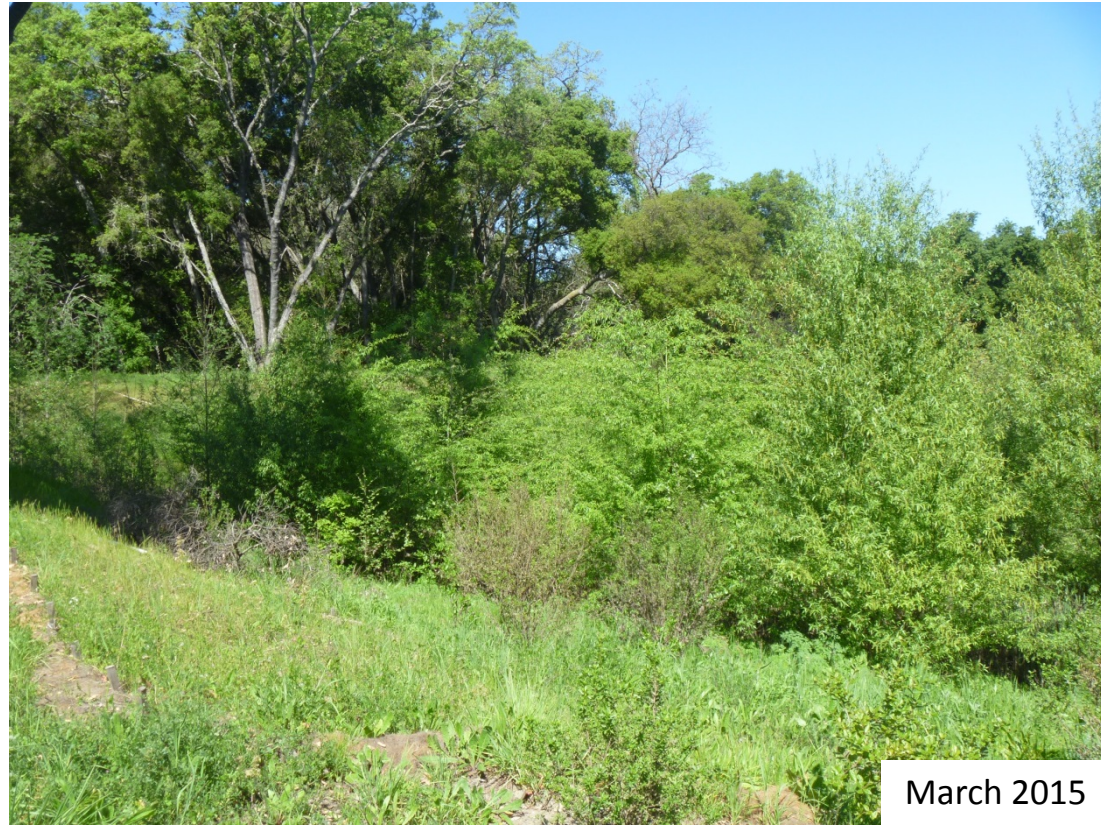
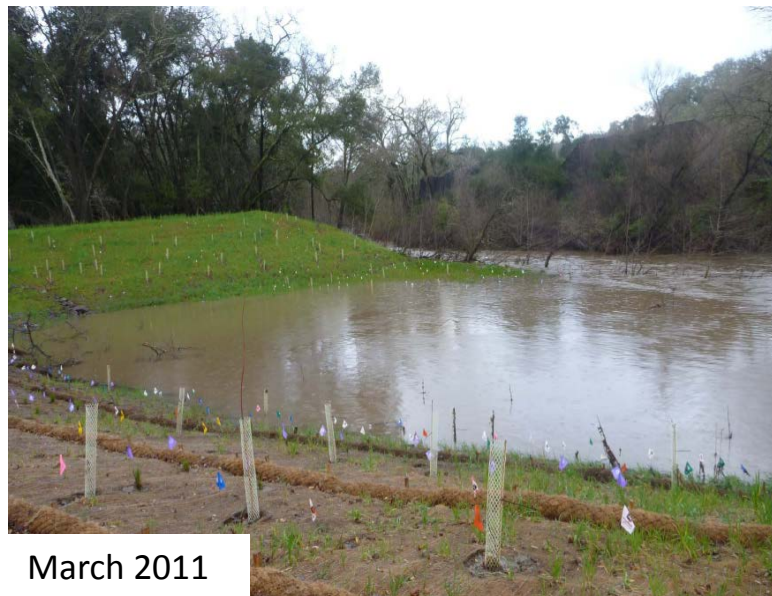
River Station 219+50
Alcove: The Ranch Winery / Sutter Home, West Bank

September 2009

March 2015

March 2011

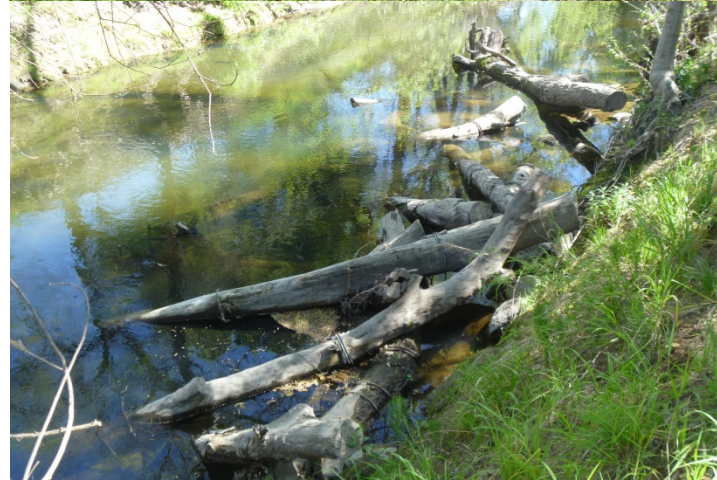
LWD, Ranch Winery,
March 2015

As part of the annual channel survey naturally recruited and installed large wood debris (LWD), and boulder clusters, have been monitored since 2009. Naturally recruited LWD is monitored for year-to-year comparison to track trends in location, quantity, size, and function. Installed LWD and boulder clusters are assessed to verify their persistence, functionality (summer and winter refugia) and to assess potential damage or maintenance needs. For purposes of the survey, naturally recruited LWD is defined as piece of wood located in channel below top of bank that is at least 6 feet in length and 18 inches in diameter. For each occurrence, it is noted whether the LWD or boulder cluster is performing any of the following functions: spawning gravel recruitment, hydraulic constriction, pool scour, summer refugia, winter high-flow refugia, or bank stability. Some occurrences provide multiple functions, and some are not currently providing any of the listed functions.

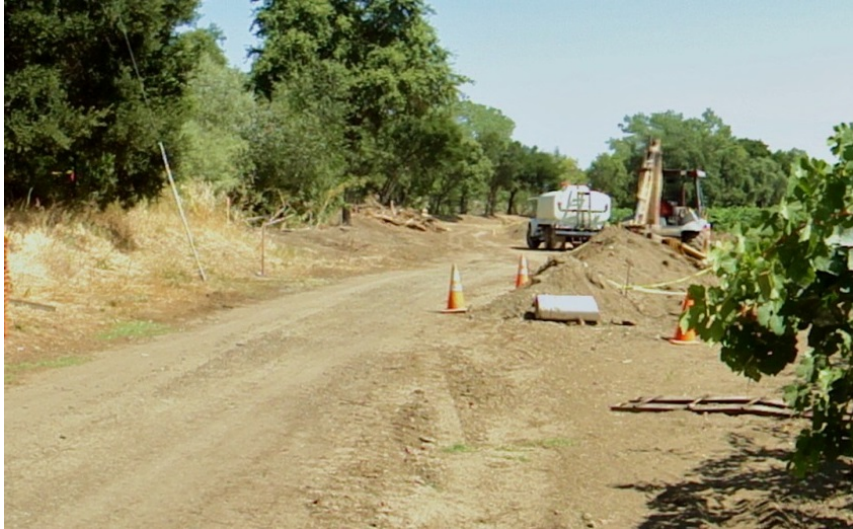
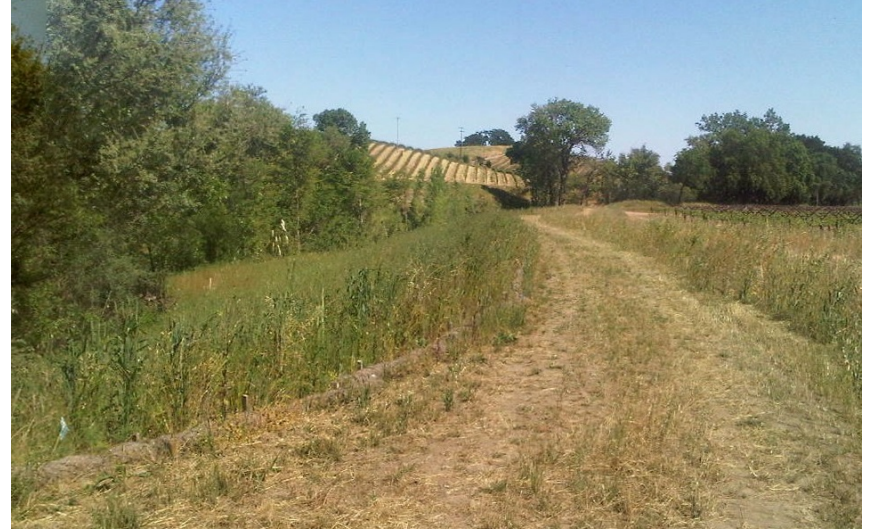
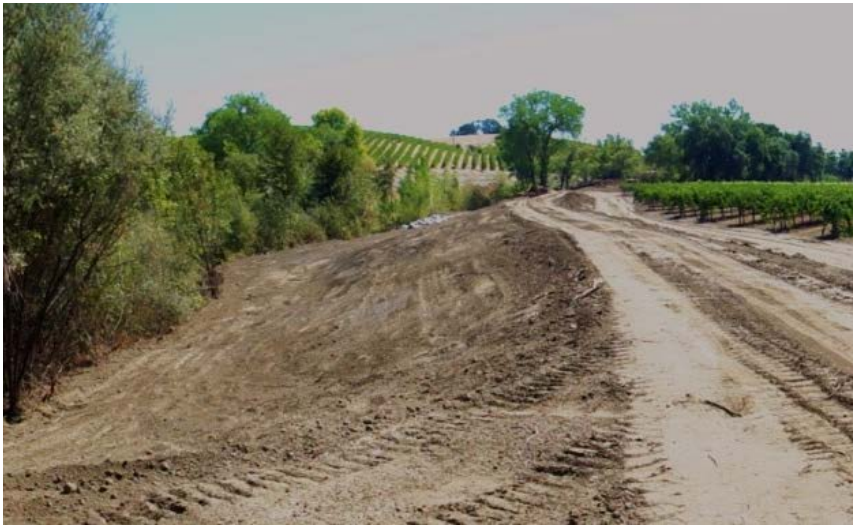
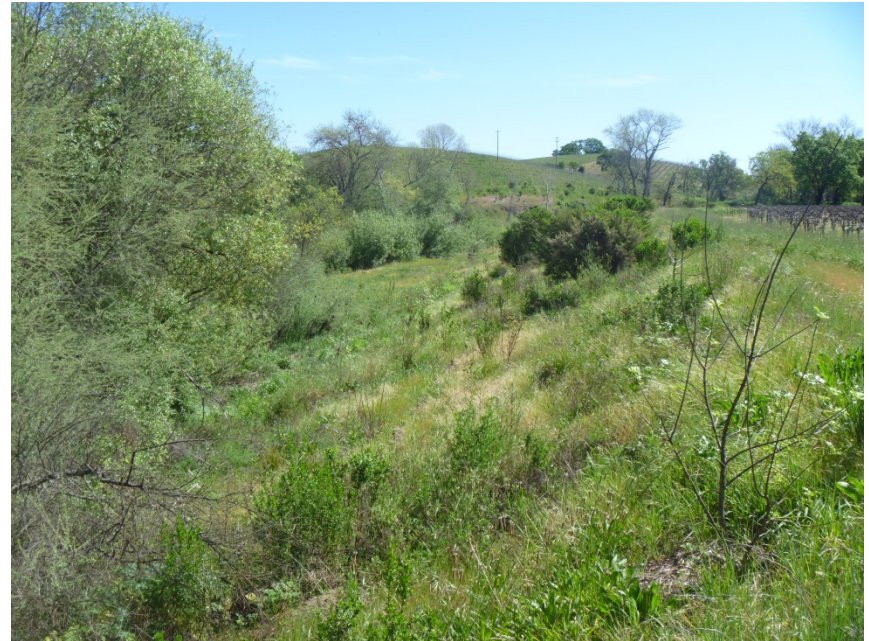
River Station 198+50
Bench: Frog's Leap, West Bank

July 2010

August 2010

April 2015

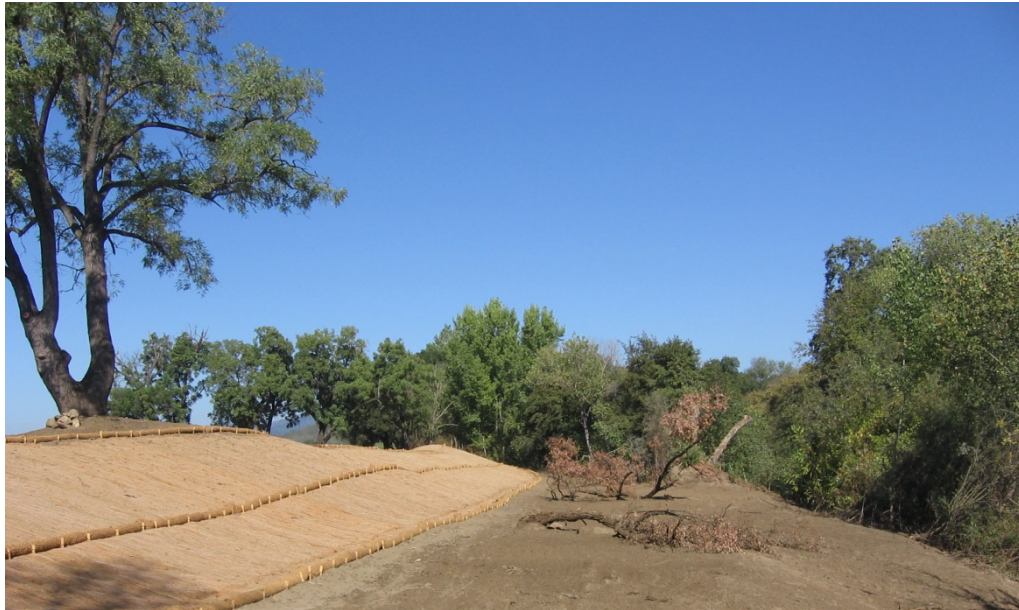
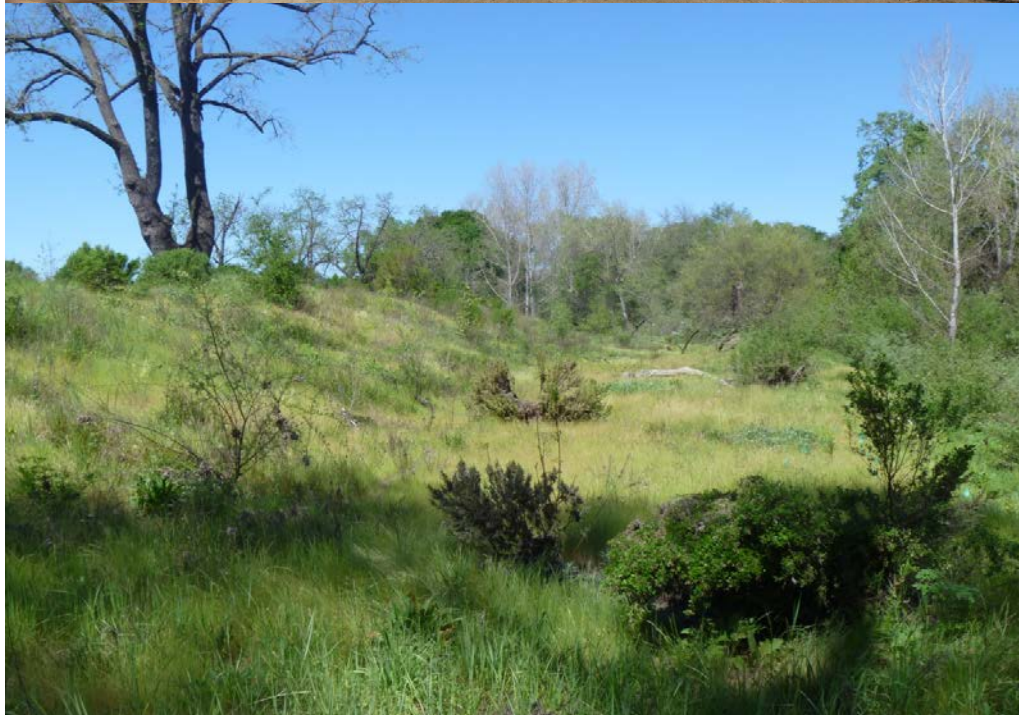
River Station 181+00
Setback Berm: Caymus Bench, West Bank

December 2010

March 2015

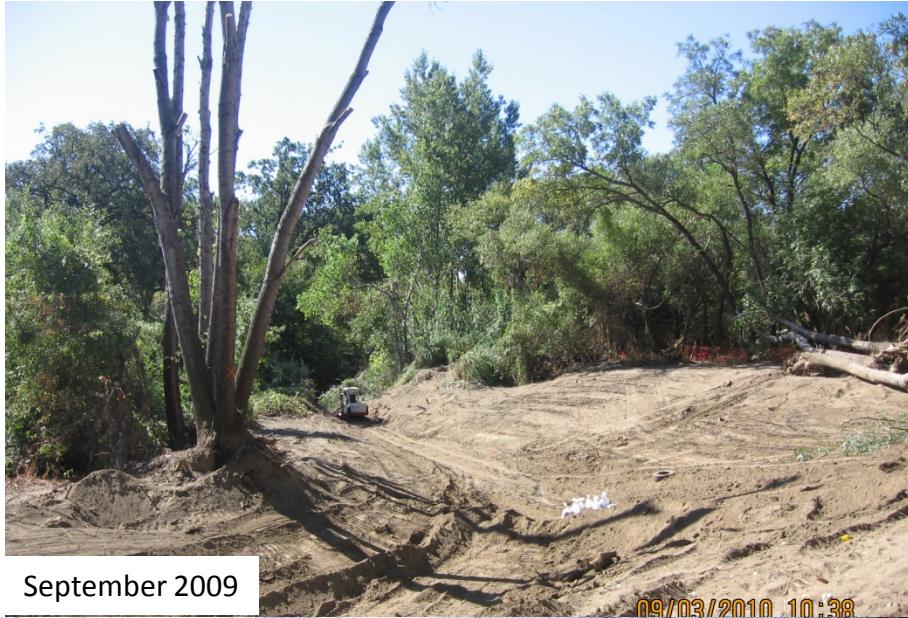
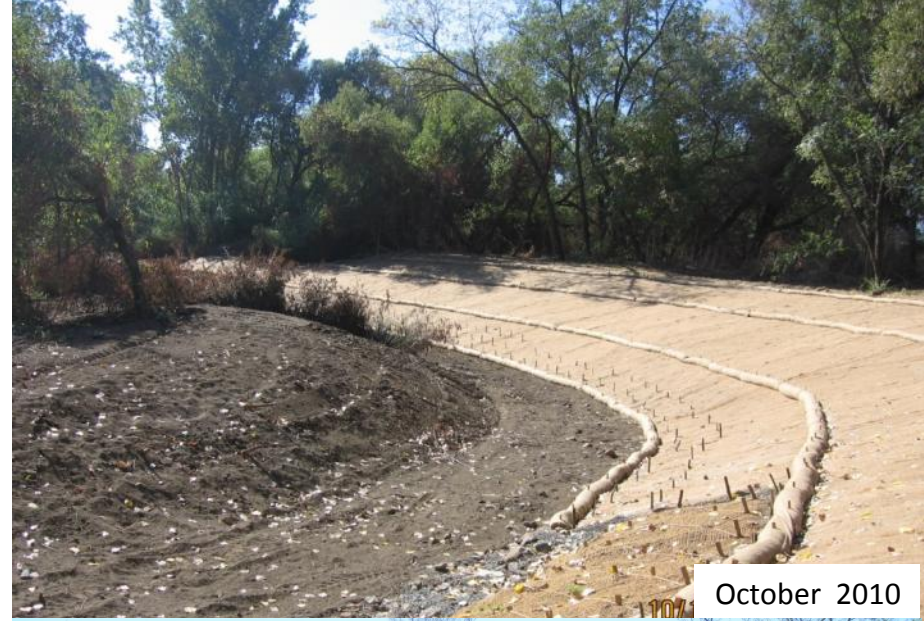
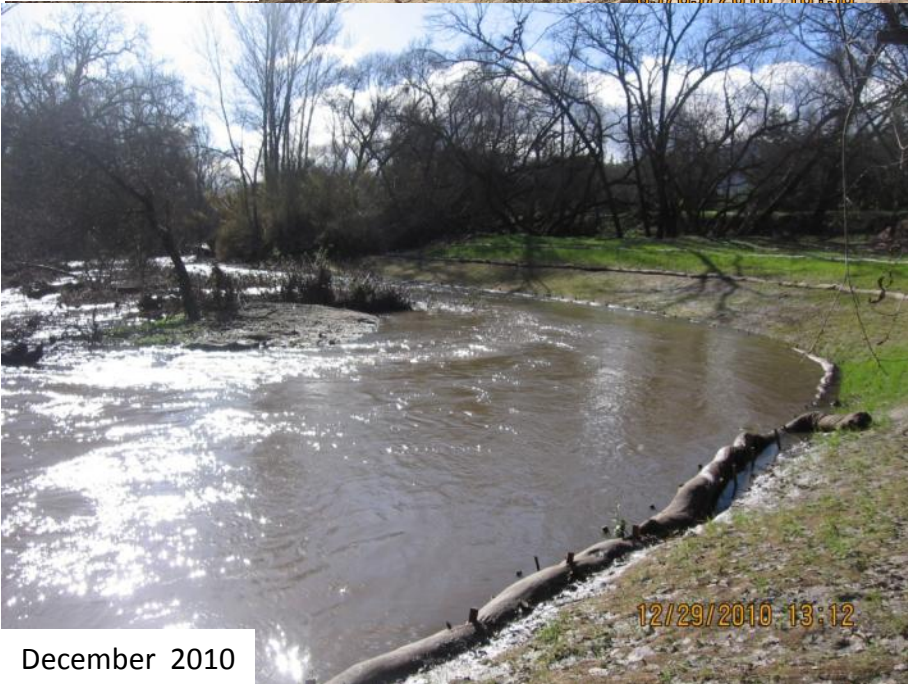
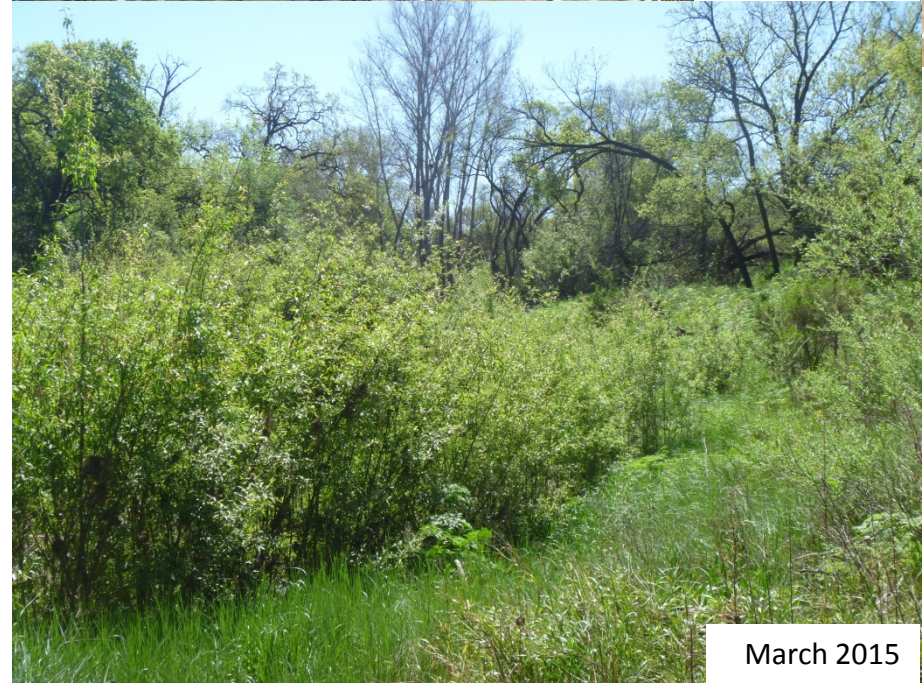
River Station 176+50
Bench 1: Caymus, West Bank

September 2009

October 2010

December 2010

March 2015

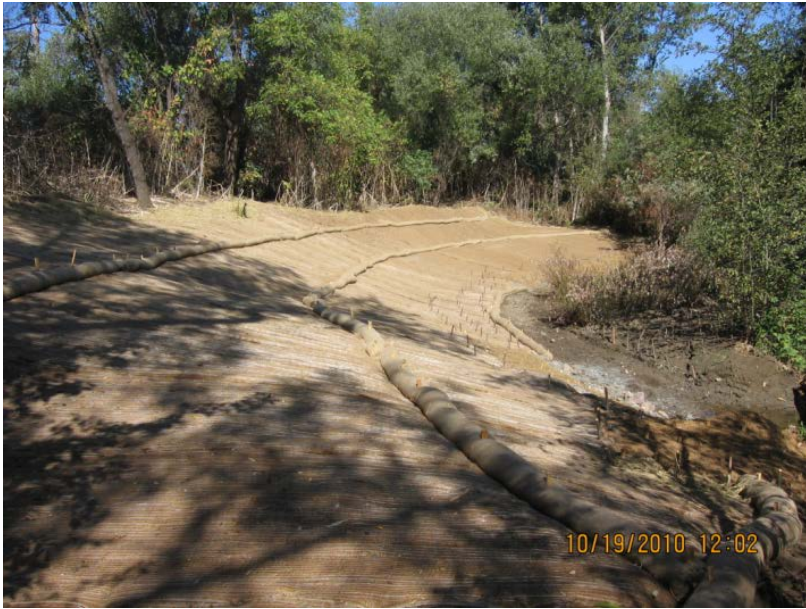
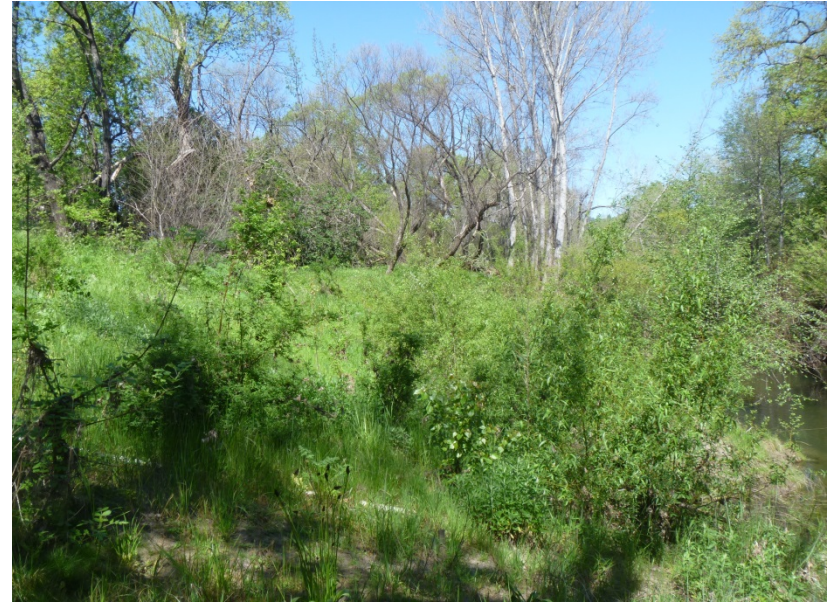
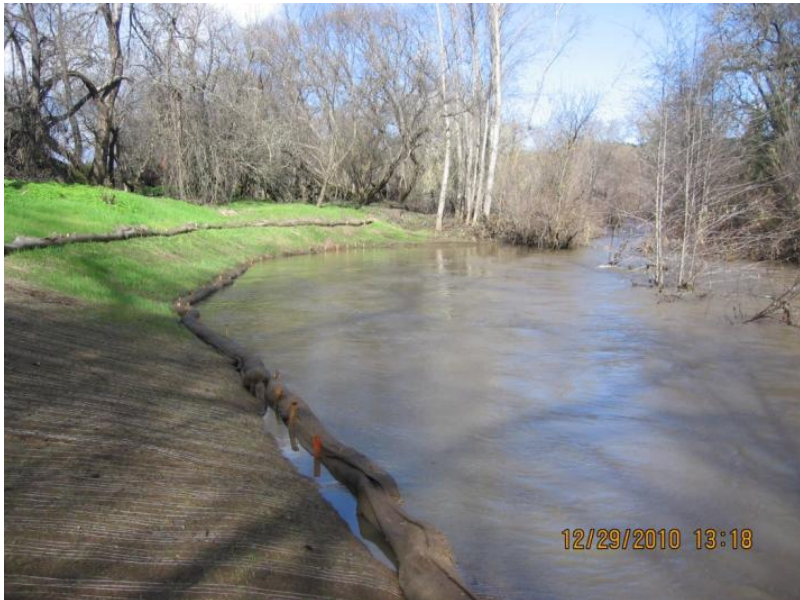
River Station 172+00
Bench 2: Caymus, West Bank

October 2010

March 2015

December 2010

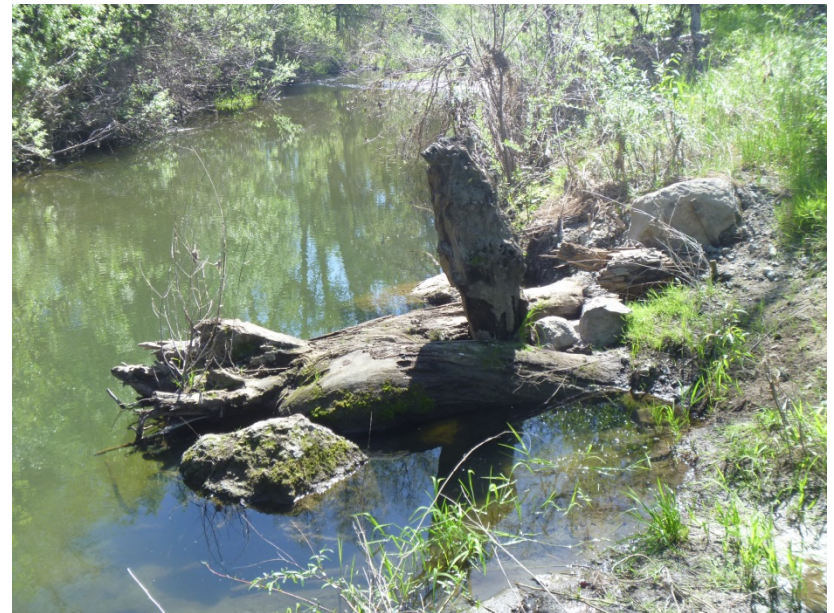
LWD, Bench 2, March 2015

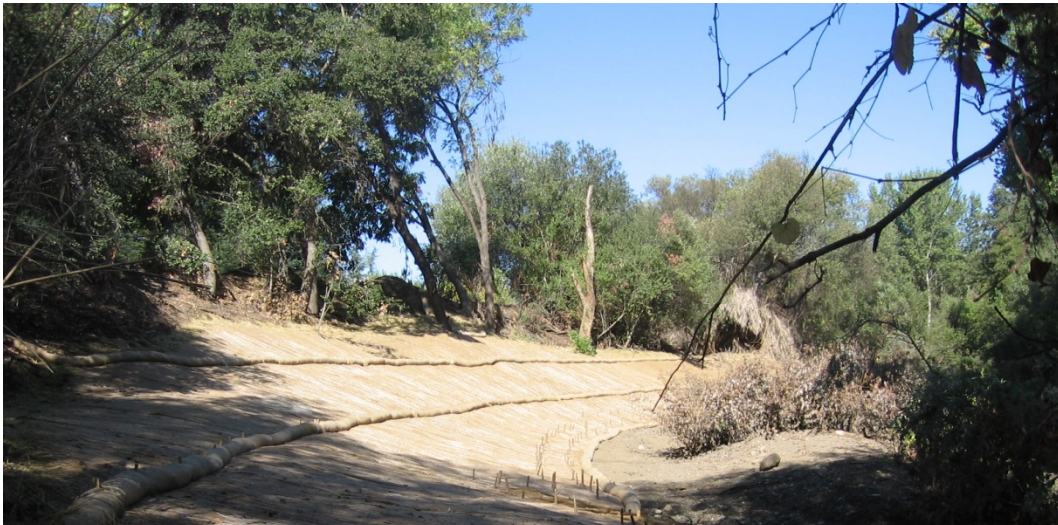
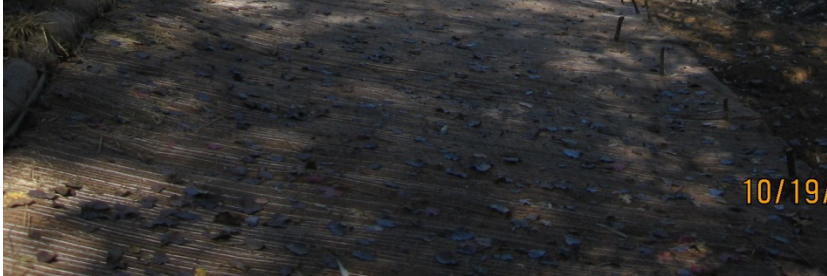
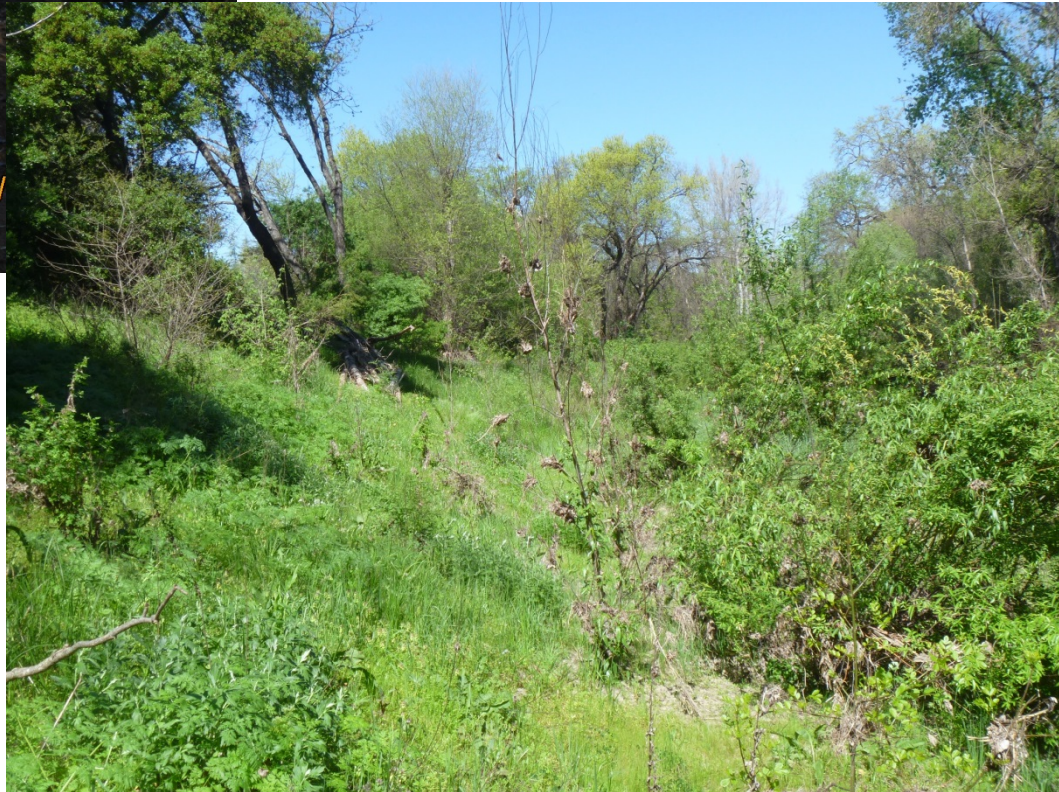
River Station 168+50
Bench 3: Caymus, Downstream to Upstream

October 2010

March 2015

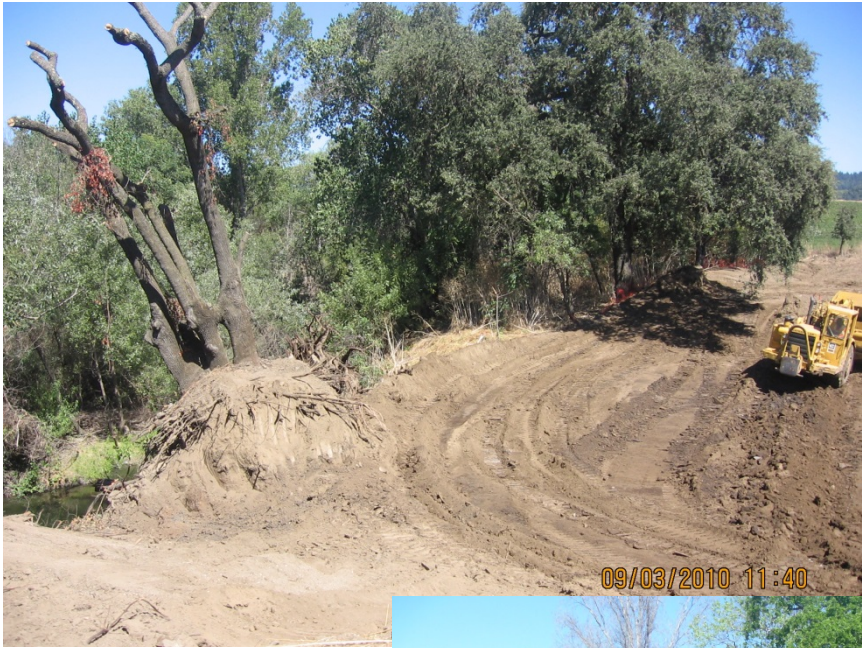
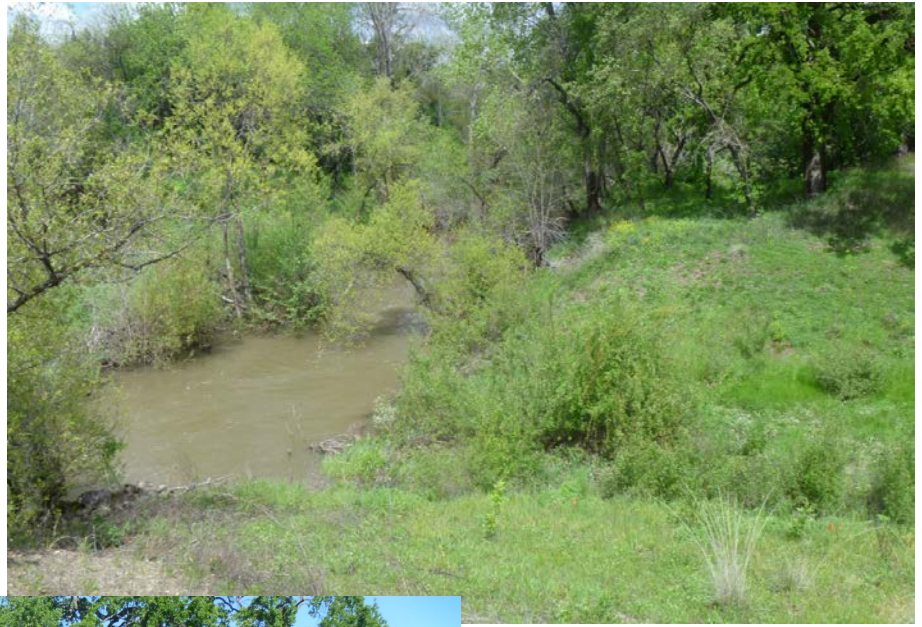
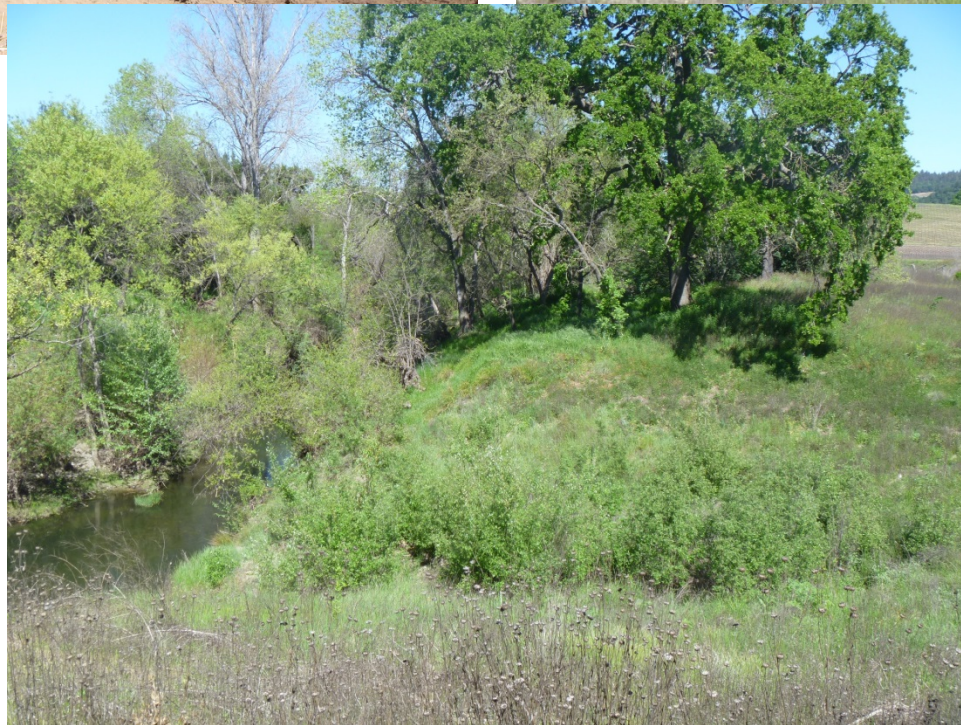
River Station 164+20
Bench 4: Carpy Conolly, East Bank

September 2010

November 2011

March 2015

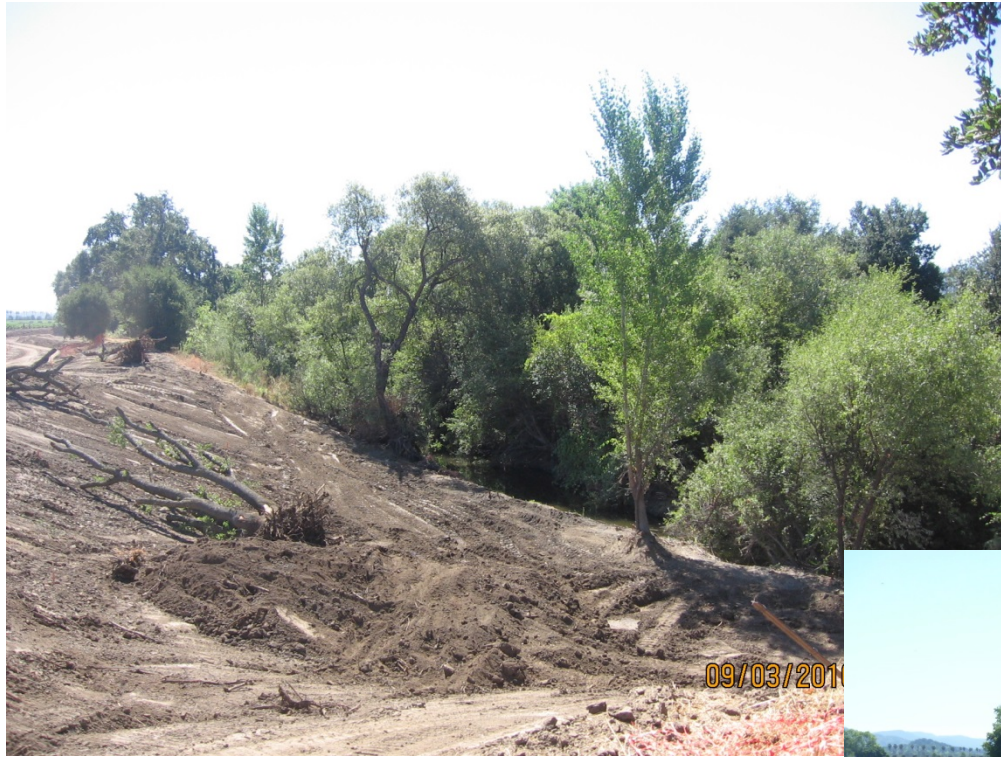
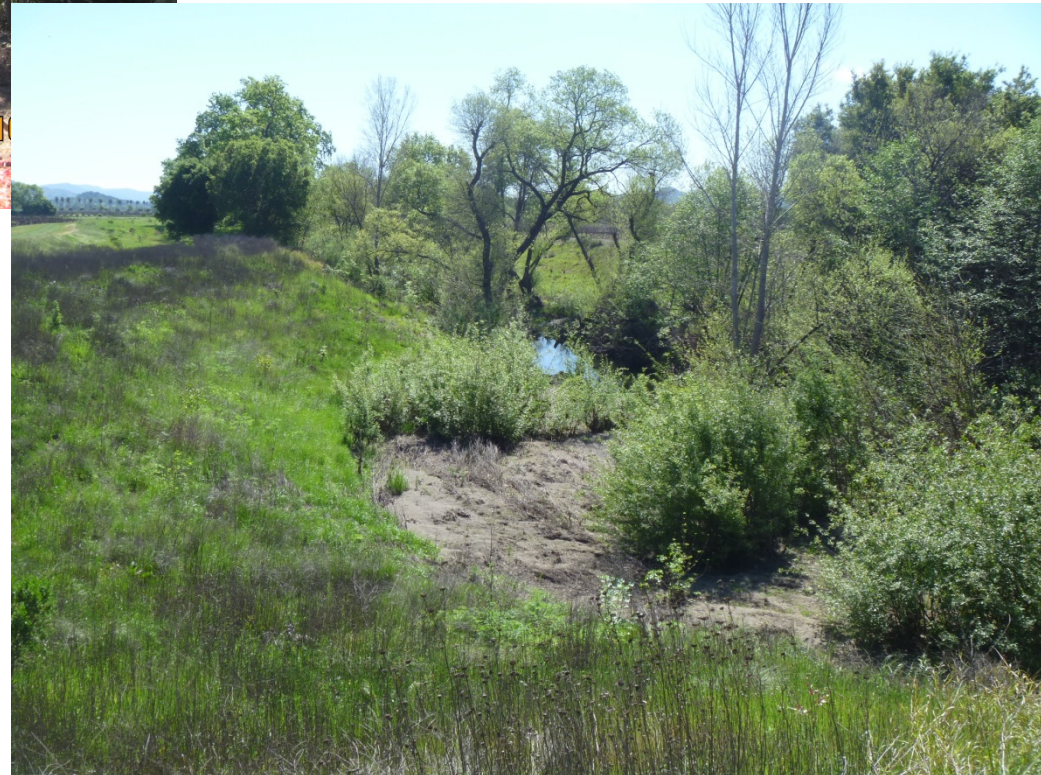
River Station 162+00
Carpy Conolly Bench 5, East Bank

September 2011

March 2015

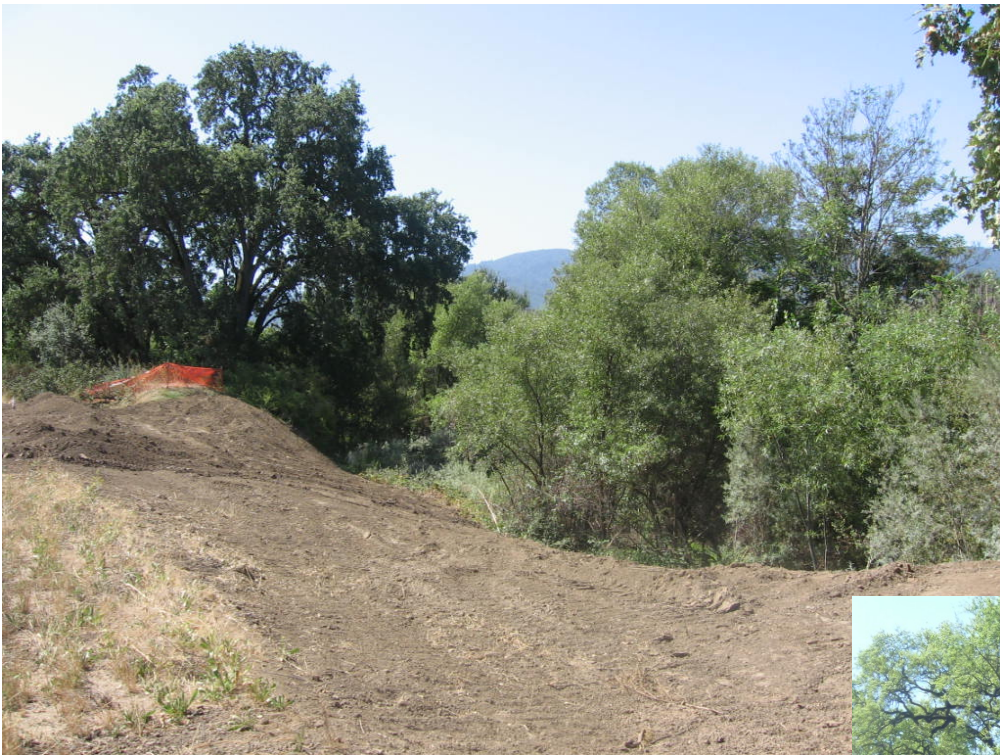
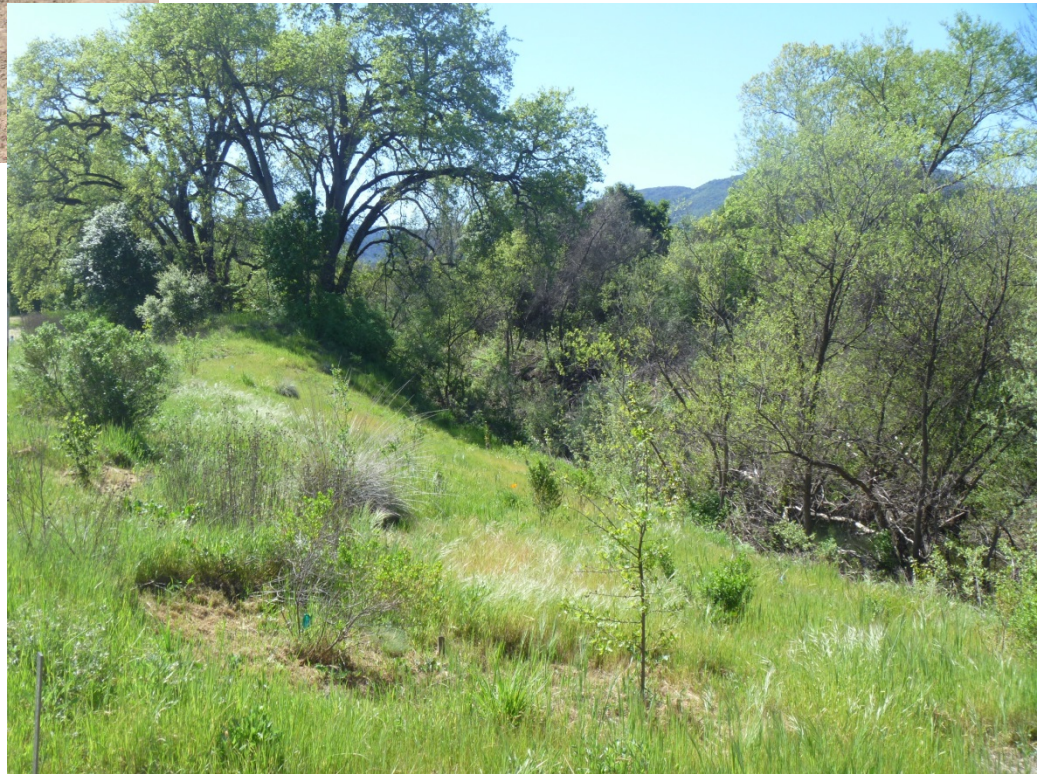
River Station 144+00 Carpy Conolly Bench 6, East Bank

August 2011

March 2015

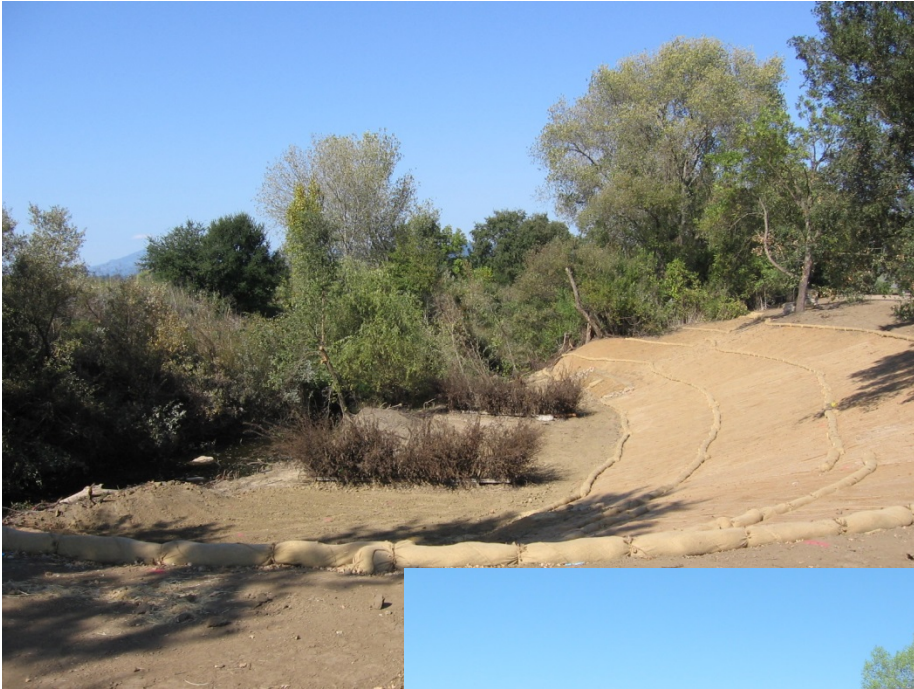
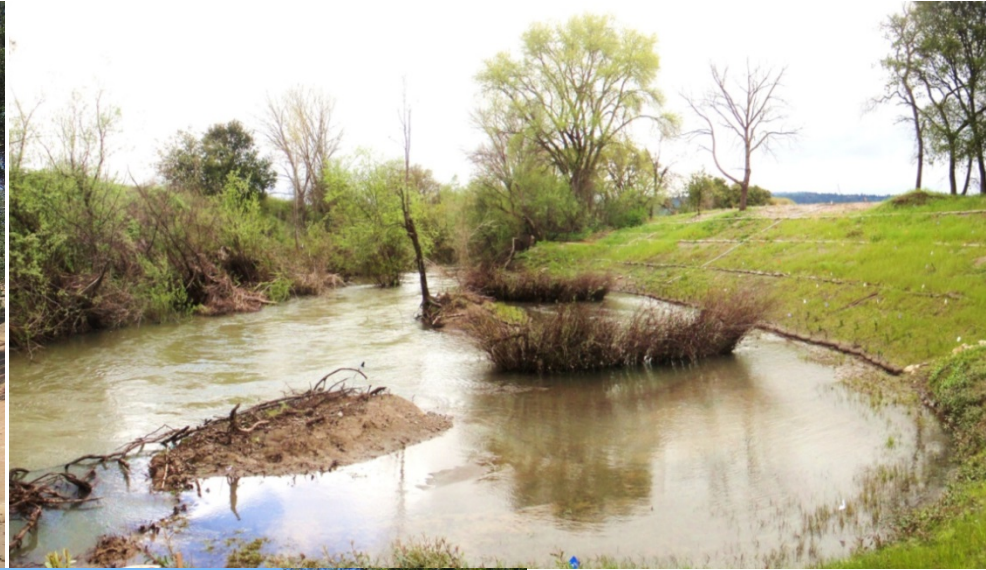
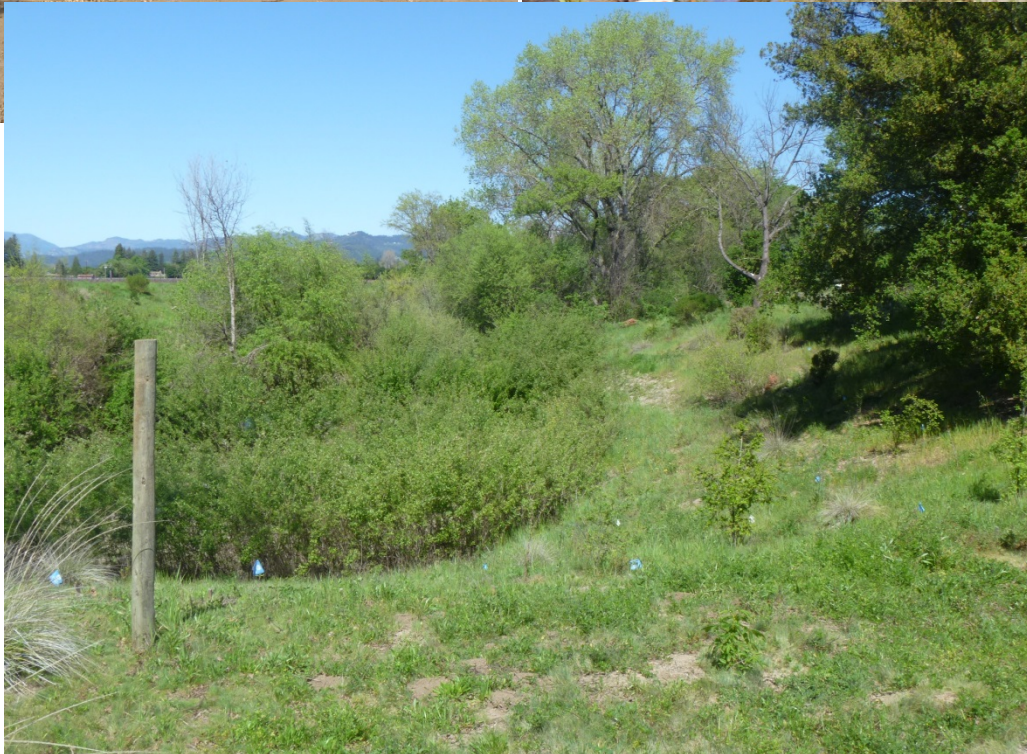
River Station 135+40
Bench 11: Honig, East Bank

October 2011

March 2012

March 2015

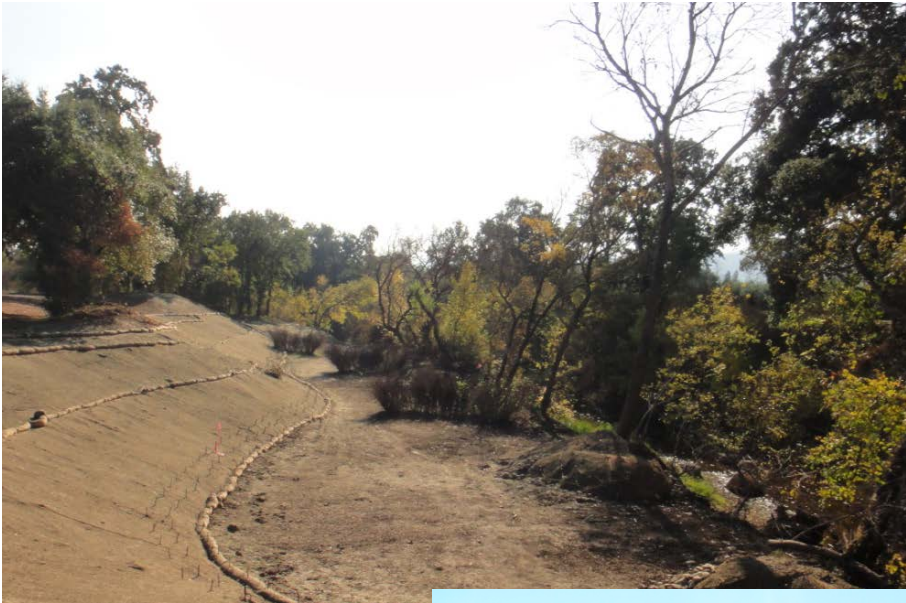
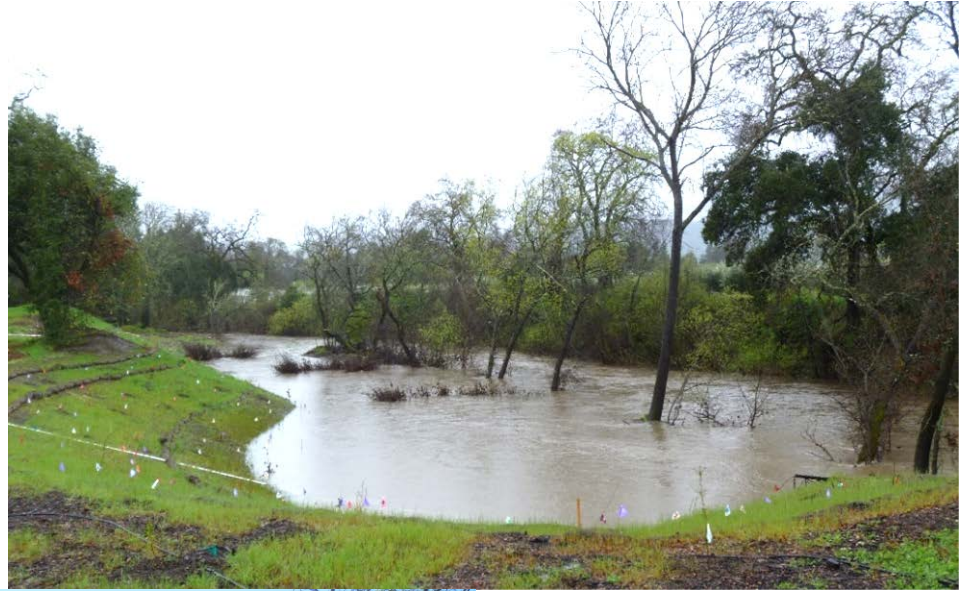
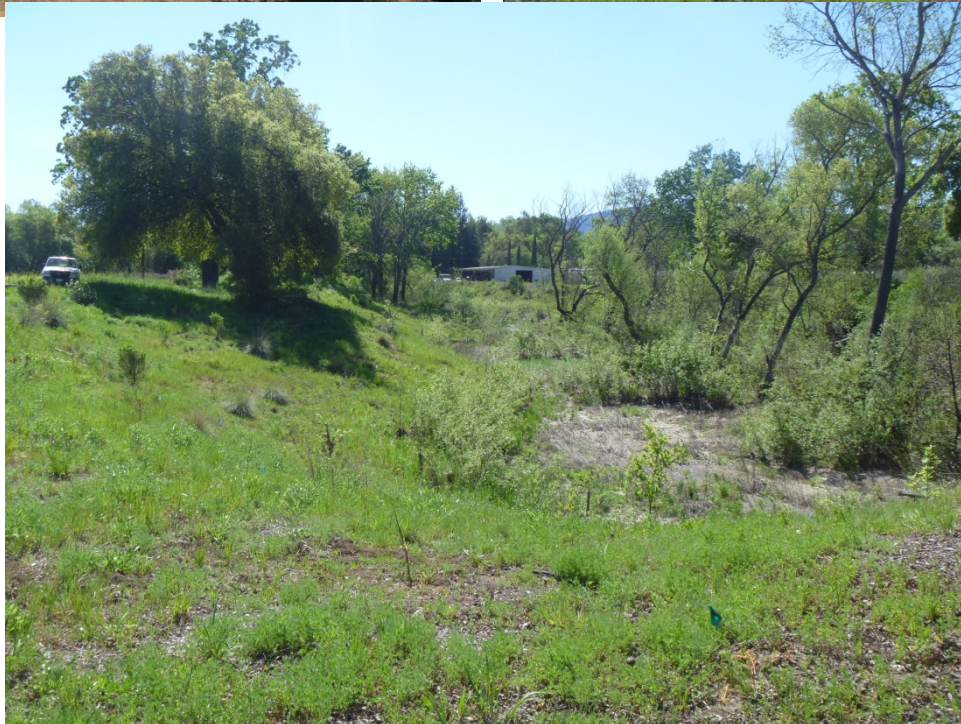
River Station 130+50
Bench 13: Honig, East Bank

August 2011

March 2012

March 2015

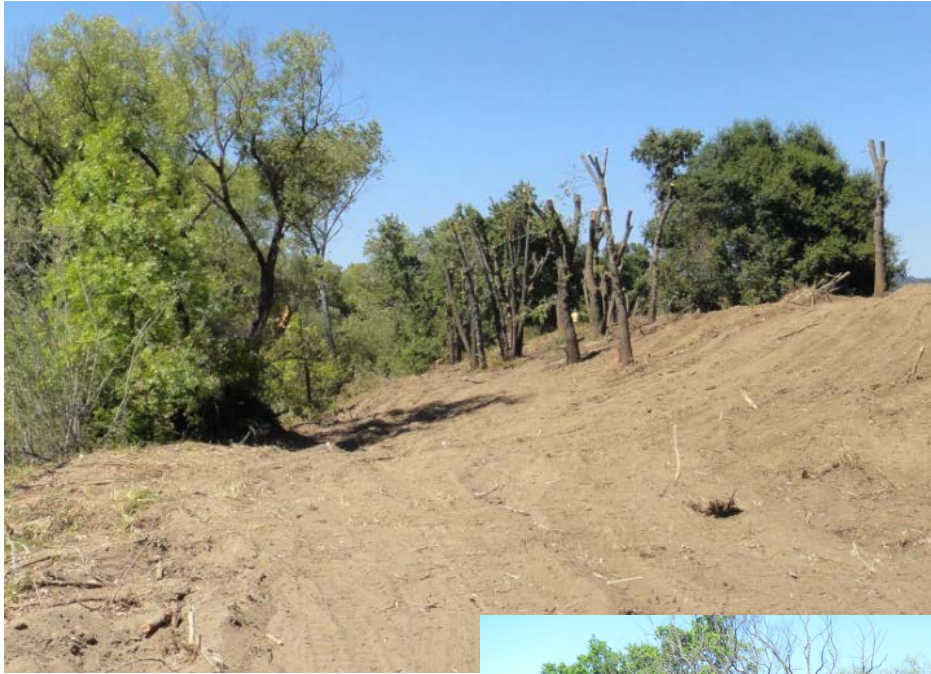
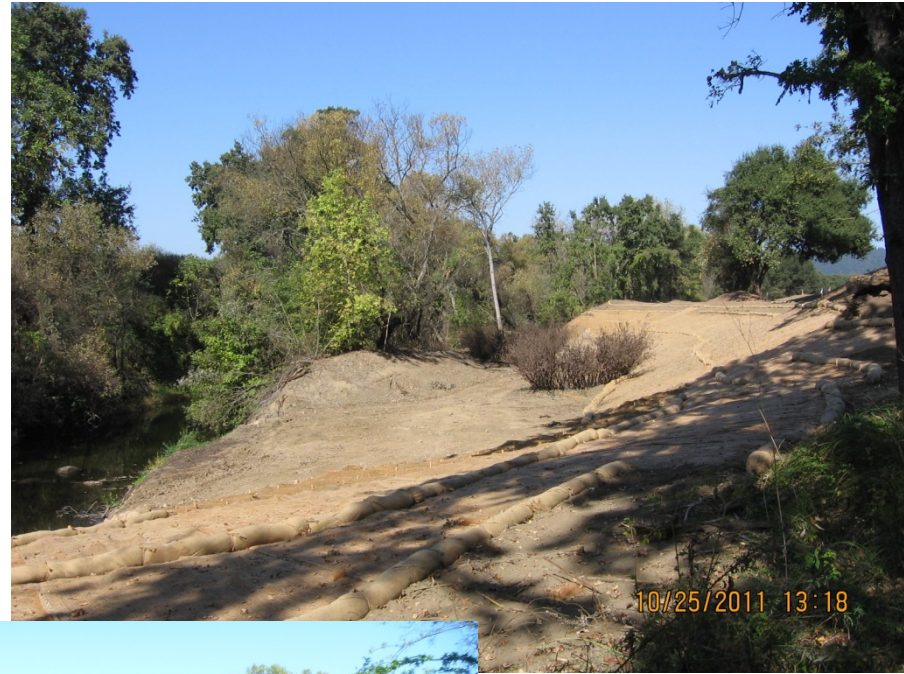
River Station 127+50
Bench 13: Honig, East Bank to Upstream

May 2011

October 2011
