NAPA RIVER RUTHERFORD REACH RESTORATION PROJECT ANNUAL MONITORING REPORT- 2014

Prepared April 2015 by:

Napa County Flood Control and Water Conservation District
804 First Street
Napa, California, 94559
Contact: Jeremy Sarrow
(707) 259-8204

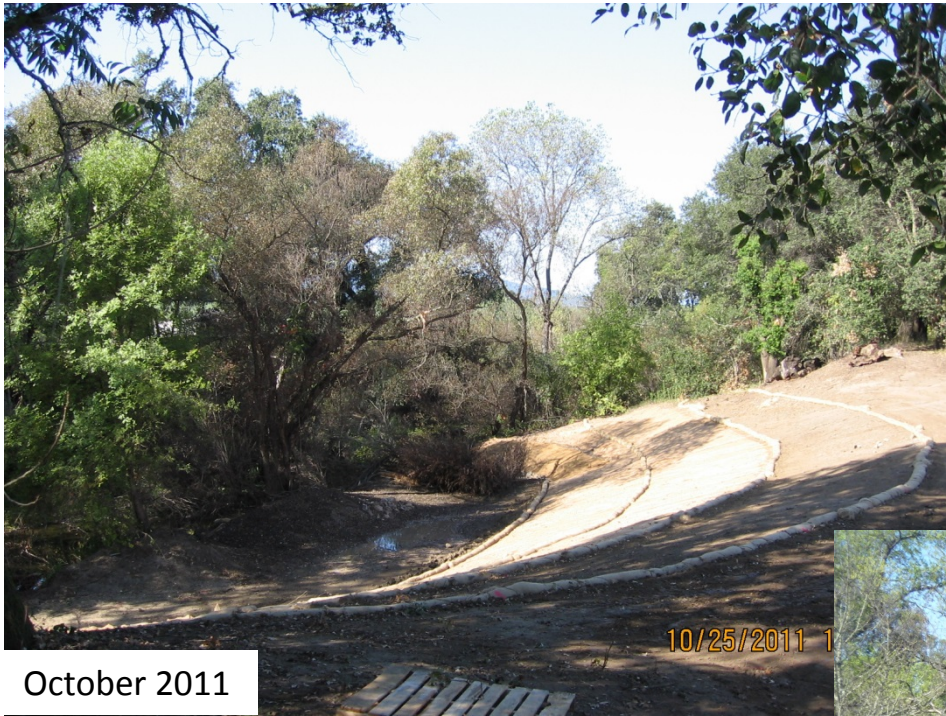
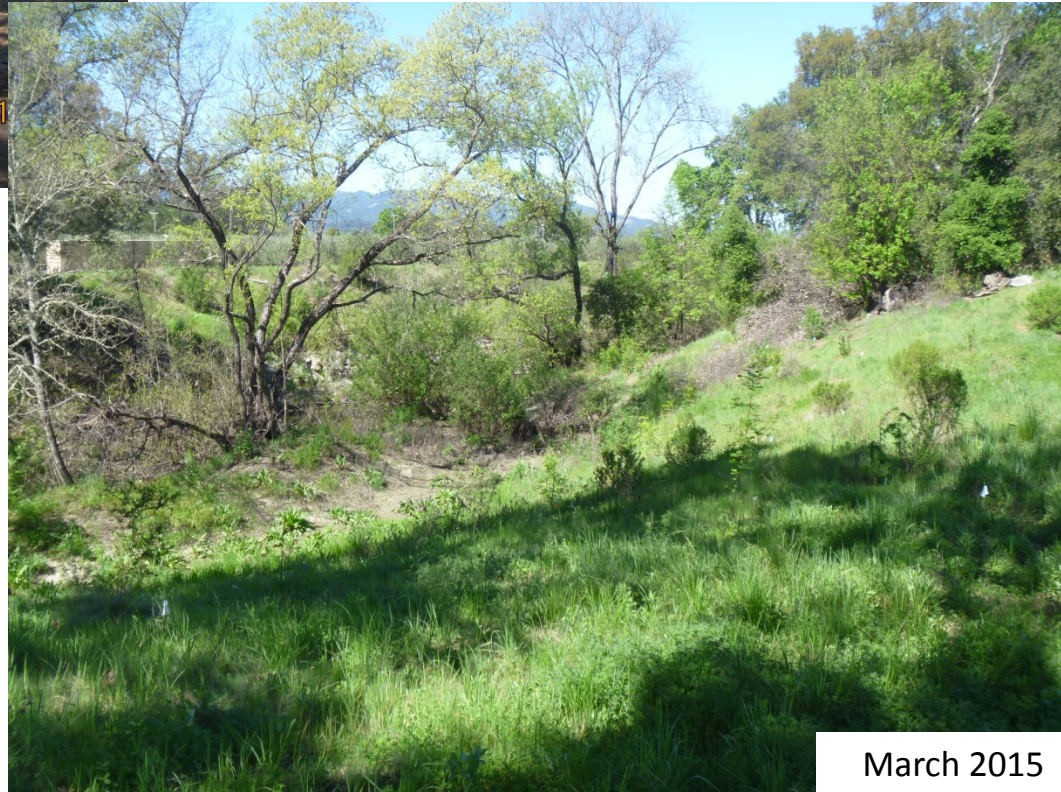
River Station 124+25
Bench 14: Round Pond, East Bank

October 2011

March 2015

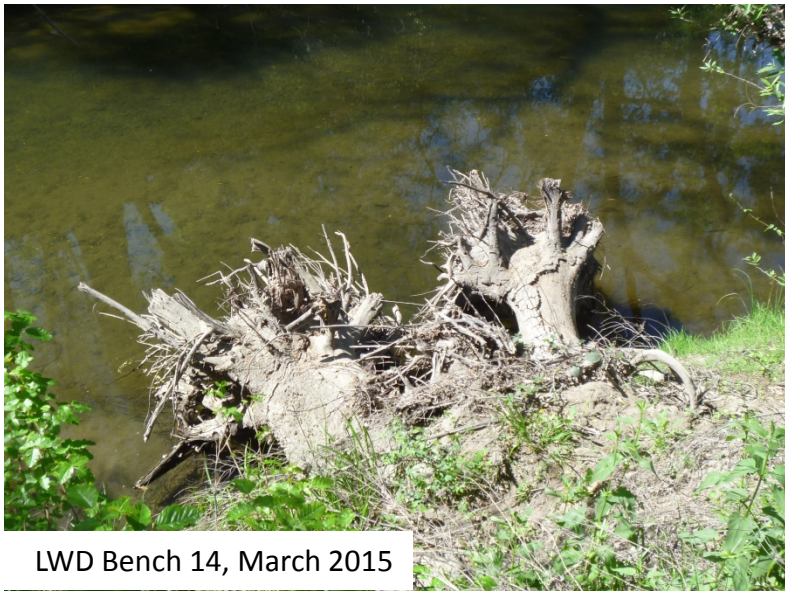
LWD Bench 14, March 2015

As part of the annual channel survey naturally recruited and installed large wood debris (LWD), and boulder clusters, have been monitored since 2009. Naturally recruited LWD is monitored for year-to-year comparison to track trends in location, quantity, size, and function. Installed LWD and boulder clusters are assessed to verify their persistence, functionality (summer and winter refugia) and to assess potential damage or maintenance needs. For purposes of the survey, naturally recruited LWD is defined as piece of wood located in channel below top of bank that is at least 6 feet in length and 18 inches in diameter. For each occurrence, it is noted whether the LWD or boulder cluster is performing any of the following functions: spawning gravel recruitment, hydraulic constriction, pool scour, summer refugia, winter high-flow refugia, or bank stability. Some occurrences provide multiple functions, and some are not currently providing any of the listed functions.

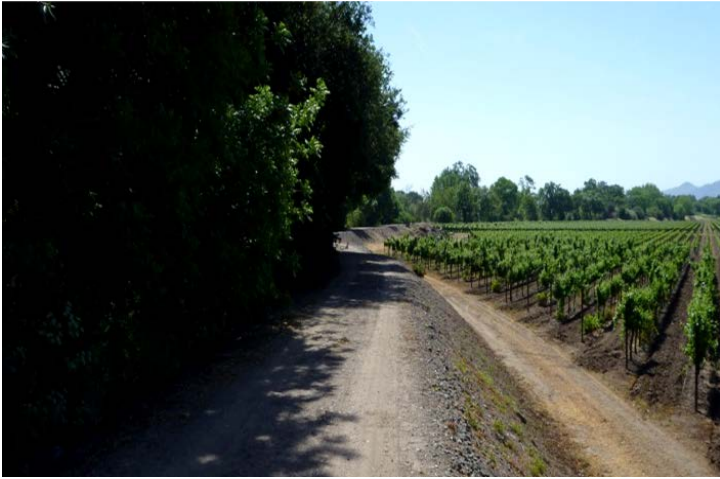
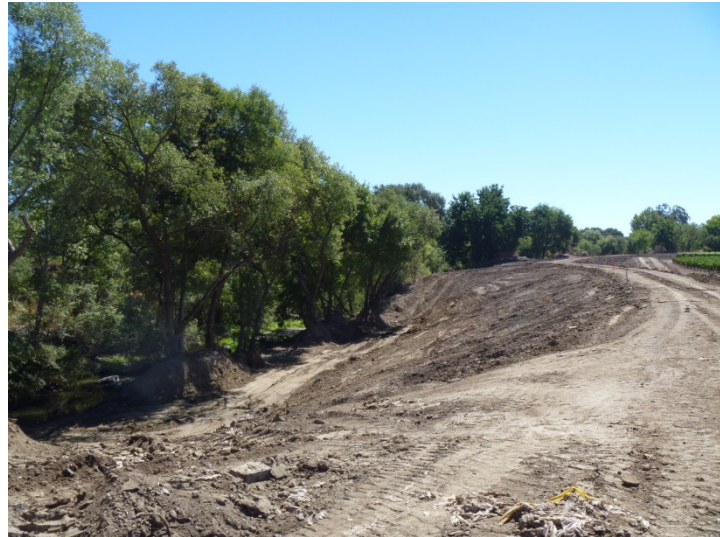
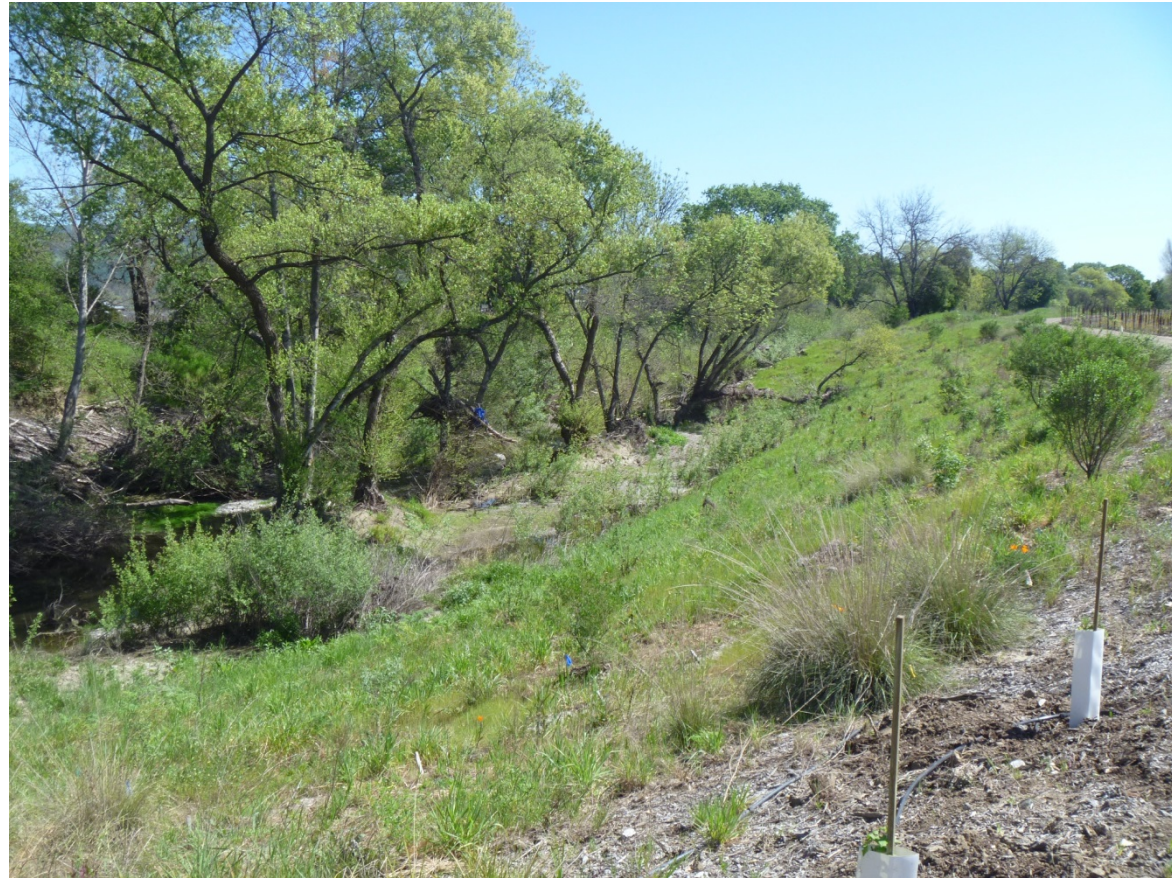
River Station 161+10
Bench 6: Emmolo, West Bank

May 2012

November 2012

March 2015

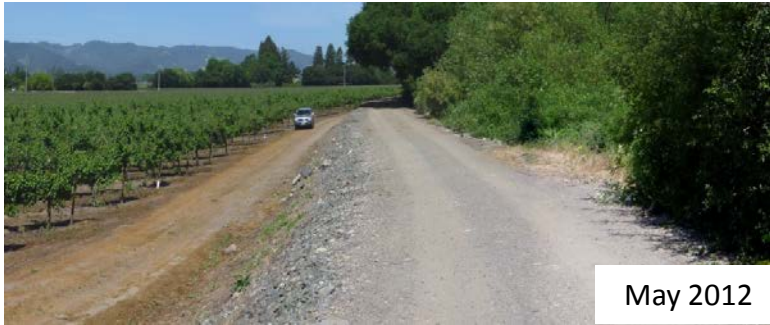
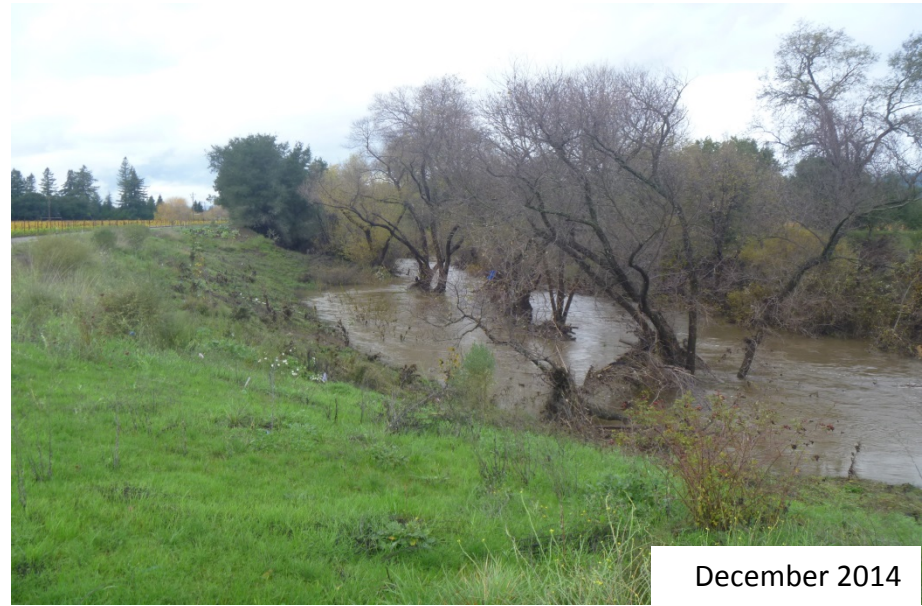
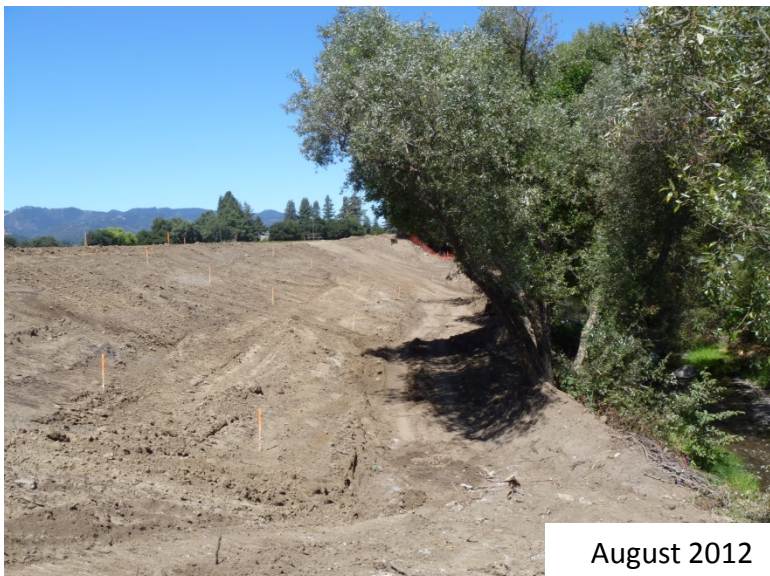
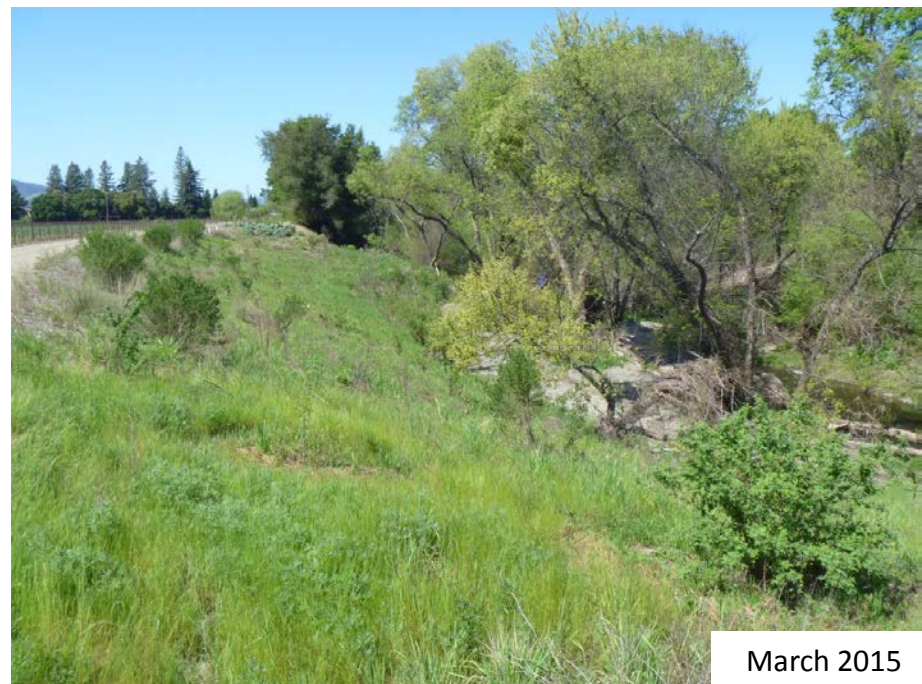
River Station 157+60
Bench 6: Emmolo, West Bank to Upstream

May 2012

December 2014

August 2012

March 2015

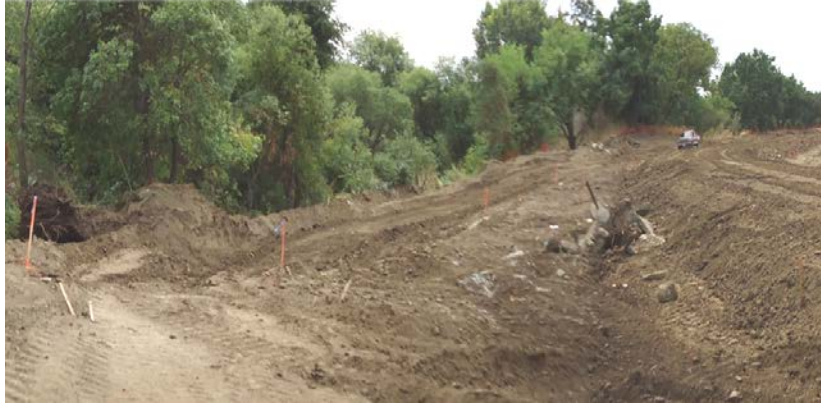
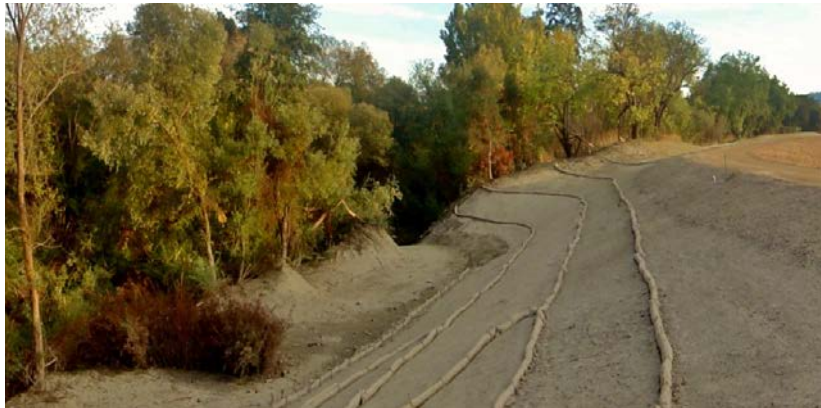
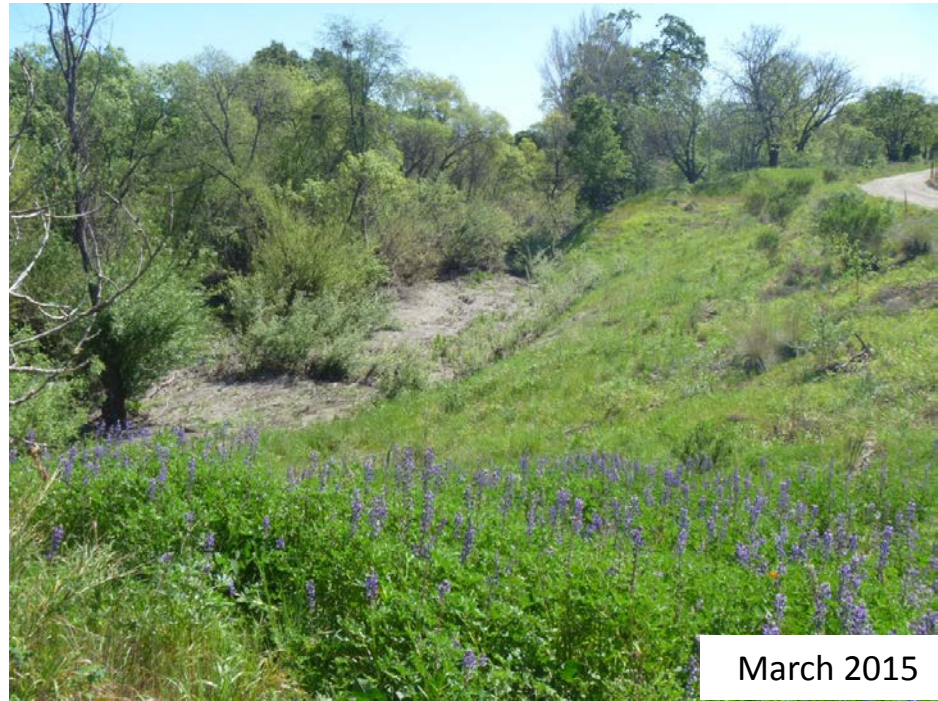
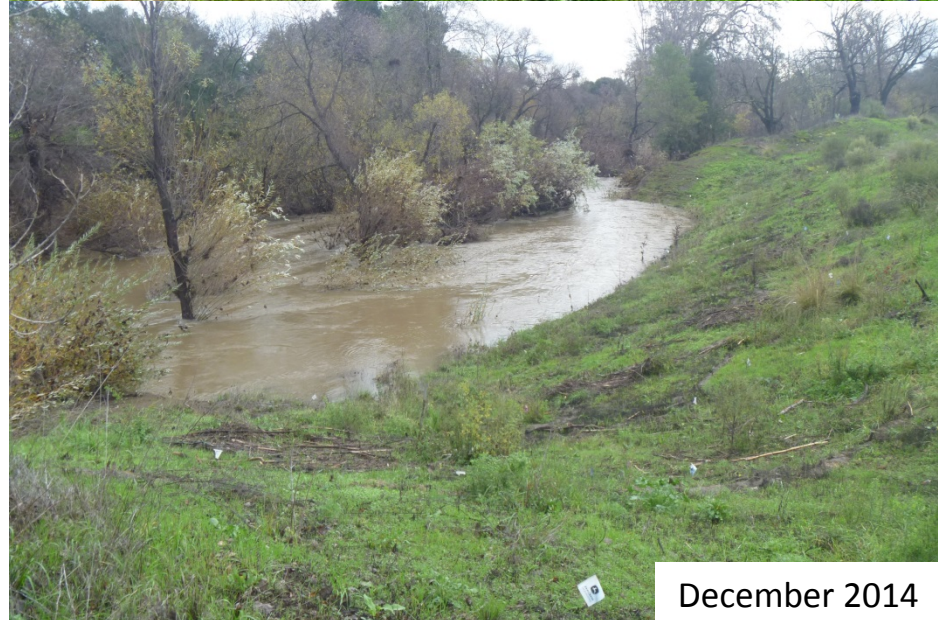
River Station 152+90
Bench 8: Emmolo, West Bank to Downstream

May 2012

November 2012

March 2015

December 2014

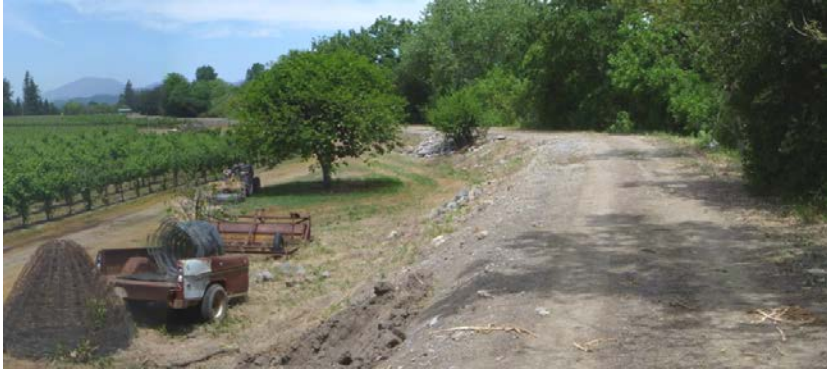
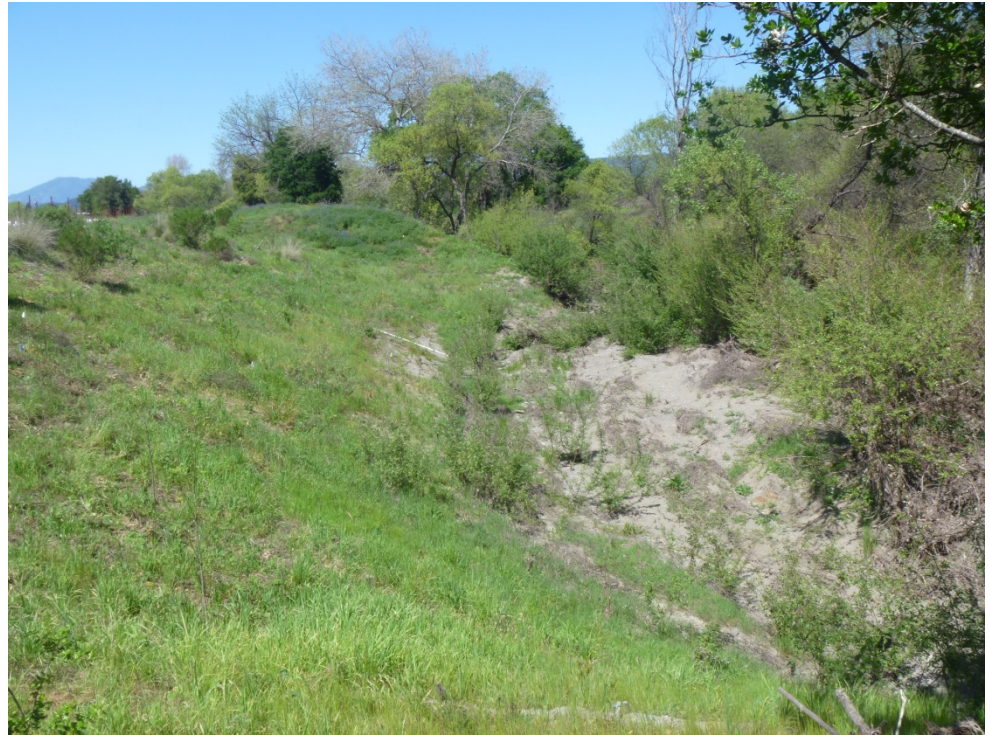
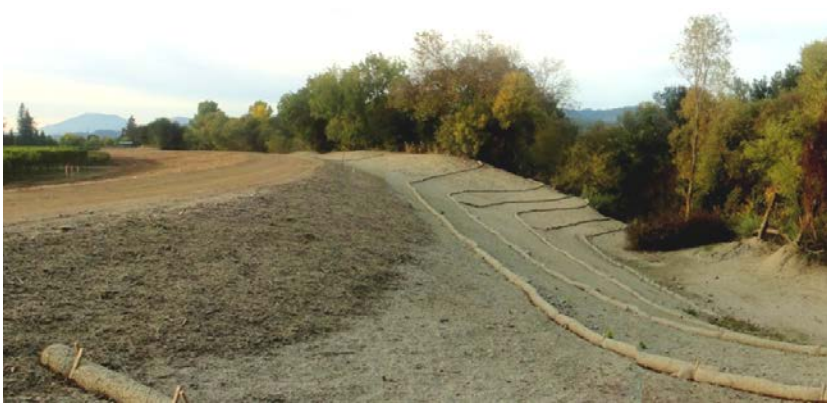
River Station 15,000
Bench 8: Emmolo, West Bank to Upstream

May 2012

March 2015

November 2012

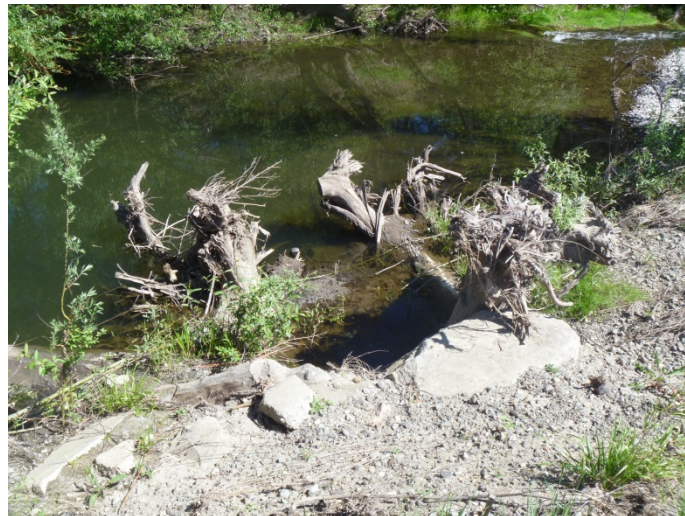
LWD, Bench 8,
March 2015

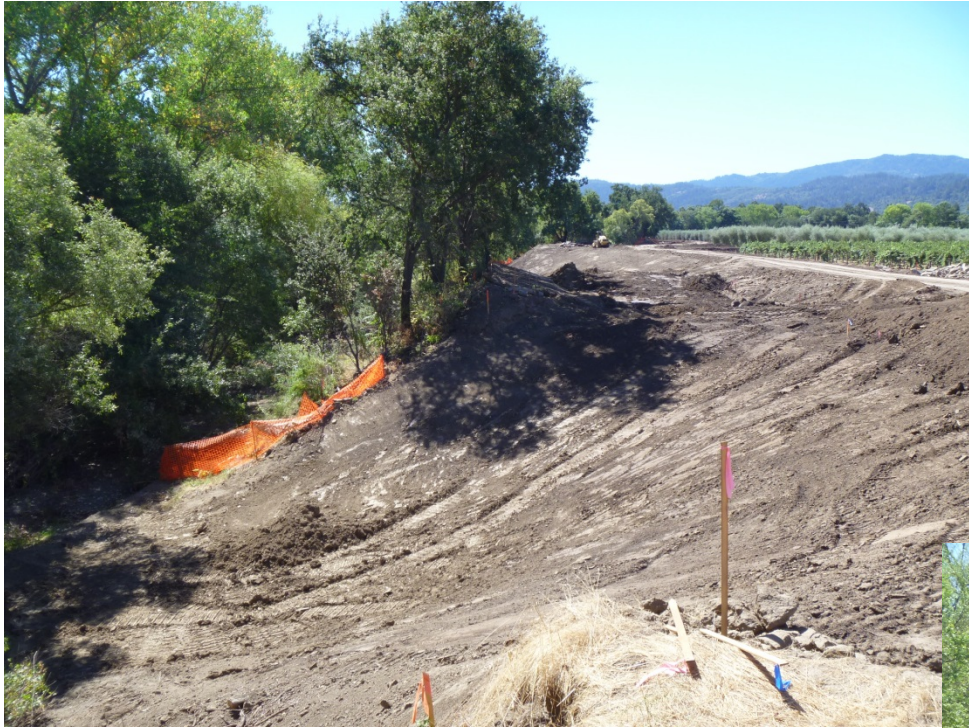
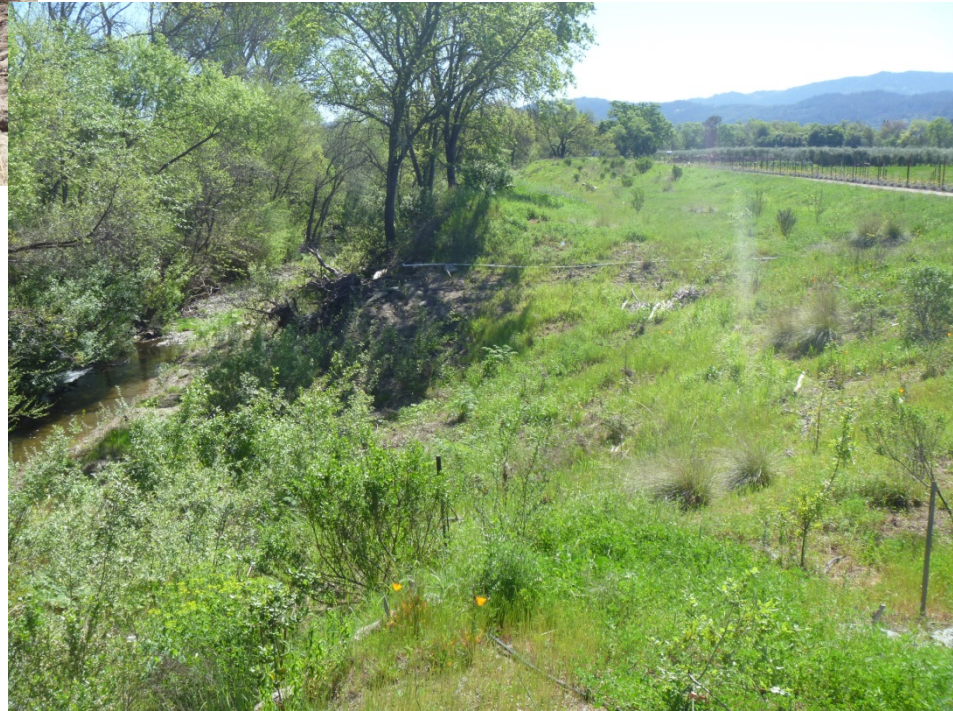
River Station 141+00
Bench 9: Caymus, West Bank

August 2012

March 2015

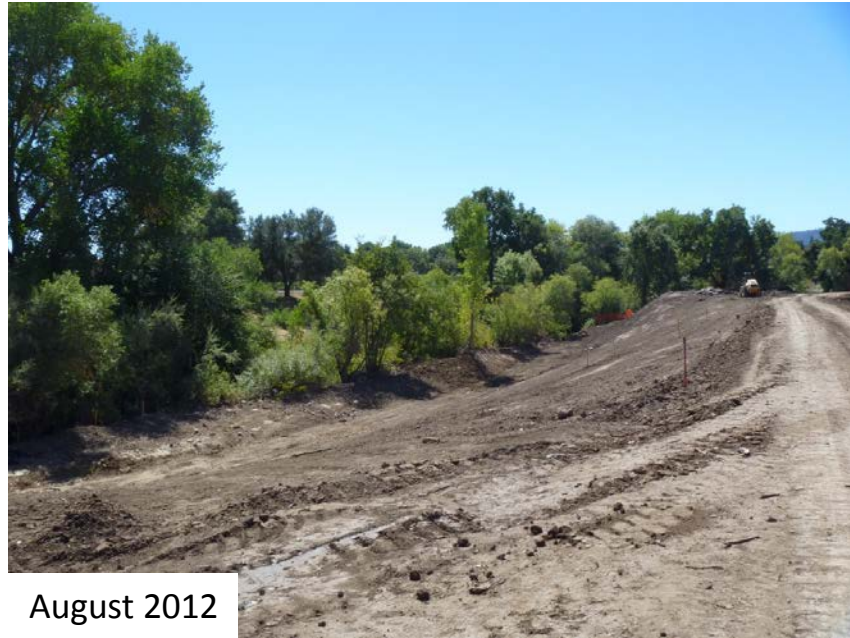
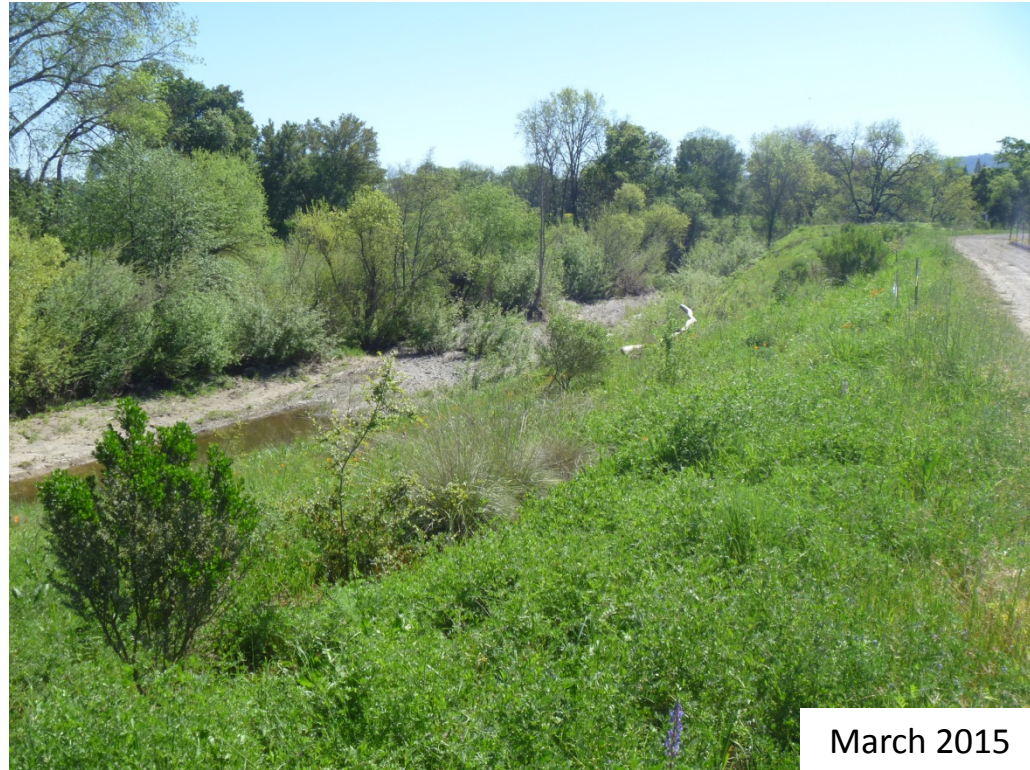
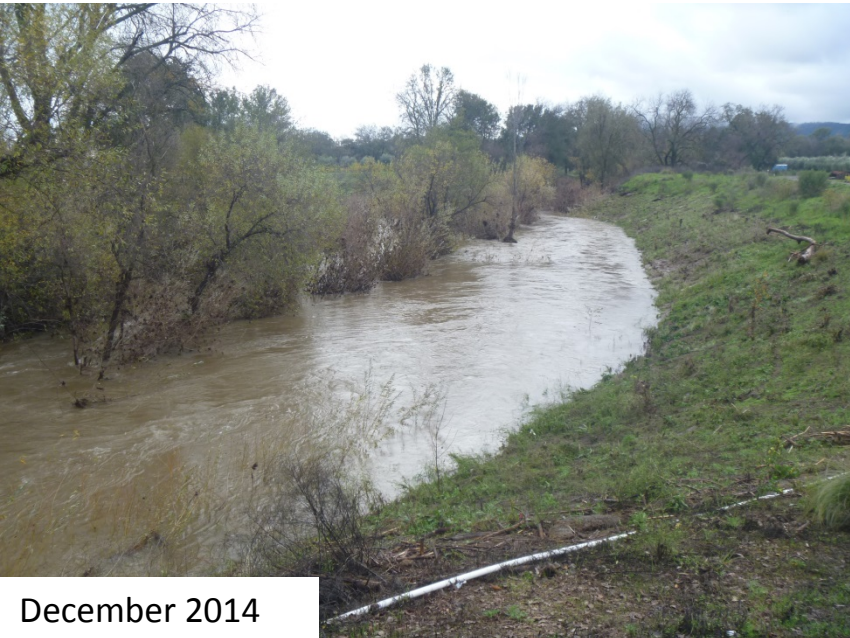
River Station 139+20
Bench 10: Caymus, West Bank to Downstream

August 2012

March 2015

December 2014

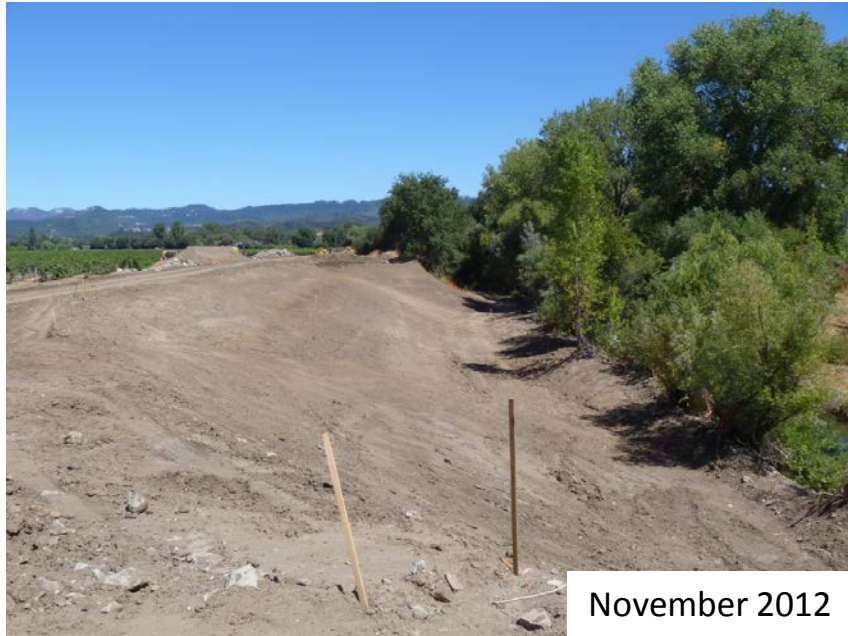
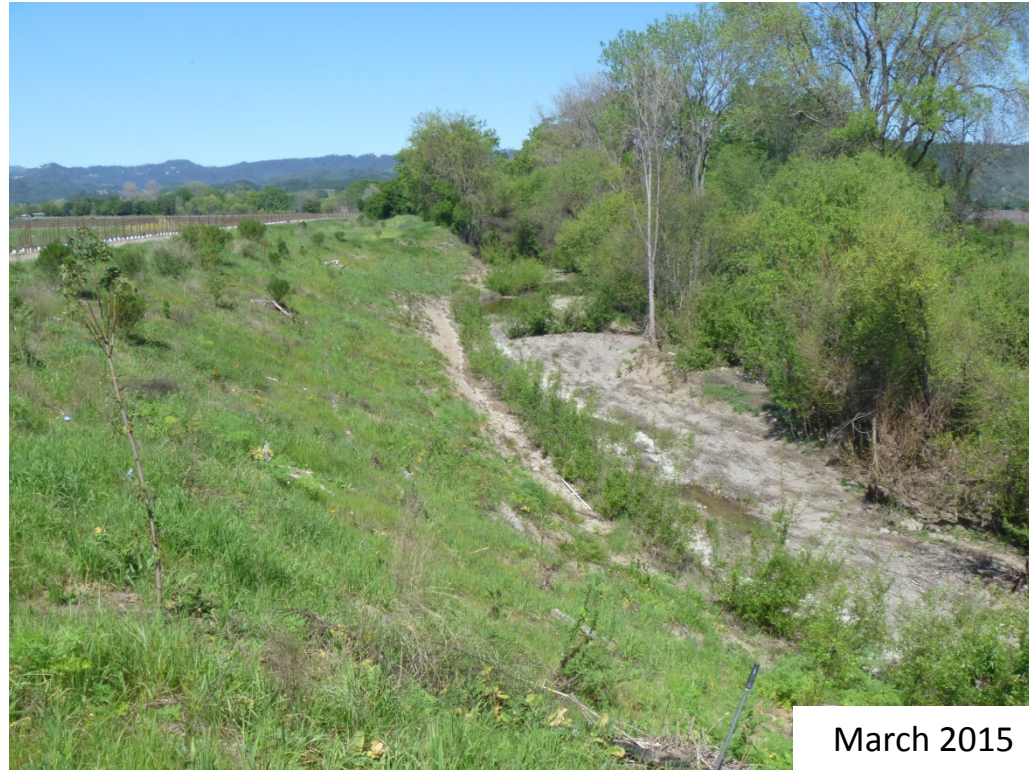
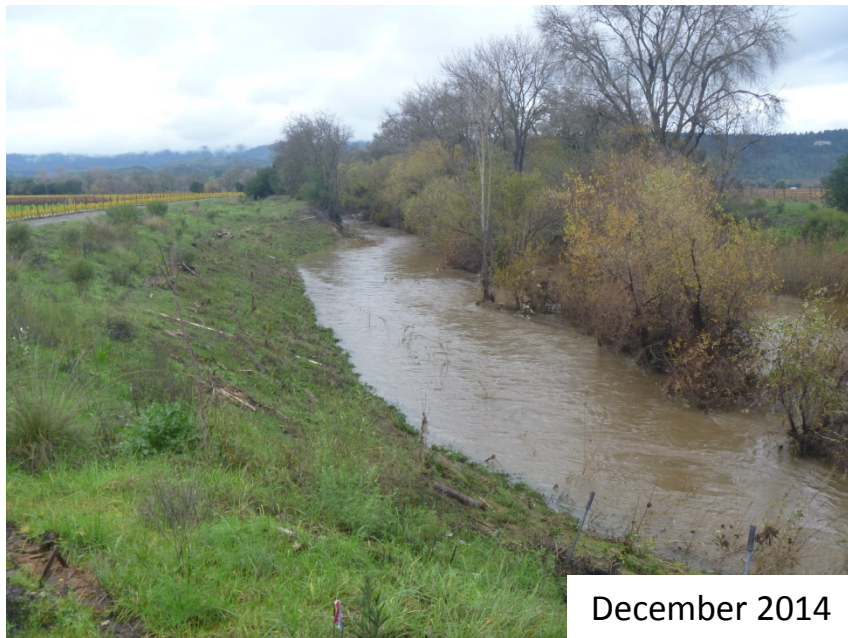
River Station 135+60
Bench 10: Caymus, West Bank to Upstream

November 2012

March 2015

December 2014

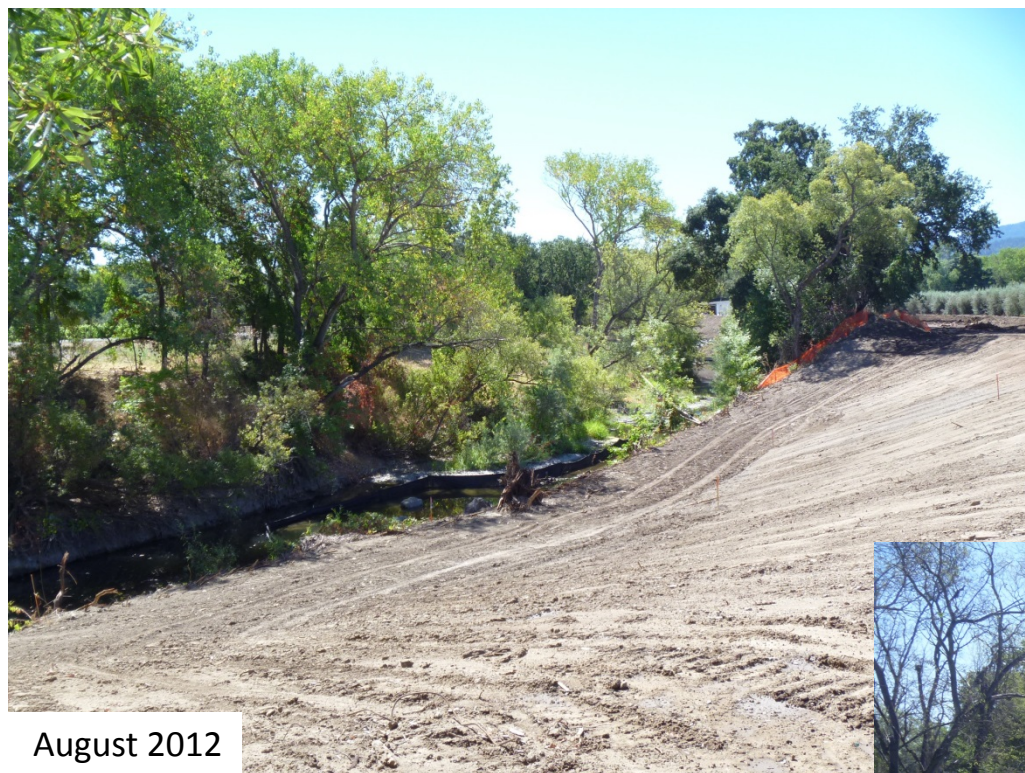
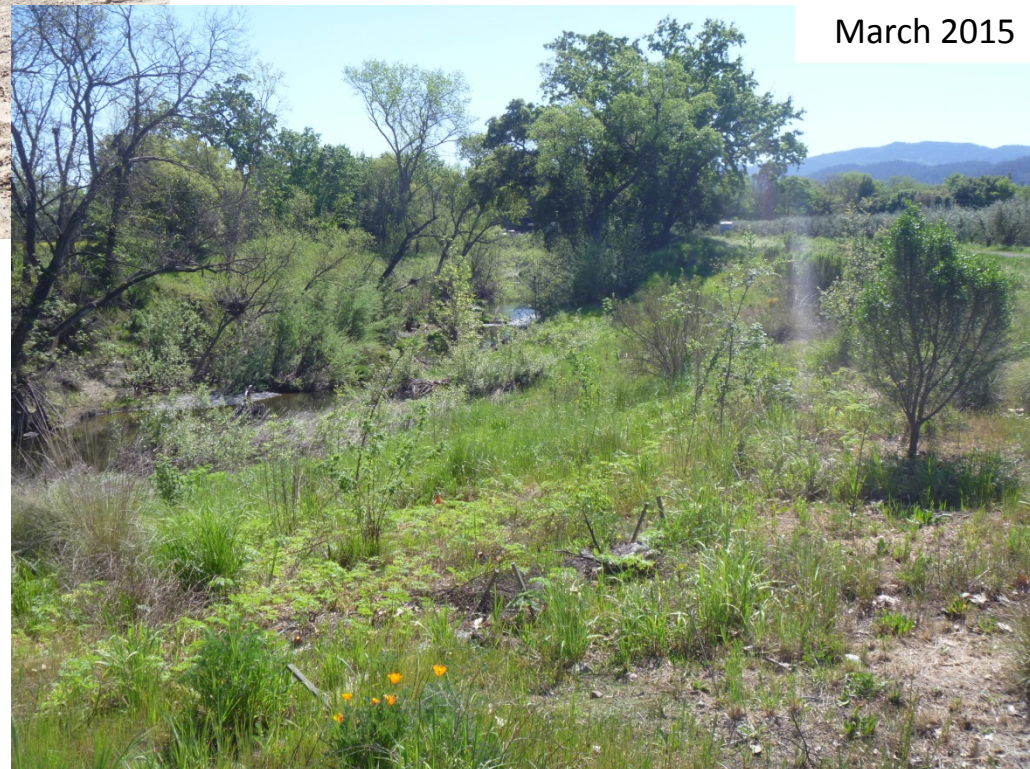
River Station 133+30
Bench 12: Round Pond West, West Bank to Downstream

August 2012

March 2015

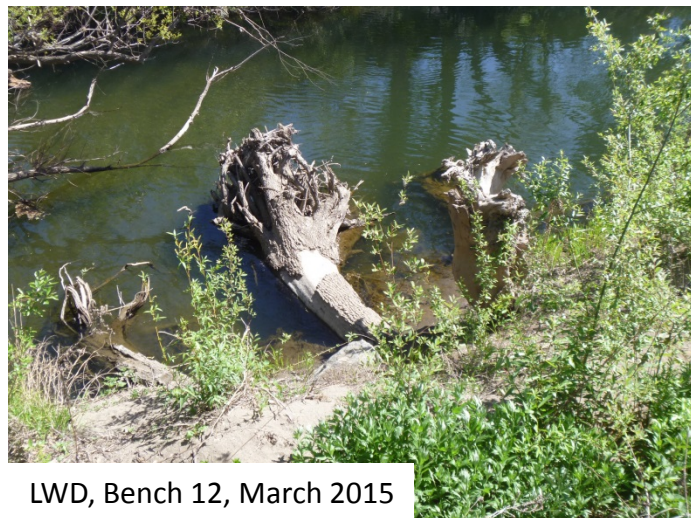
LWD, Bench 12, March 2015

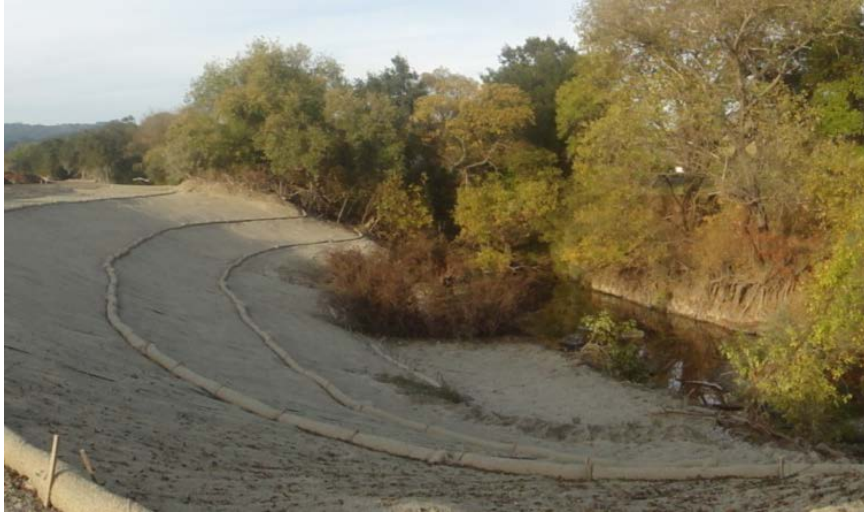
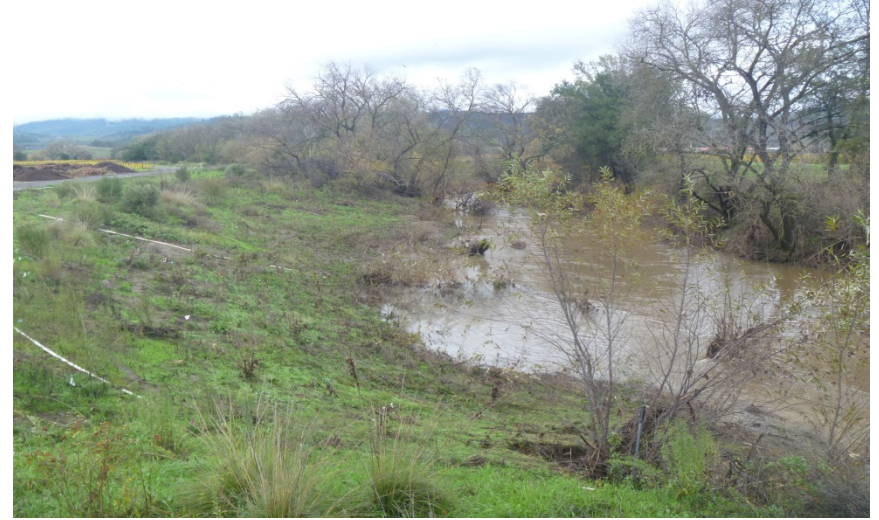
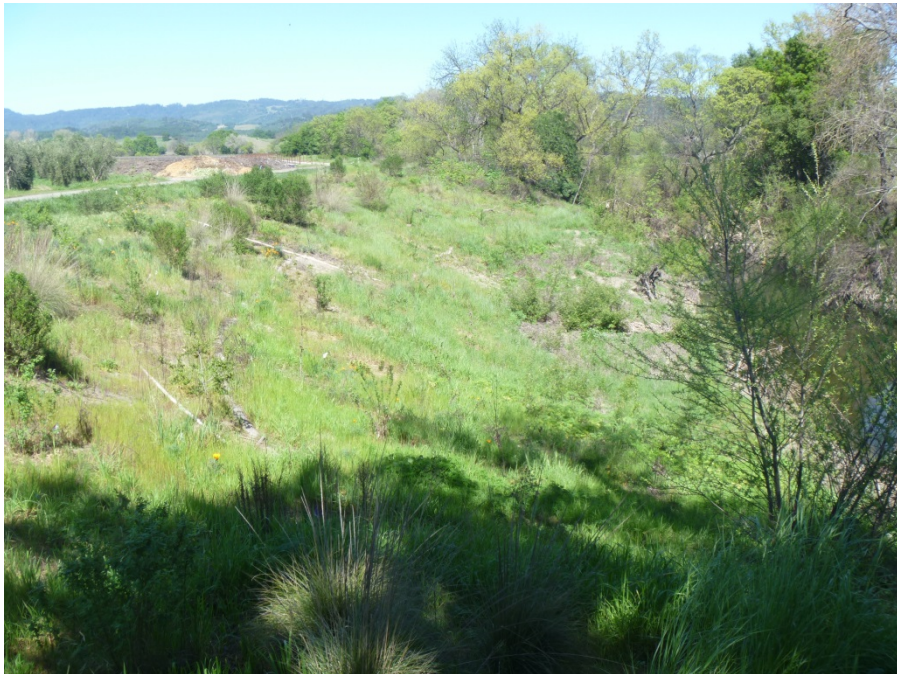
River Station 130+80
Bench 12: Round Pond West, West Bank to Upstream

November 2012

December 2014

March 2015

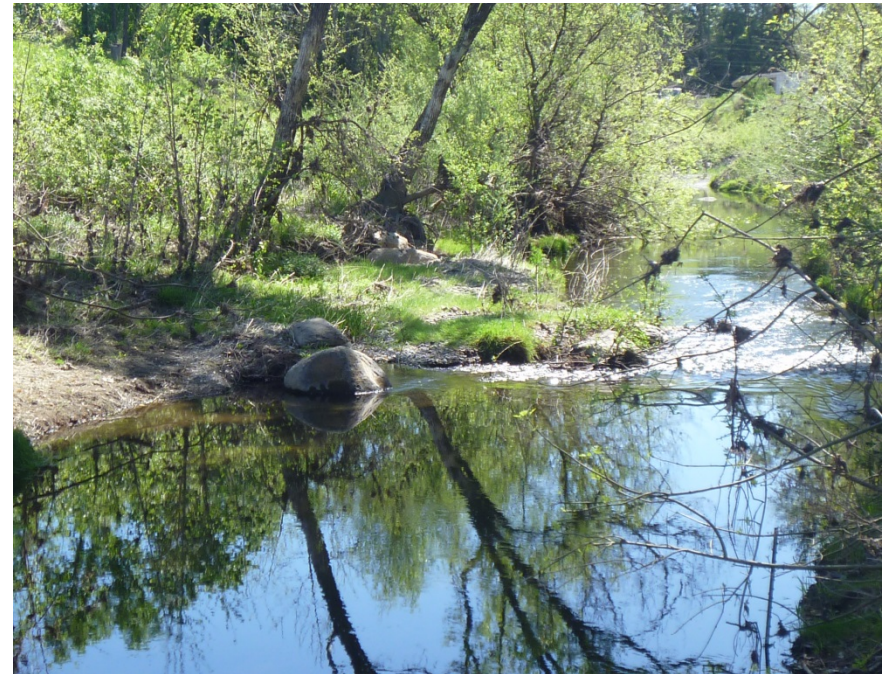
Boulder Cluster, Reach 4, March 2015

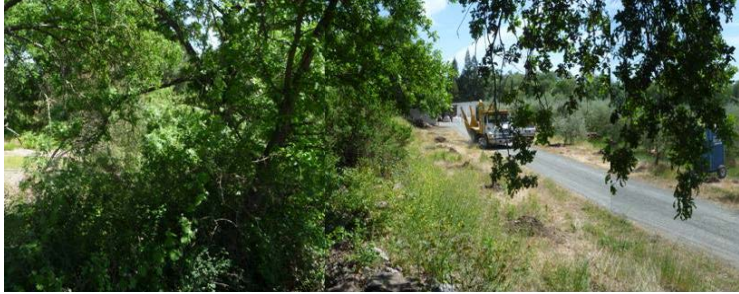
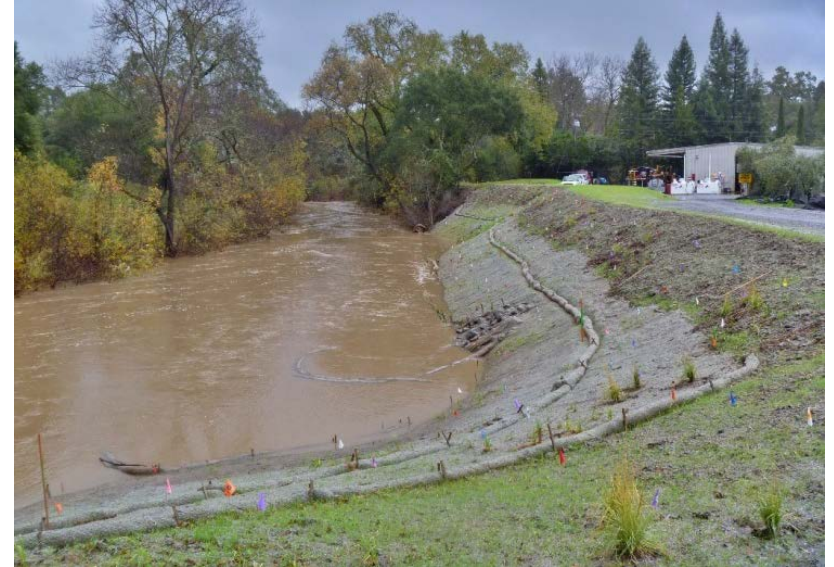
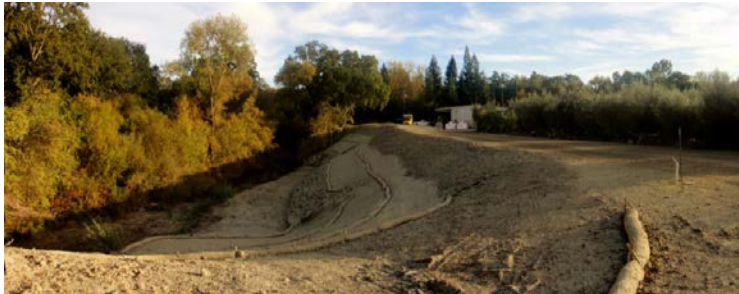
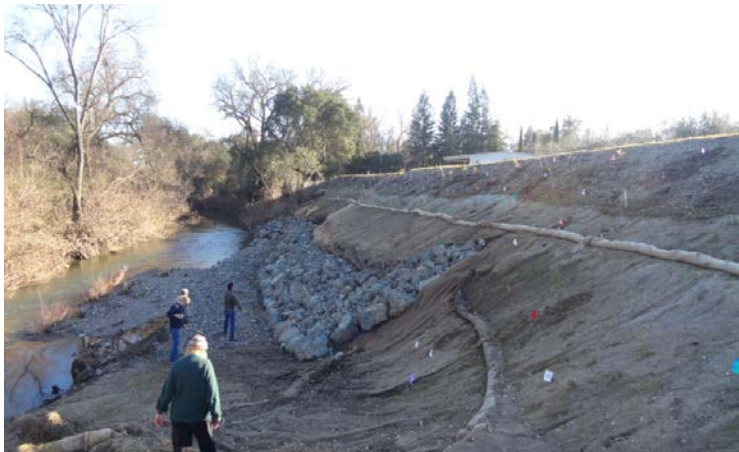
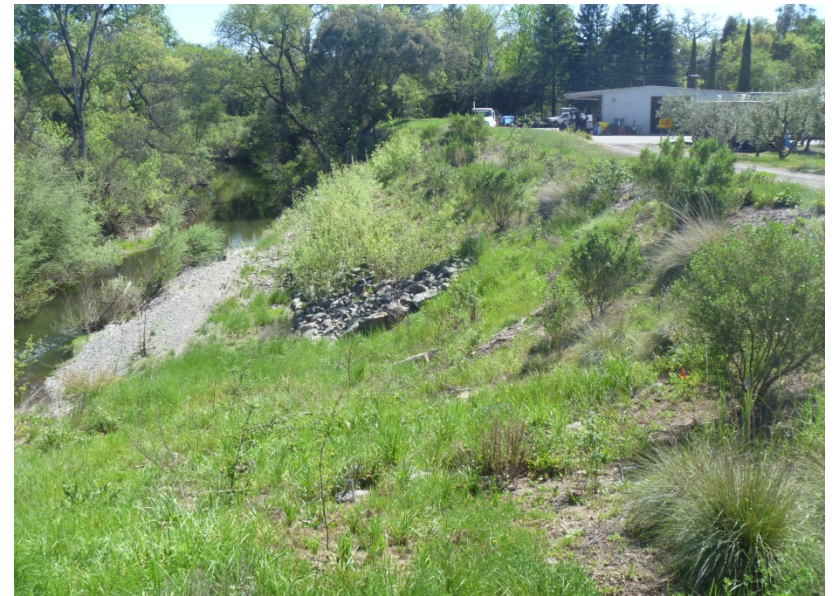
River Station 127+80
Bank Stabilization 3: Round Pond West, West Bank to Downstream

May 2012

December 2012

November 2012

January 2013

March 2015

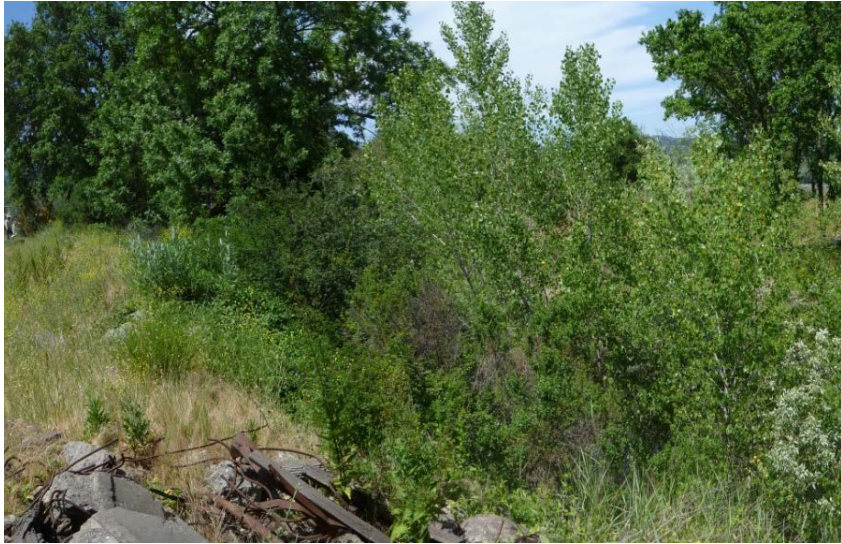
River Station 126+00
Bank Stabilization 3: Round Pond West, West Bank to Upstream

May 2012
