NAPA RIVER RUTHERFORD REACH RESTORATION PROJECT ANNUAL MONITORING REPORT- 2014

Prepared April 2015 by:

Napa County Flood Control and Water Conservation District
804 First Street
Napa, California, 94559
Contact: Jeremy Sarrow
(707) 259-8204

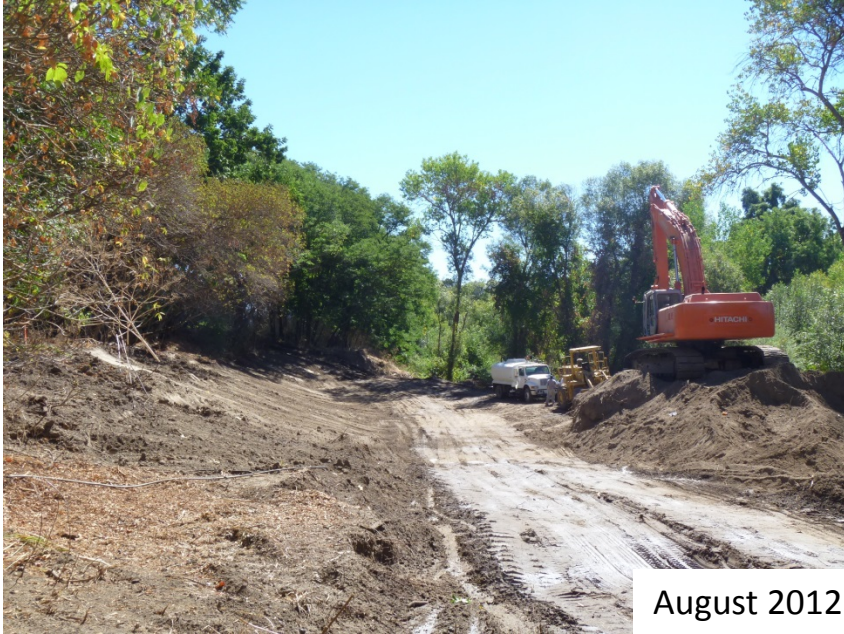
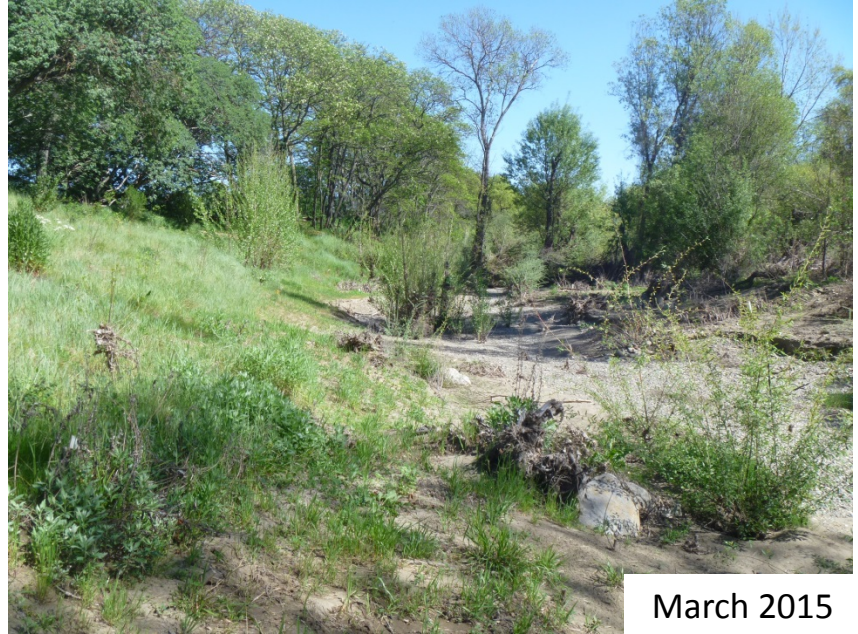
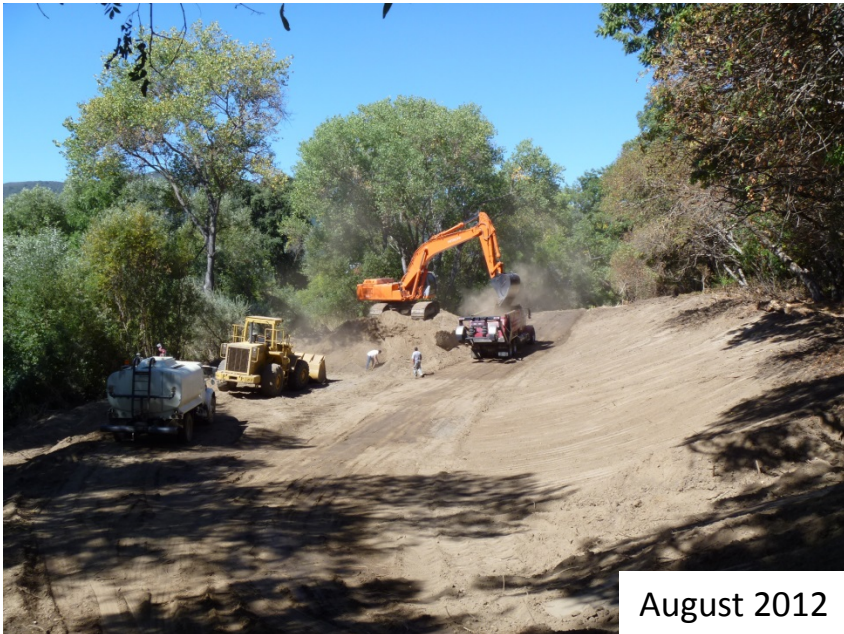
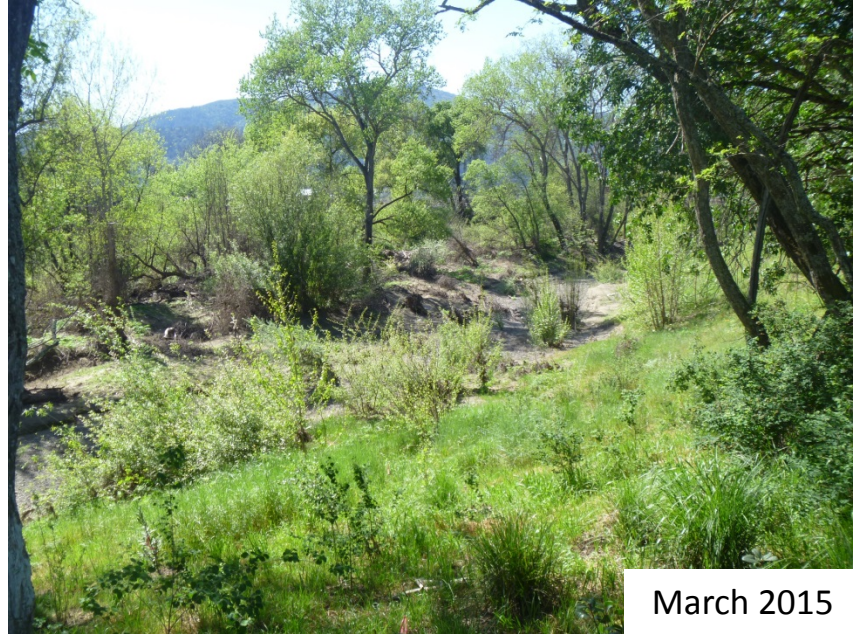
River Station 65+50
Bench 1 Secondary Channel: Wilsey, East Bank

**Part of Phase 4a: Reach 8 North
Secondary Channel on Bench 1 on Wilsey**

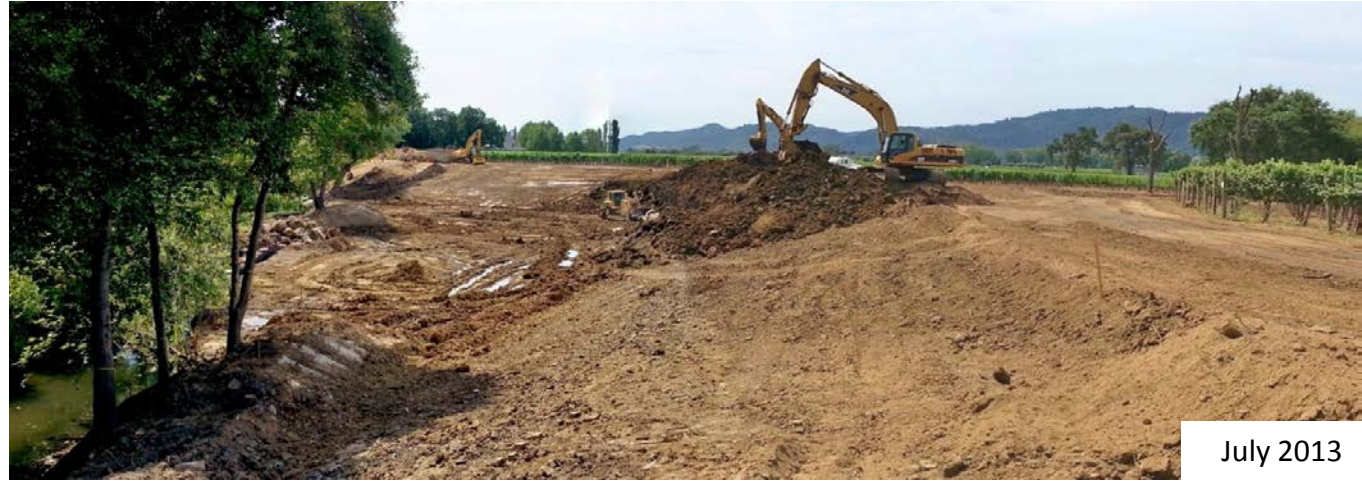
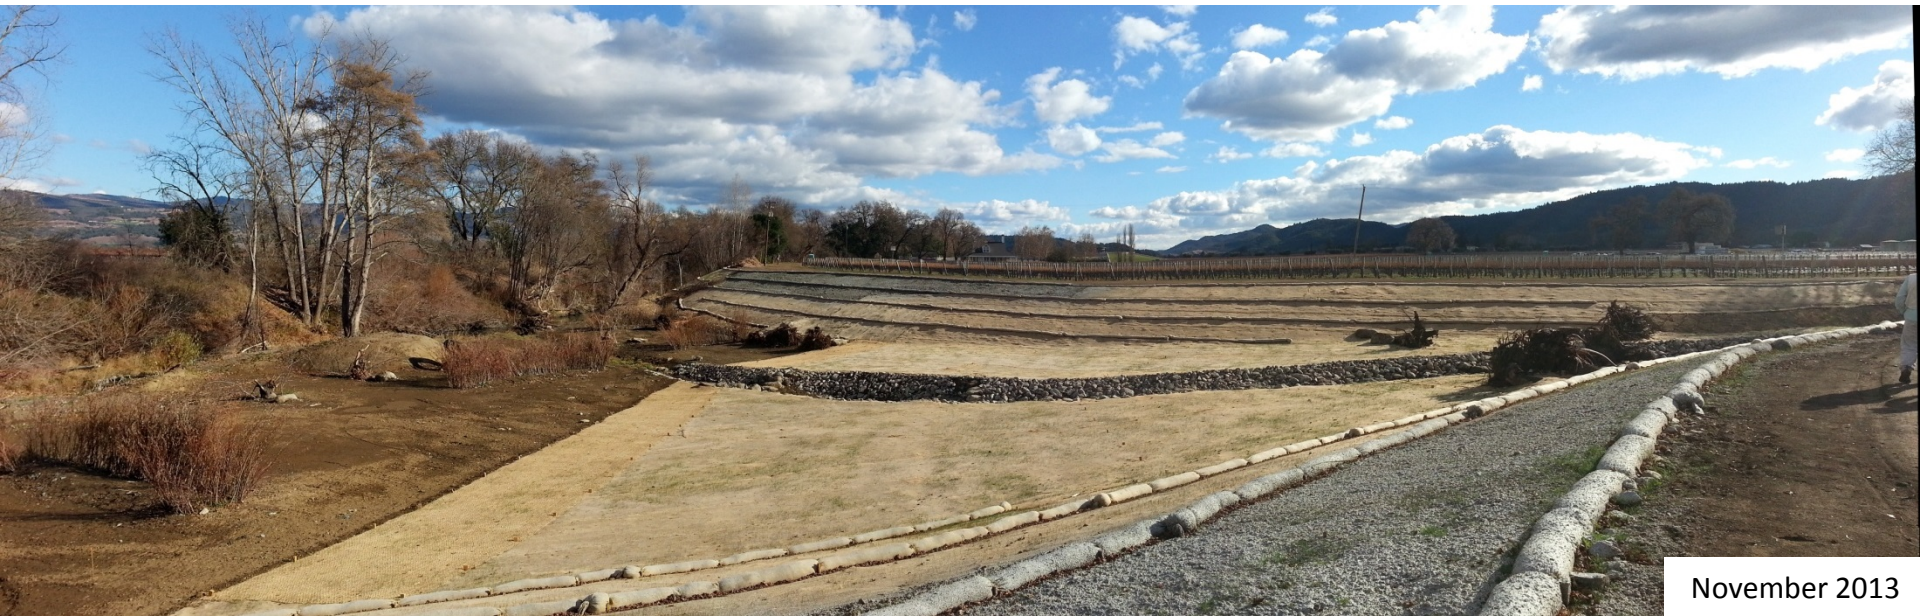
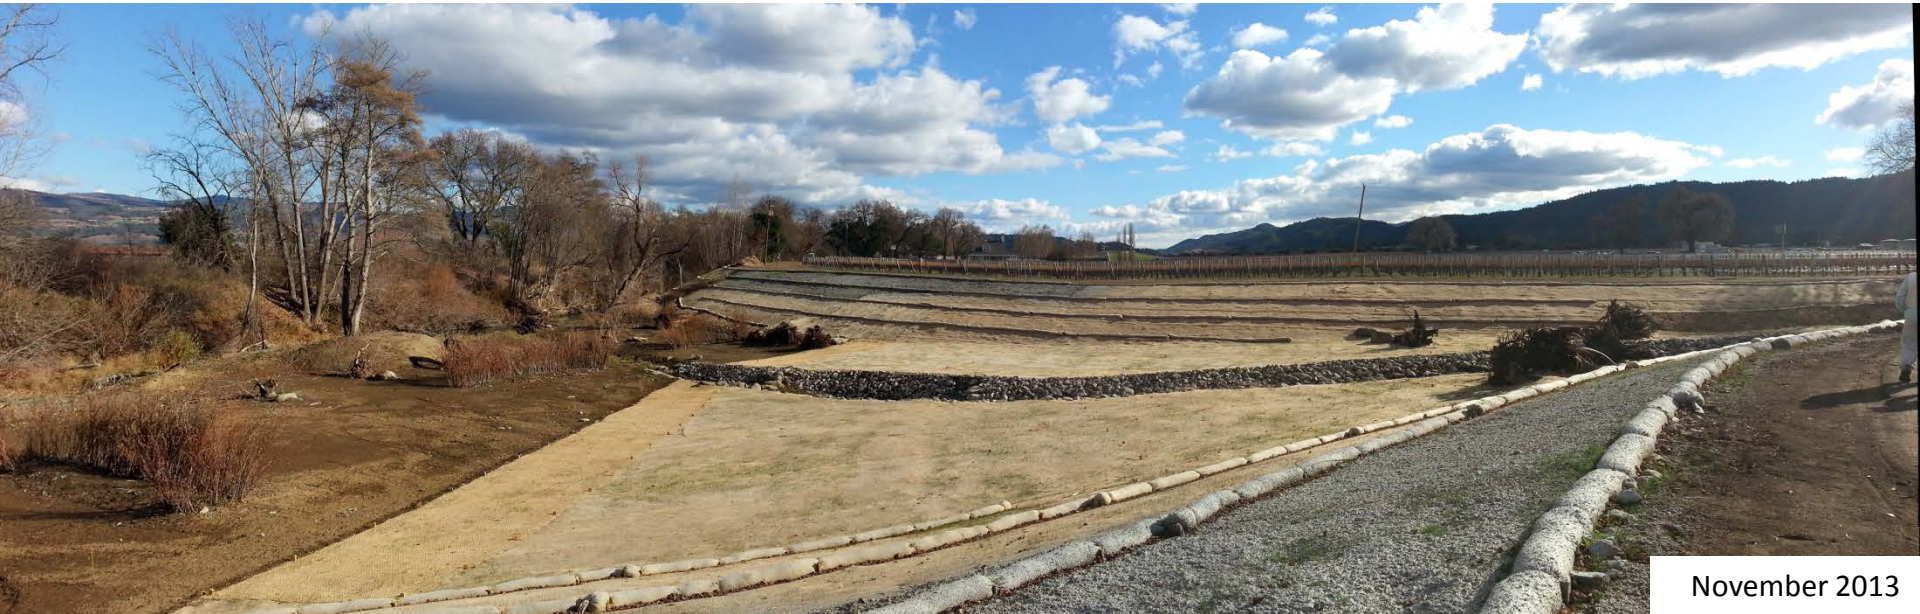
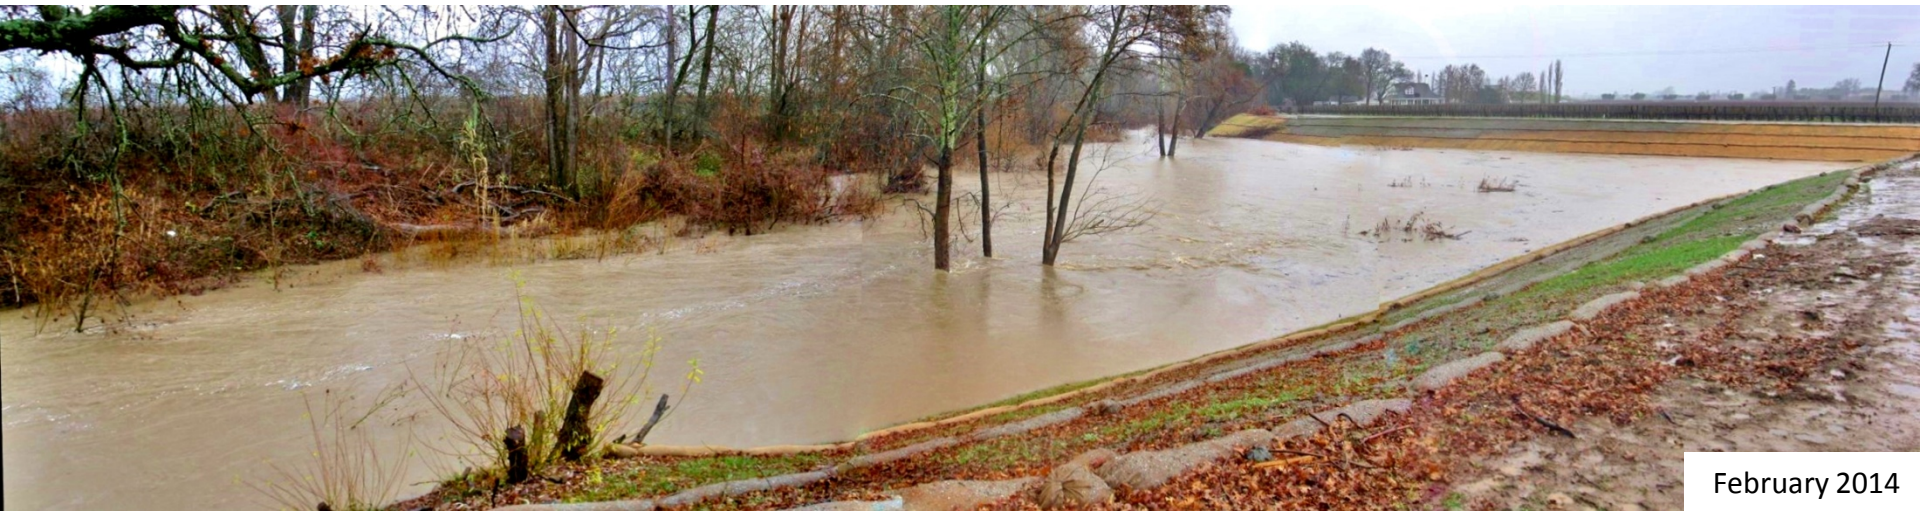
River Station 36+00
Reach 8 South, Bella Oaks Tributary Alcove: Upstream to Downstream

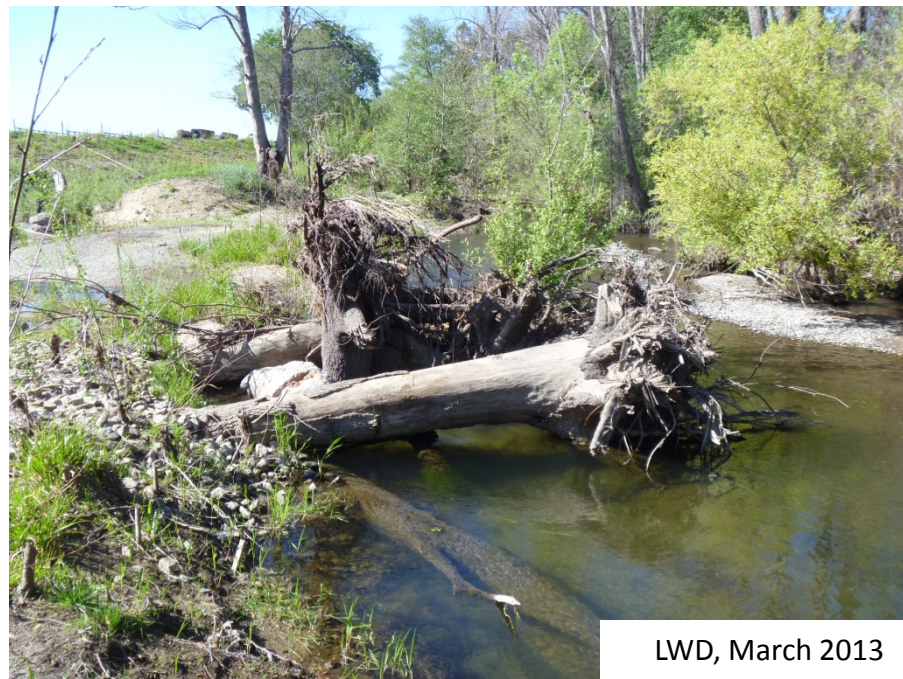
Reach 8 South, Cakebread Alcove Detail

LWD, March 2013

As part of the annual channel survey naturally recruited and installed large wood debris (LWD), and boulder clusters, have been monitored since 2009. Naturally recruited LWD is monitored for year-to-year comparison to track trends in location, quantity, size, and function. Installed LWD and boulder clusters are assessed to verify their persistence, functionality (summer and winter refugia) and to assess potential damage or maintenance needs. For purposes of the survey, naturally recruited LWD is defined as piece of wood located in channel below top of bank that is at least 6 feet in length and 18 inches in diameter. For each occurrence, it is noted whether the LWD or boulder cluster is performing any of the following functions: spawning gravel recruitment, hydraulic constriction, pool scour, summer refugia, winter high-flow refugia, or bank stability. Some occurrences provide multiple functions, and some are not currently providing any of the listed functions.

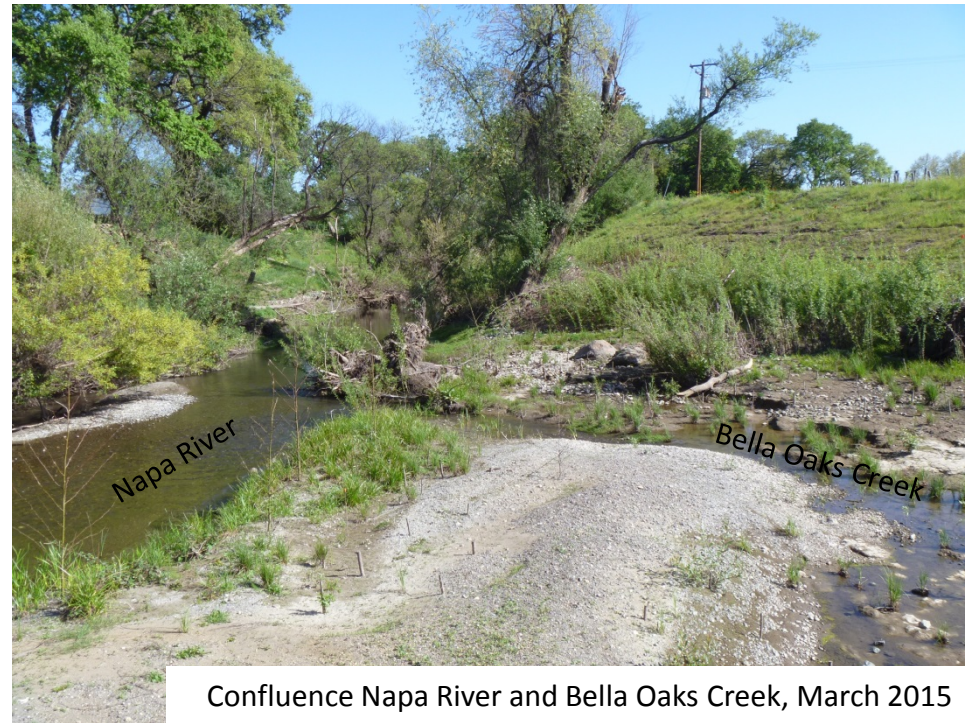
Confluence Napa River and Bella Oaks Creek, March 2015

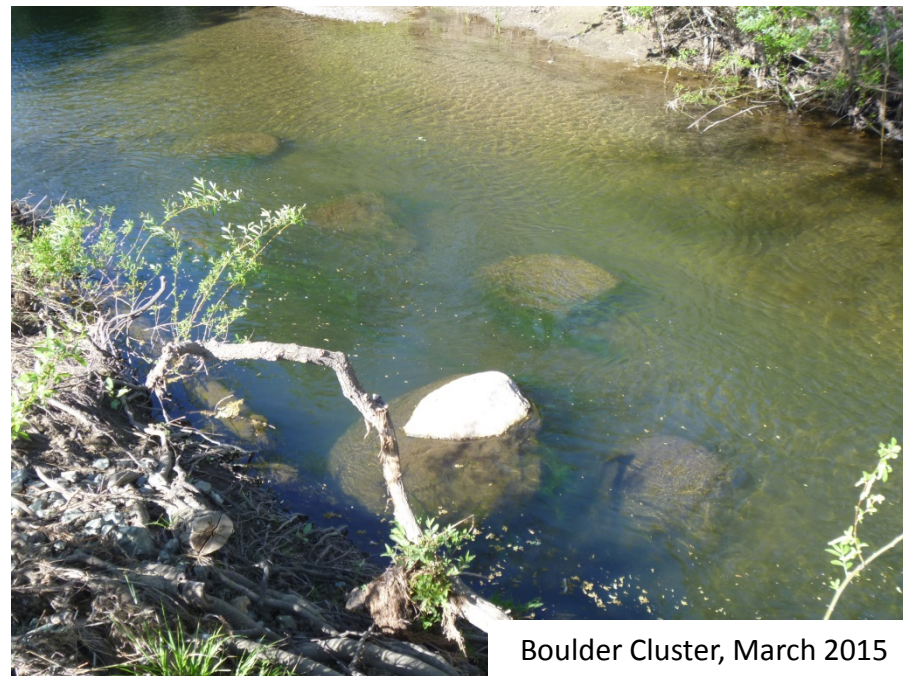
Boulder Cluster, March 2015

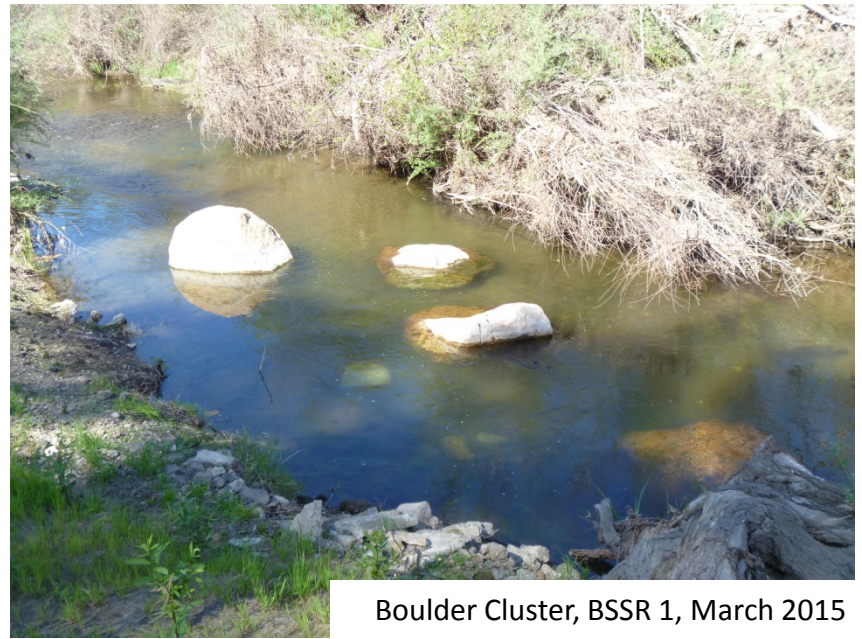
Boulder Cluster, BSSR 1, March 2015

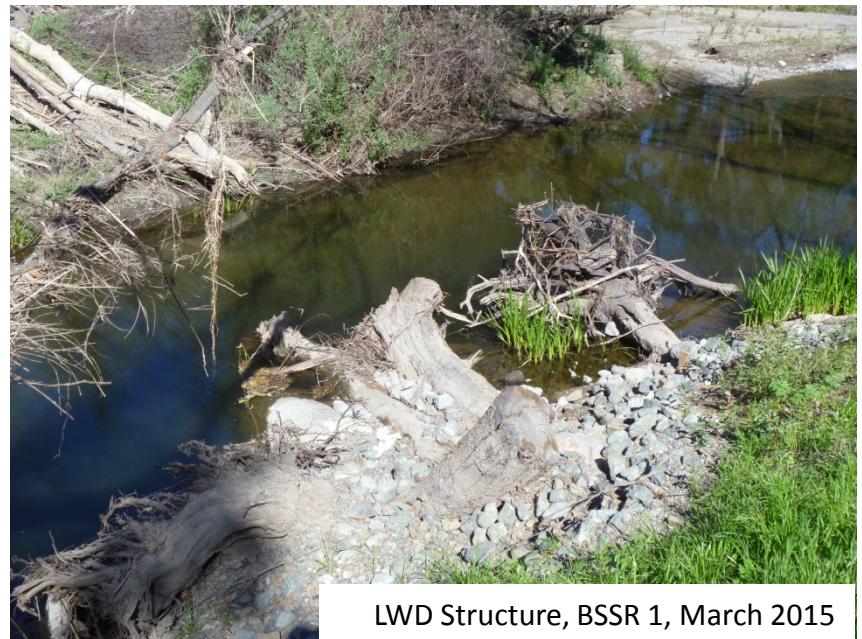
LWD Structure, BSSR 1, March 2015

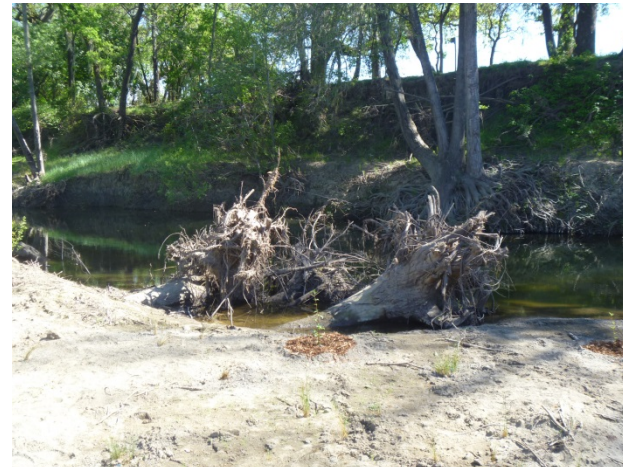
LWD, Bench 1,
March 2015

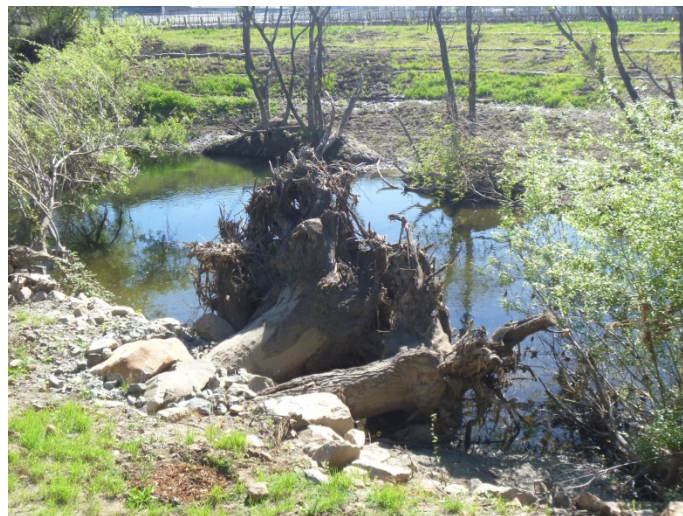
LWD, Bench 2,
March 2015
