NAPA RIVER RUTHERFORD REACH RESTORATION PROJECT ANNUAL MONITORING REPORT- 2015

Napa County Flood Control and Water Conservation District
804 First Street
Napa, California, 94559
Contact: Jeremy Sarrow
(707) 259-8204

Napa County Resource Conservation District
1303 Jefferson Street, Suite 500 B
Napa, California, 94558
Contact: Paul Blank/Jonathan Koehler
(707) 252-4188

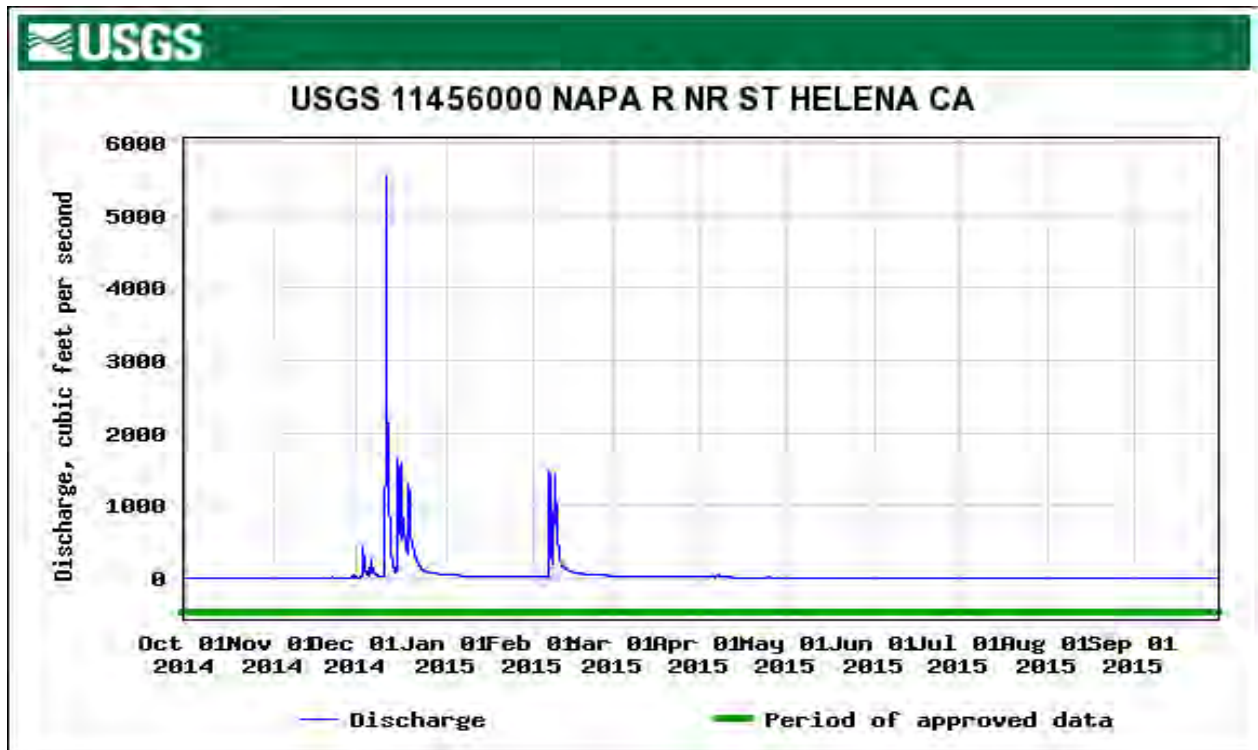
Figure 6. 2014-2015 streamflow, Napa River Rutherford Restoration Reach, USGS Station 11456000.

During the 2014-15 water year (October 1, 2014 through September 30, 2015), measureable streamflow began at Station 11456000 in late November and continued through early July. The peak flow of the season occurred on December 11, 2014, and was measured to be 5,540 cfs, approximately a 2-year peak flood. Following the last significant storm of the season in mid-February, flows in the river receded until the channel finally dried up in early July. A plot of streamflow measured at Station 11456000 during the 2014-15 water year is included as **Figure 6**.

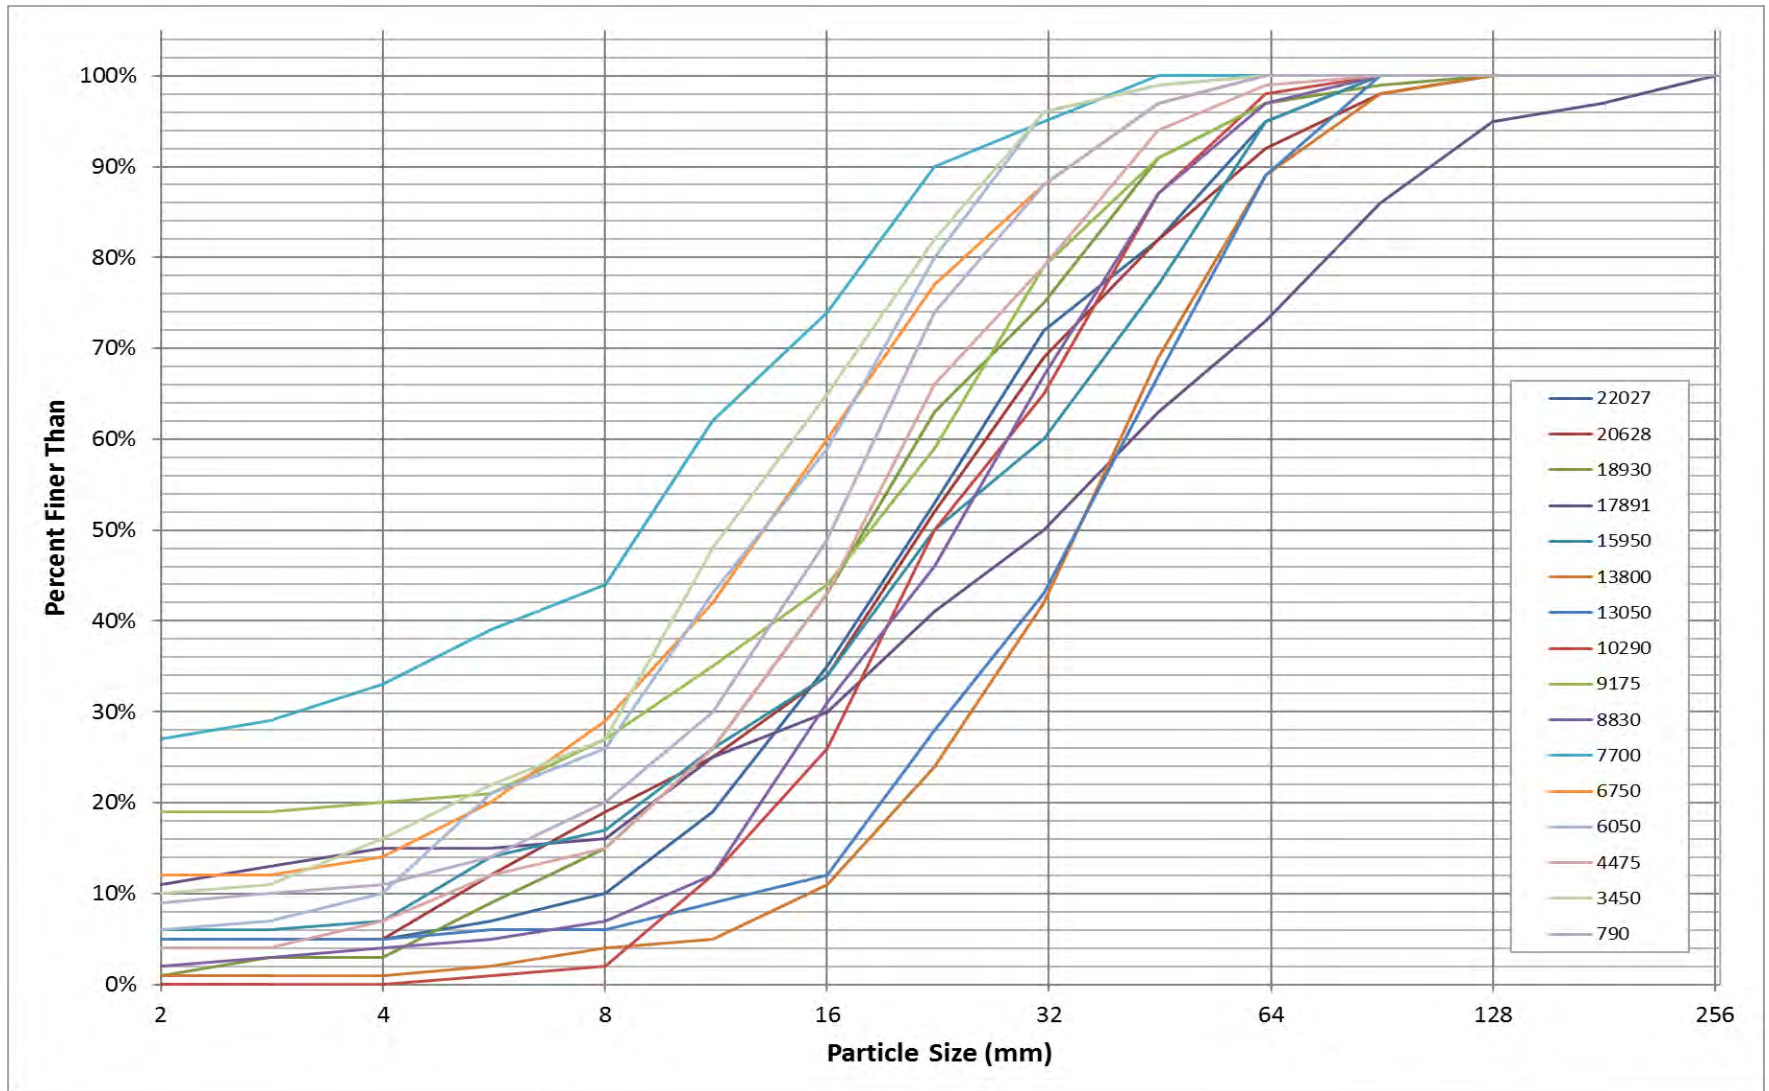
Figure 8. Grain size distributions for the 2015 pebble counts.

The field data were entered into a spreadsheet that tallied the values into standard sieve size classes, plotted the grain size distributions, and computed statistics. The 2015 pebble count results are listed in **Table 9**. The grain size distributions are presented on **Figure 8**.

The fine-grained fractions of the samples collected at Cross Sections 7700 and 9175 were too great to calculate d_{16} values, and therefore d_g , s_g , and sk as well. Although Sample 9175 had a high proportion of fine-grained material, the framework particles were within the size range of the other samples. Sample 7700 had a high percentage of fine-grained material and also anomalously fine framework gravels. The site of this sample should be re-evaluated to confirm that it is a potential spawning site, and then re-sampled to confirm the results.

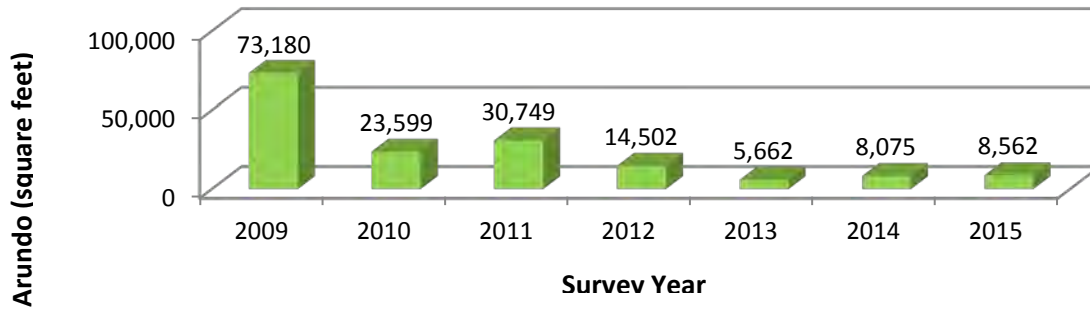
Chart 1: Arundo mapped and treated (2009-2015)

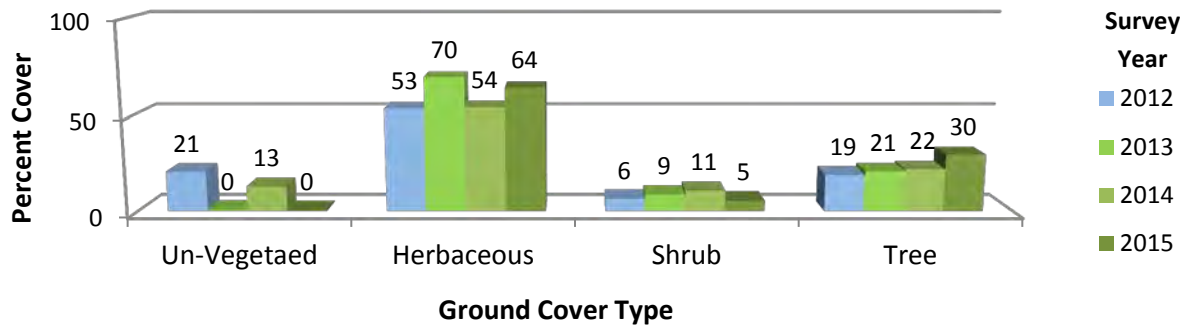
Chart 2: Average percent cover by ground cover type for line transect surveys (2012-2015)

Line intercept transects have been established at 22 locations in all of the nine monitoring reaches in order to measure changes in vegetation cover and height class within restored areas (Harris 2005). Representative photos of the sites are shown in **Appendix B**. The transect lines range from 45 to 111 feet in length and typically span the entire width of a restoration area. **Figure 9** above shows the name and location of each transect line surveyed. **Chart 2** below presents the average relative percent native cover, by ground cover type, for all transect lines in Reaches 1- 9 for survey years 2012-2015. Results from the last four years of surveys indicate that the general trend in native ground cover is shifting from un-vegetated to herbaceous, with a gradual increase of native shrub and tree cover types; this is to be expected as sites mature and shrubs and trees grow larger and provide more cover and structure at a given restoration site. The slight decrease in herbaceous cover in 2014 and slight decline in shrub cover type in 2015 is likely due to the addition of several new transect sites at locations that were planted and established for less than a year prior to the 2014 and 2015 surveys. Now that Project construction is complete, and all restoration sites have been planted, the vegetation establishment monitoring dataset should stabilize and continue to show clear long term trends.

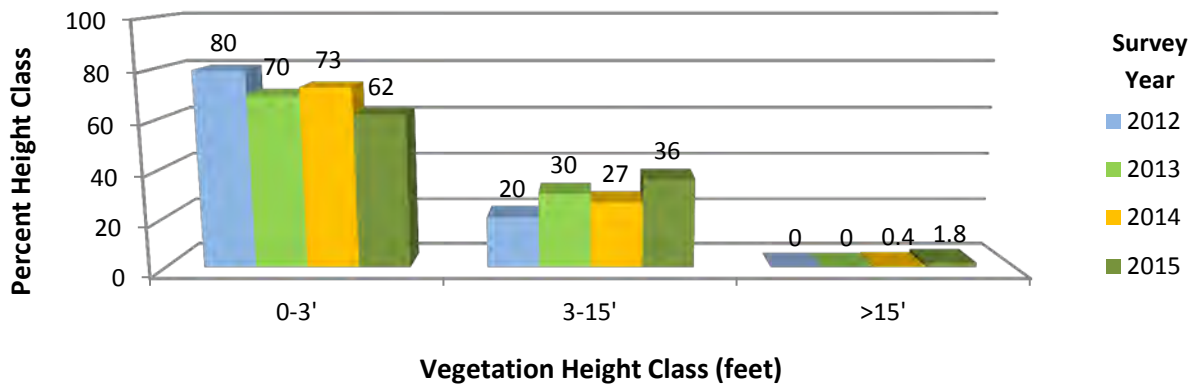
Chart 3: Average height class of herbaceous and woody vegetation for line transect surveys (2012-2015)

Chart 3 below represents the average height class of measured vegetation along all surveyed transect lines from 2012 through 2015. Approximately 62% of the vegetation measured in 2015 at a given

transect ranged between 0 and 3 feet tall, while approximately 36% of the vegetation measured in 2015 ranged between 3 and 15 feet in height. In 2015 several trees (cottonwoods) measured along a transects (CAY2 and DW1) in reach 3 and 8 were 15 feet in height or greater, providing data for the next height class and documenting maturation of the over story canopy within Project restoration areas. This represents a milestone in the relative vegetative cover measured from previous survey years and is generally indicative of successful plant establishment. Representative photos of the monitoring sites are shown in **Appendix B**.

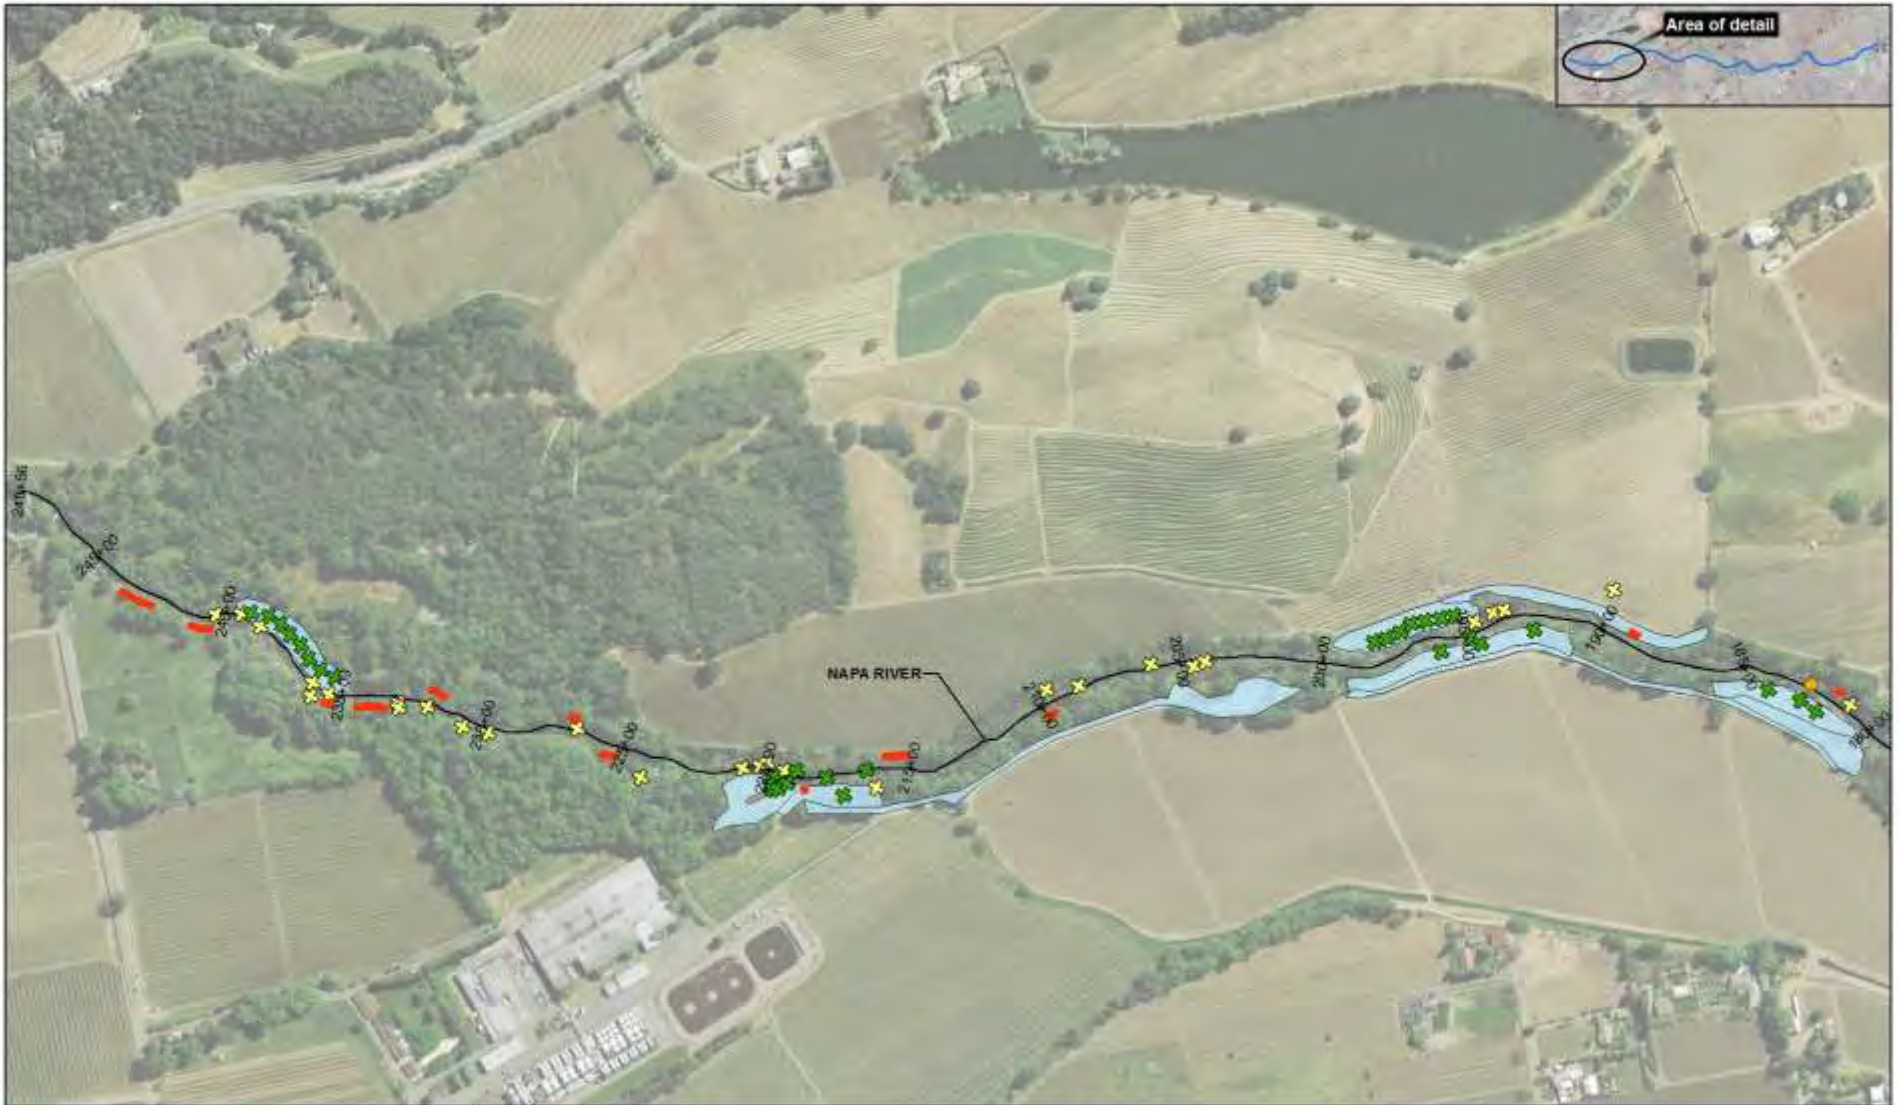
Napa River Rutherford Restoration Project Reach 1-2
2015 Eroding Stream Bank and Large Woody Debris Survey

An annual eroding stream bank survey is conducted along the entire length of the bankfull channel every year in order to evaluate the extent of any stream bank erosion within the Project area and to assess effects on fine sediment loading. During the dry season, the team walks the entire project reach in the downstream direction and maps the start and end of erosion areas on each bank. For each erosion area, the length and average height of the erosion is estimated and it is noted whether the erosion affects the whole bank, the top of bank, or the base of bank. In addition, it is noted whether the erosion is due to undercutting or a lack of vegetation. Project restoration efforts addressed eroding stream banks by grading over-steepened banks to more stable profiles and installing biotechnical bank stabilization features such as brush mats. Additional information regarding monitoring protocols and performance targets is in the *Monitoring Plan for the Rutherford Reach Restoration of the Napa River* which can be found at www.napawatersheds.org.

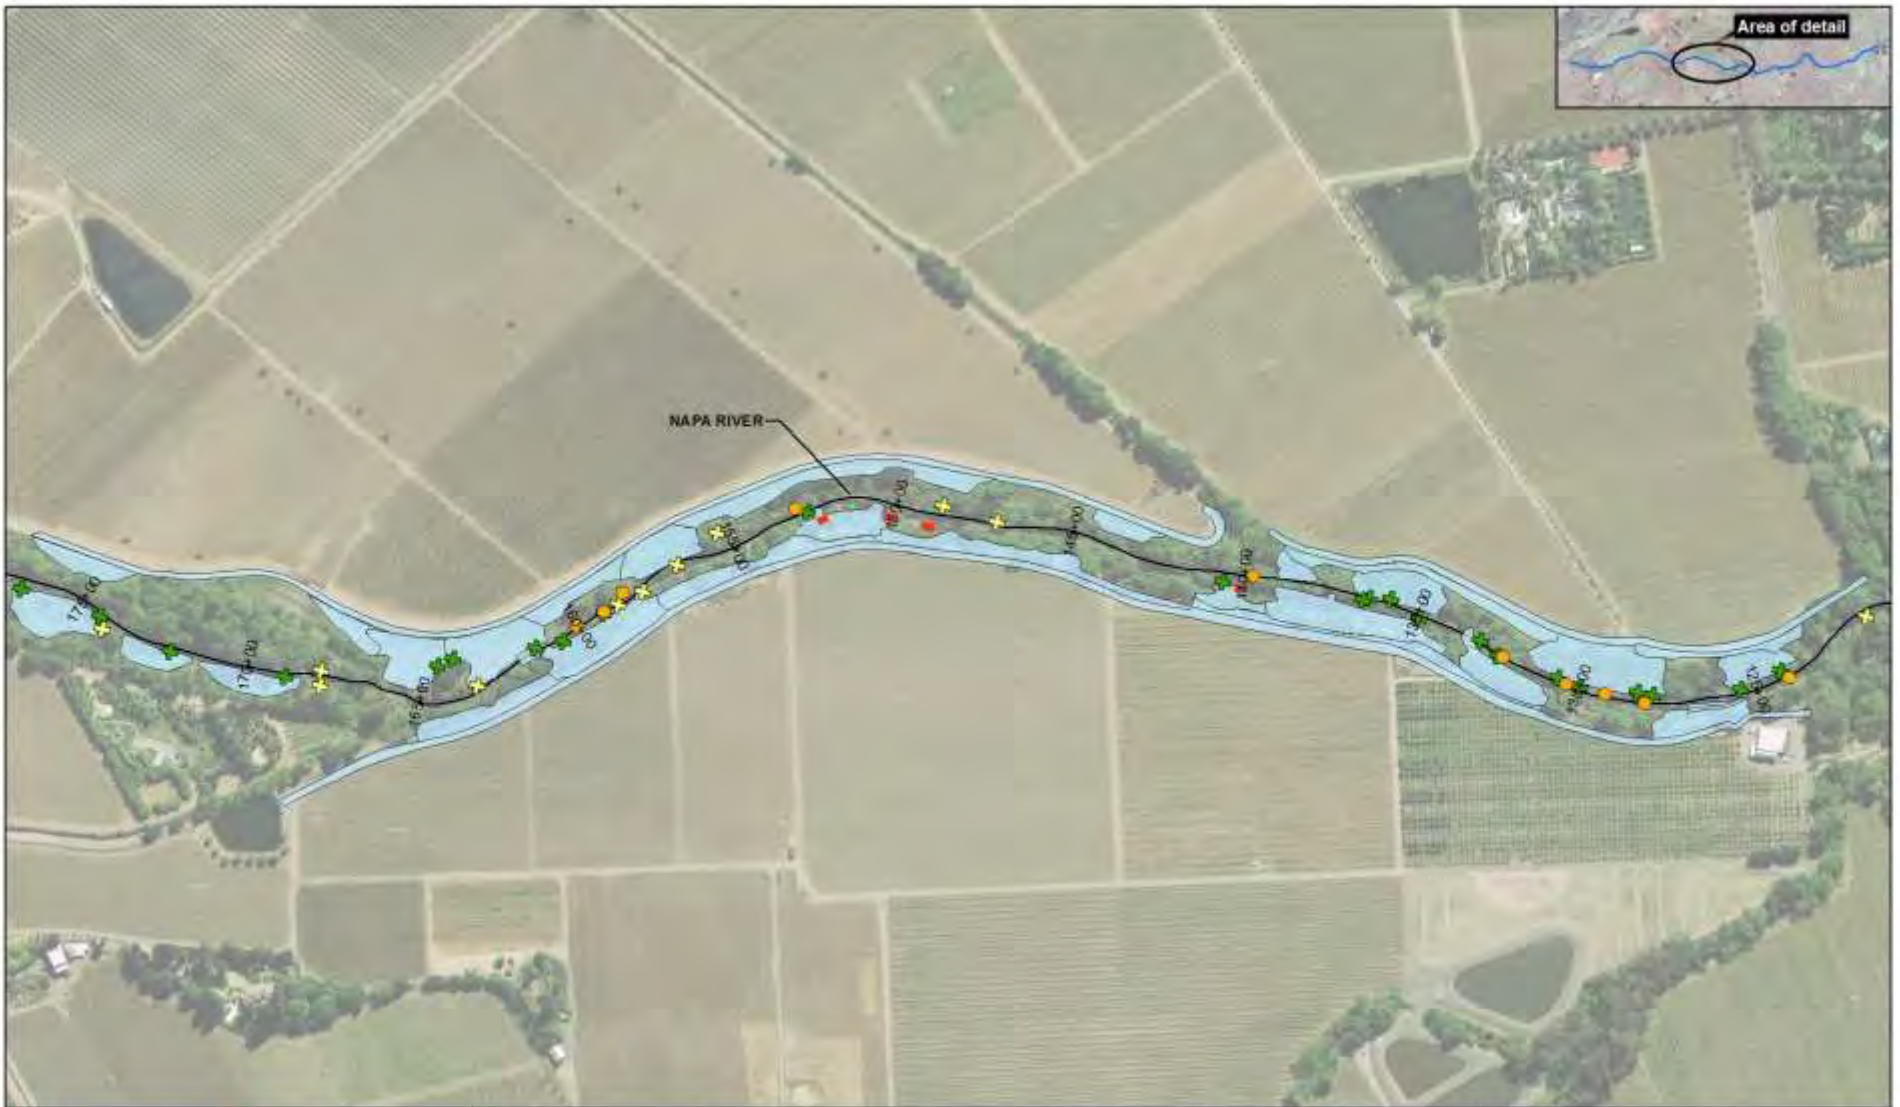
Napa River Rutherford Restoration Project Reach 3-4
 2015 Eroding Stream Bank and Large Woody Debris Survey

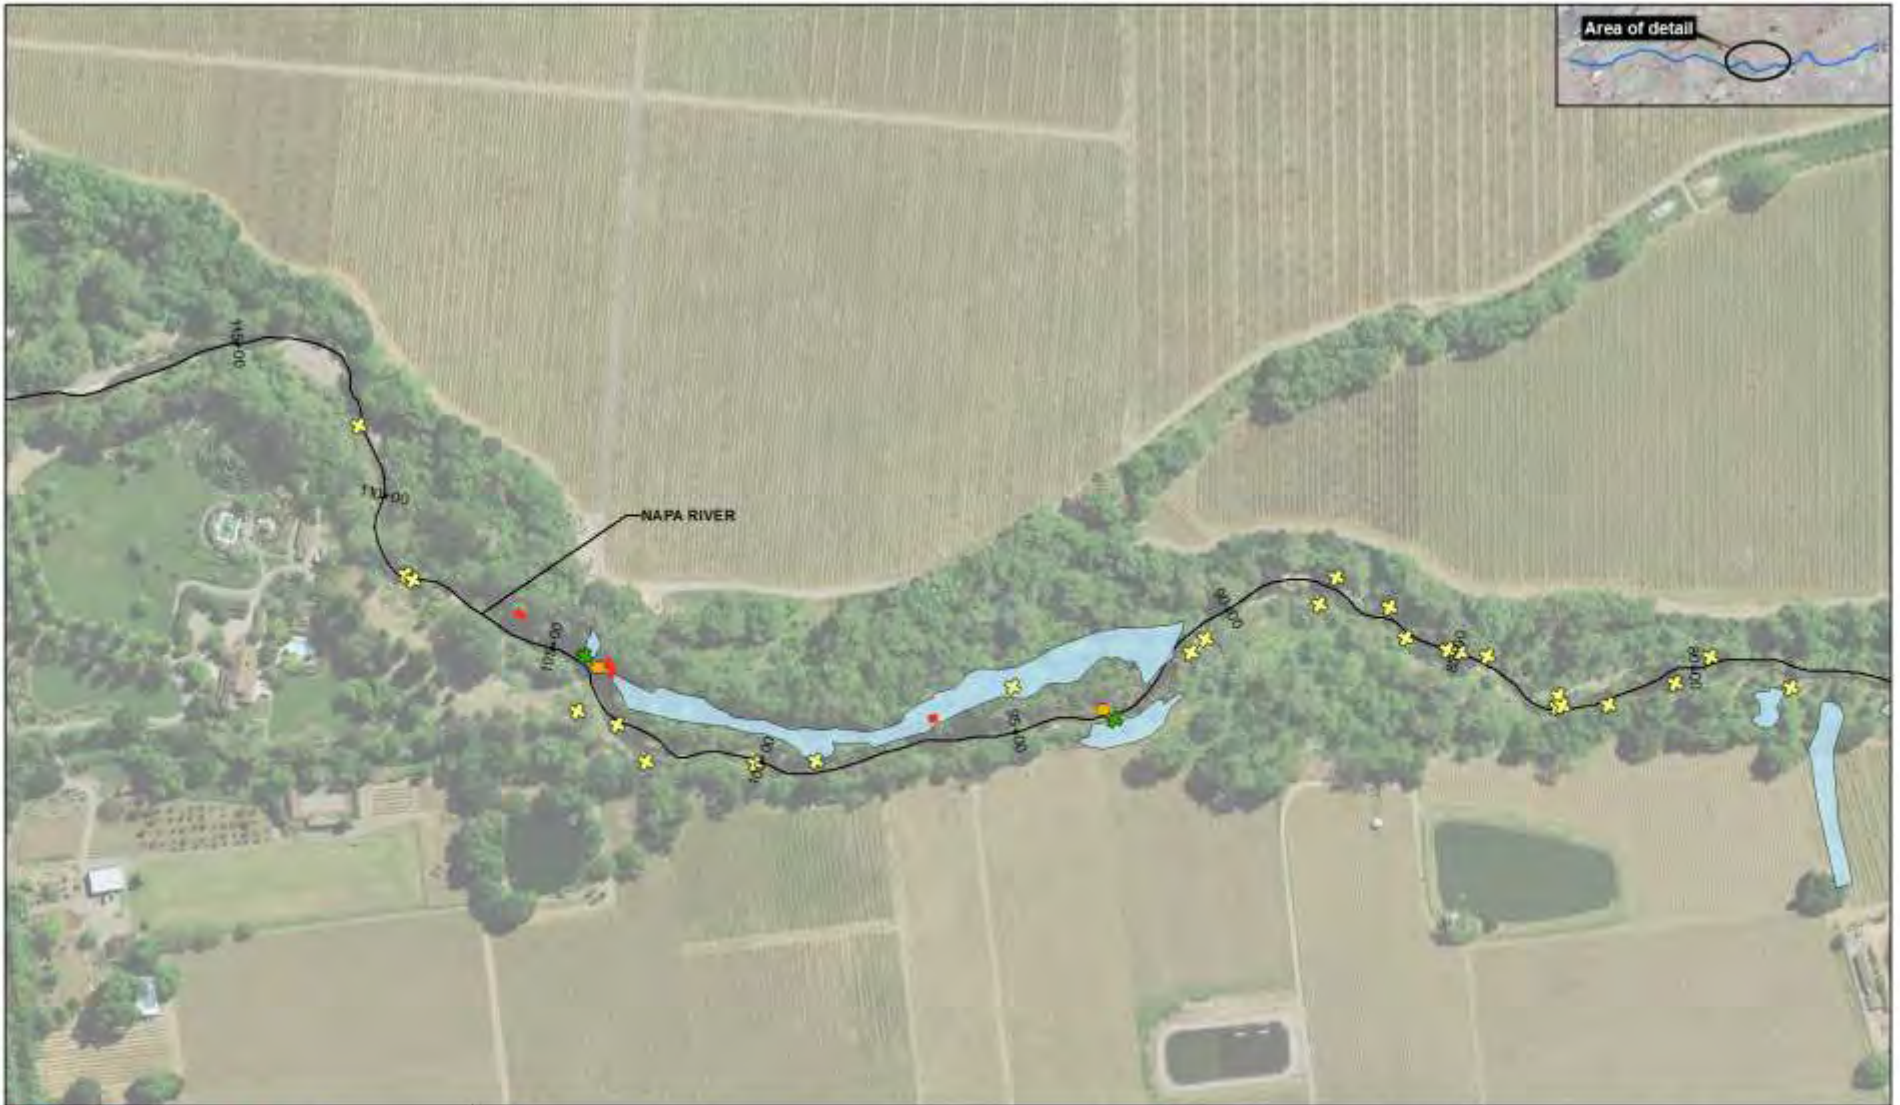
**Napa River Rutherford Restoration Project Reach 5-7
2015 Eroding Stream Bank and Large Woody Debris Survey**

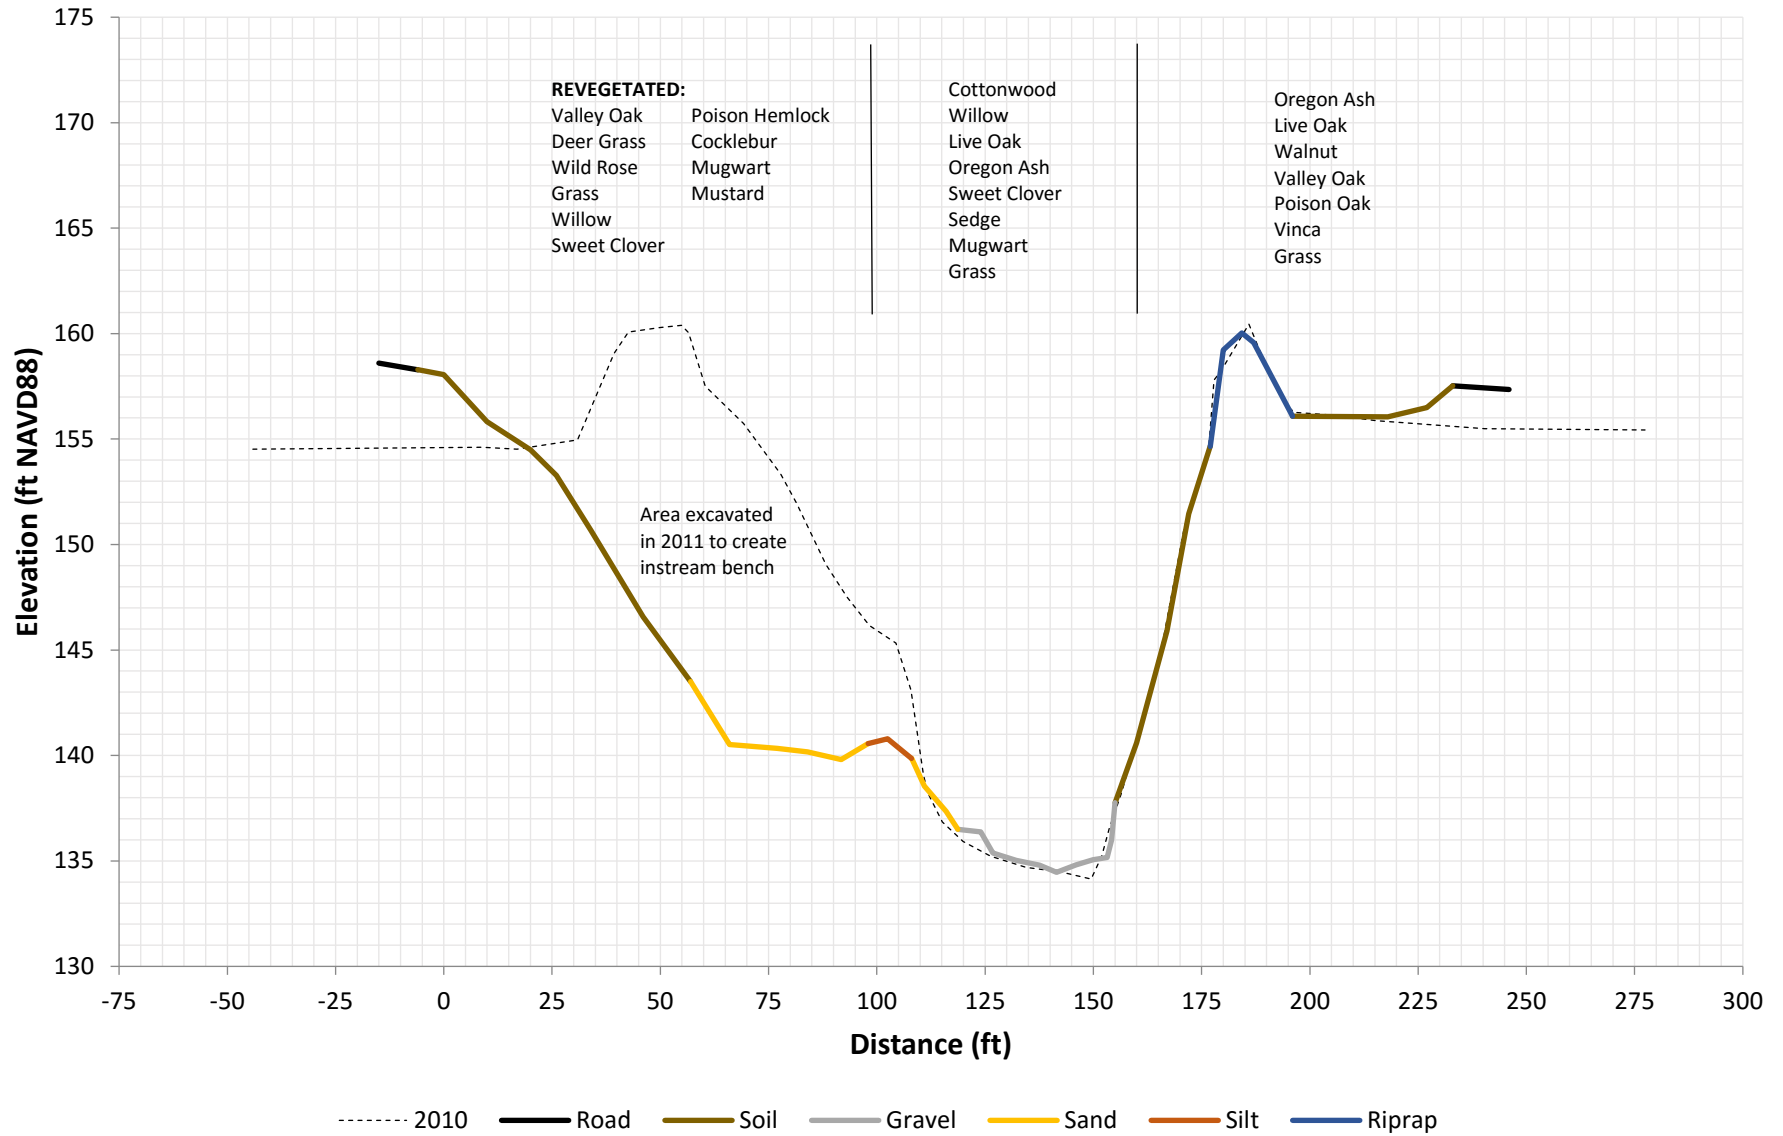
2015 Cross Section RS 13050

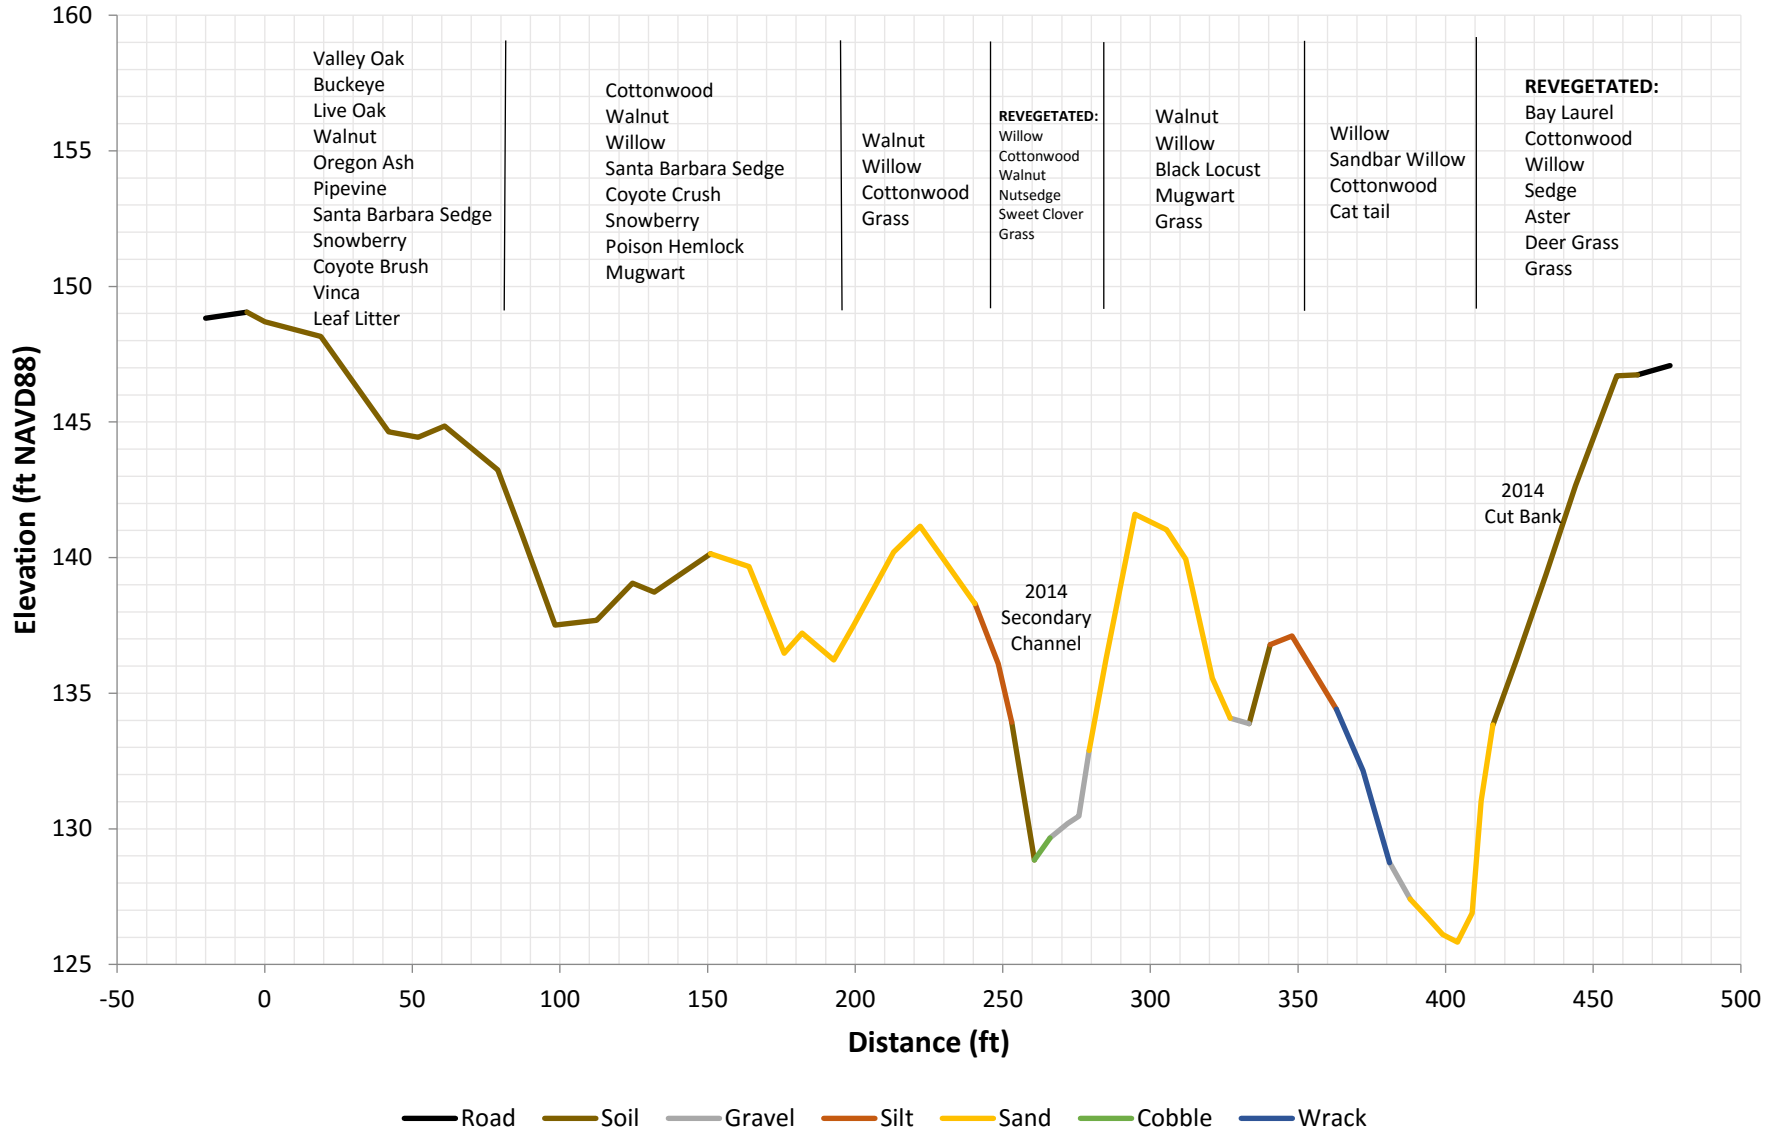
2015 Cross Section RS 9175

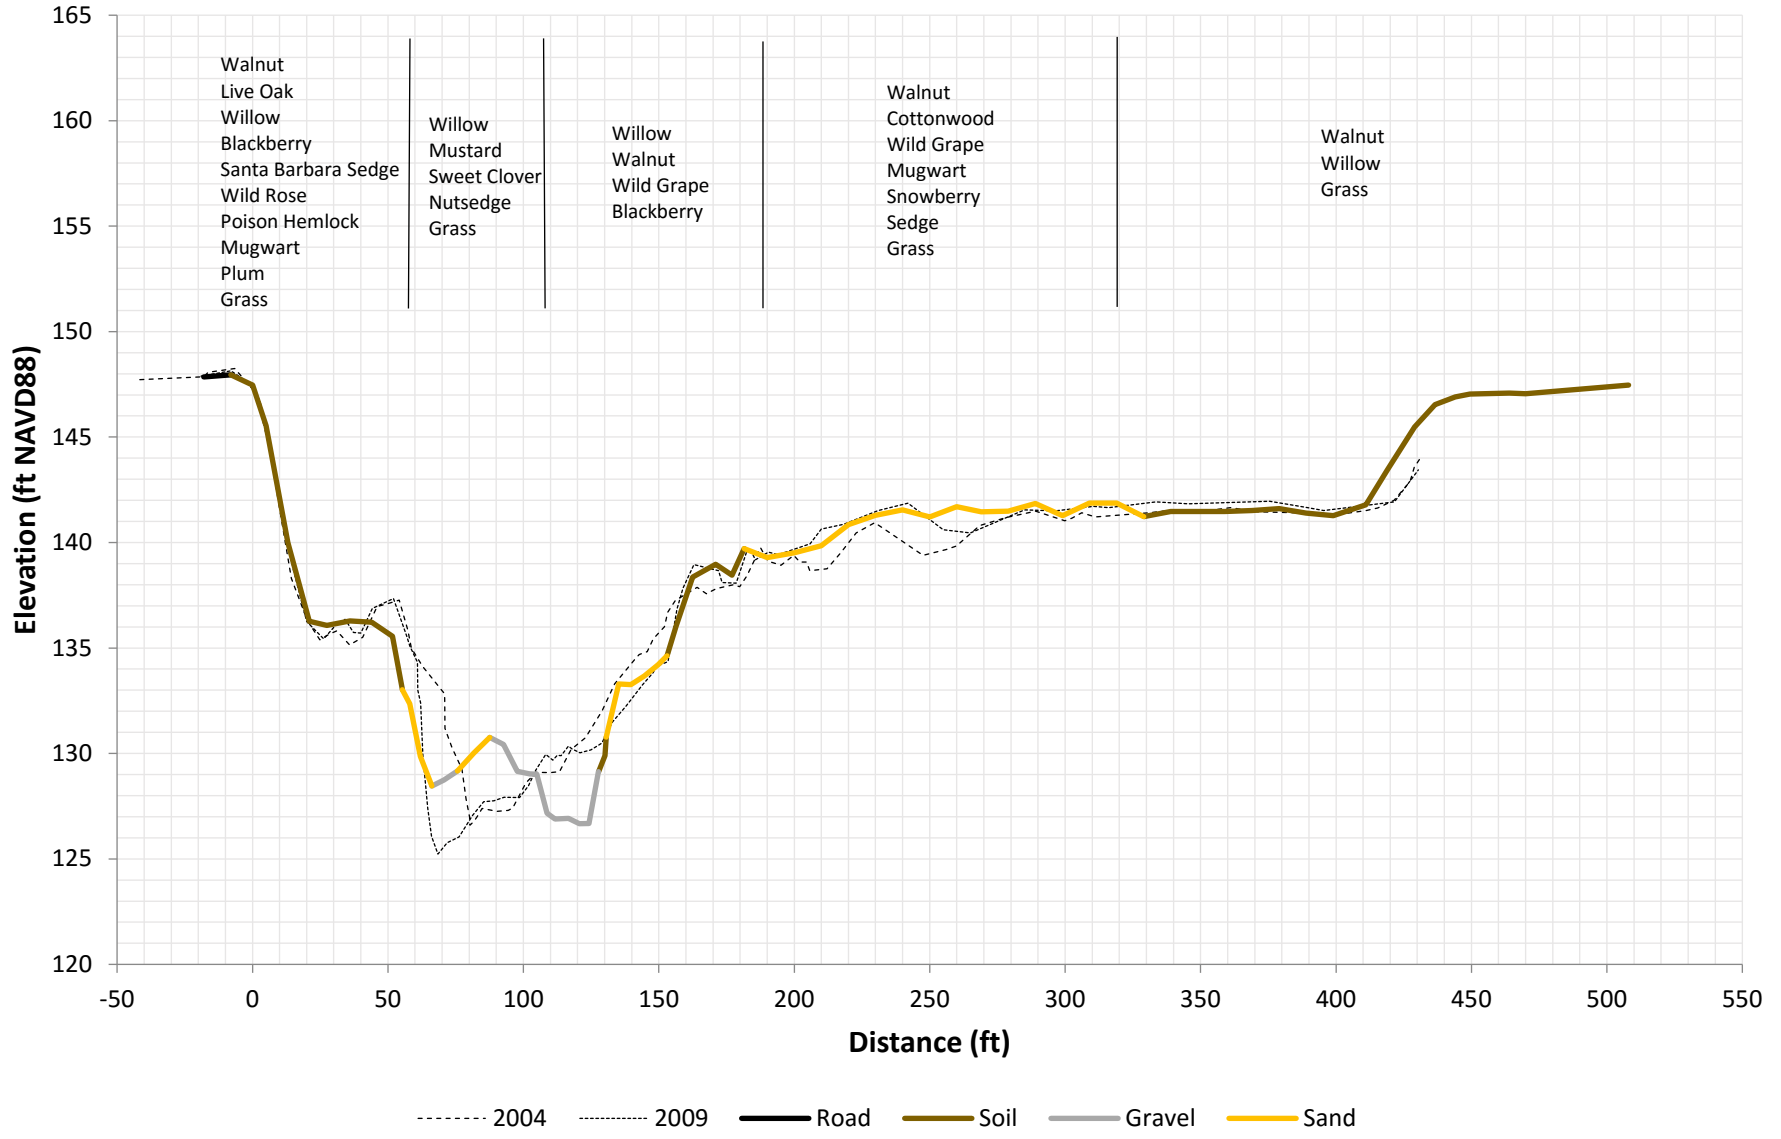
2015 Cross Section RS 8830

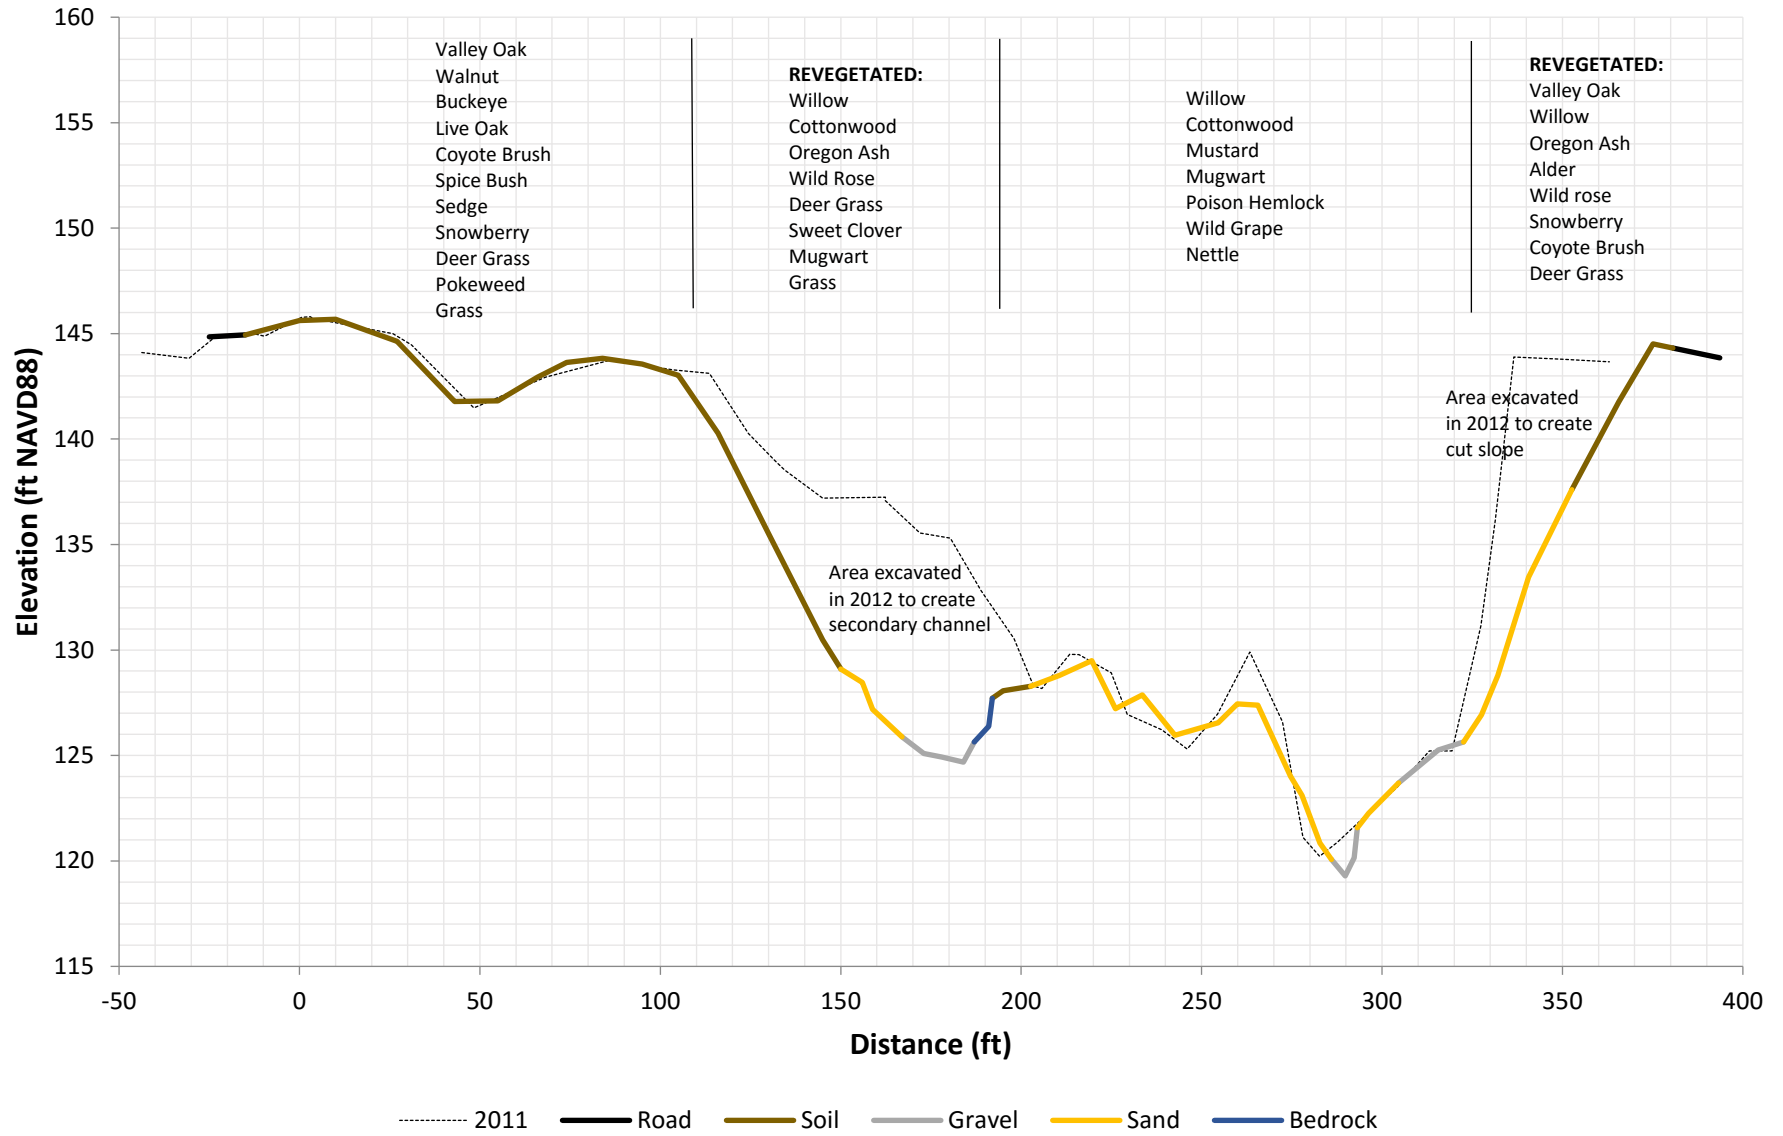
RS 6750

2015 Cross Section

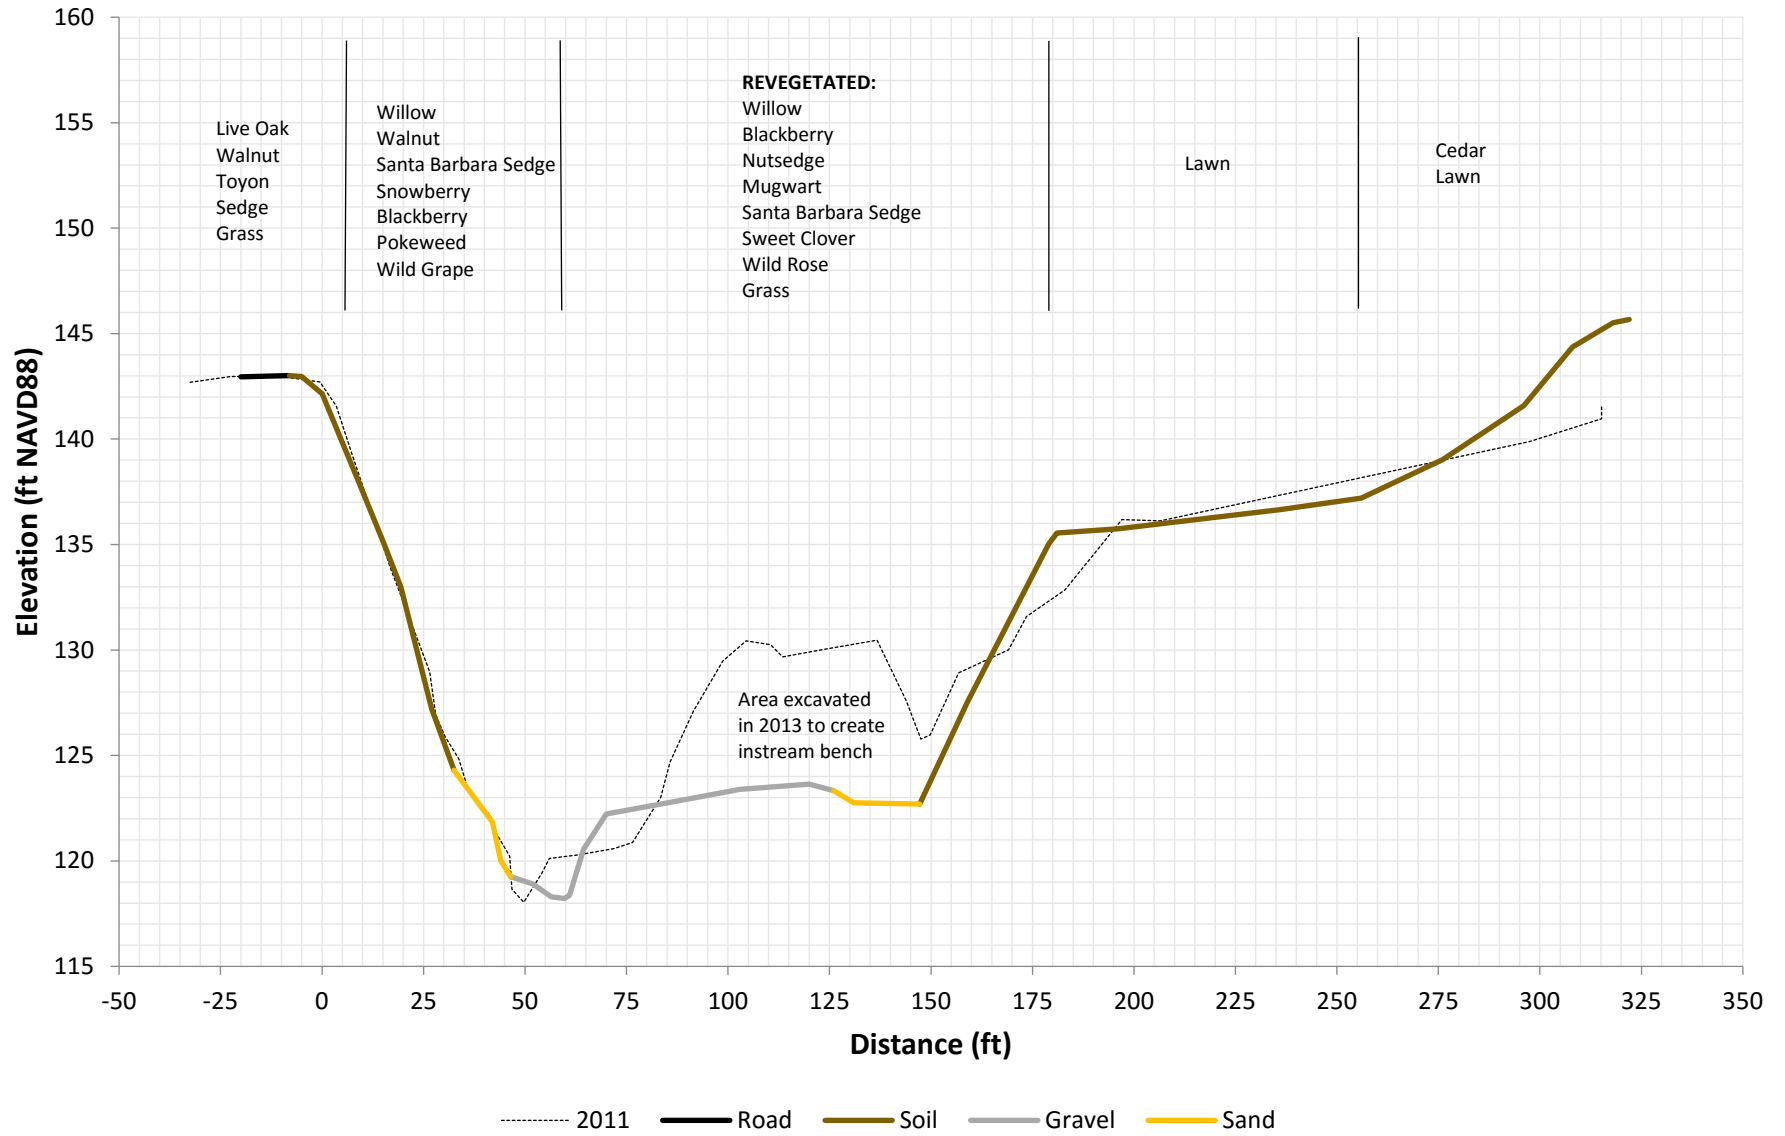
2015 Cross Section RS 6050
