NAPA RIVER RUTHERFORD REACH RESTORATION PROJECT ANNUAL MONITORING REPORT- 2015

Napa County Flood Control and Water Conservation District
804 First Street
Napa, California, 94559
Contact: Jeremy Sarrow
(707) 259-8204

Napa County Resource Conservation District
1303 Jefferson Street, Suite 500 B
Napa, California, 94558
Contact: Paul Blank/Jonathan Koehler
(707) 252-4188

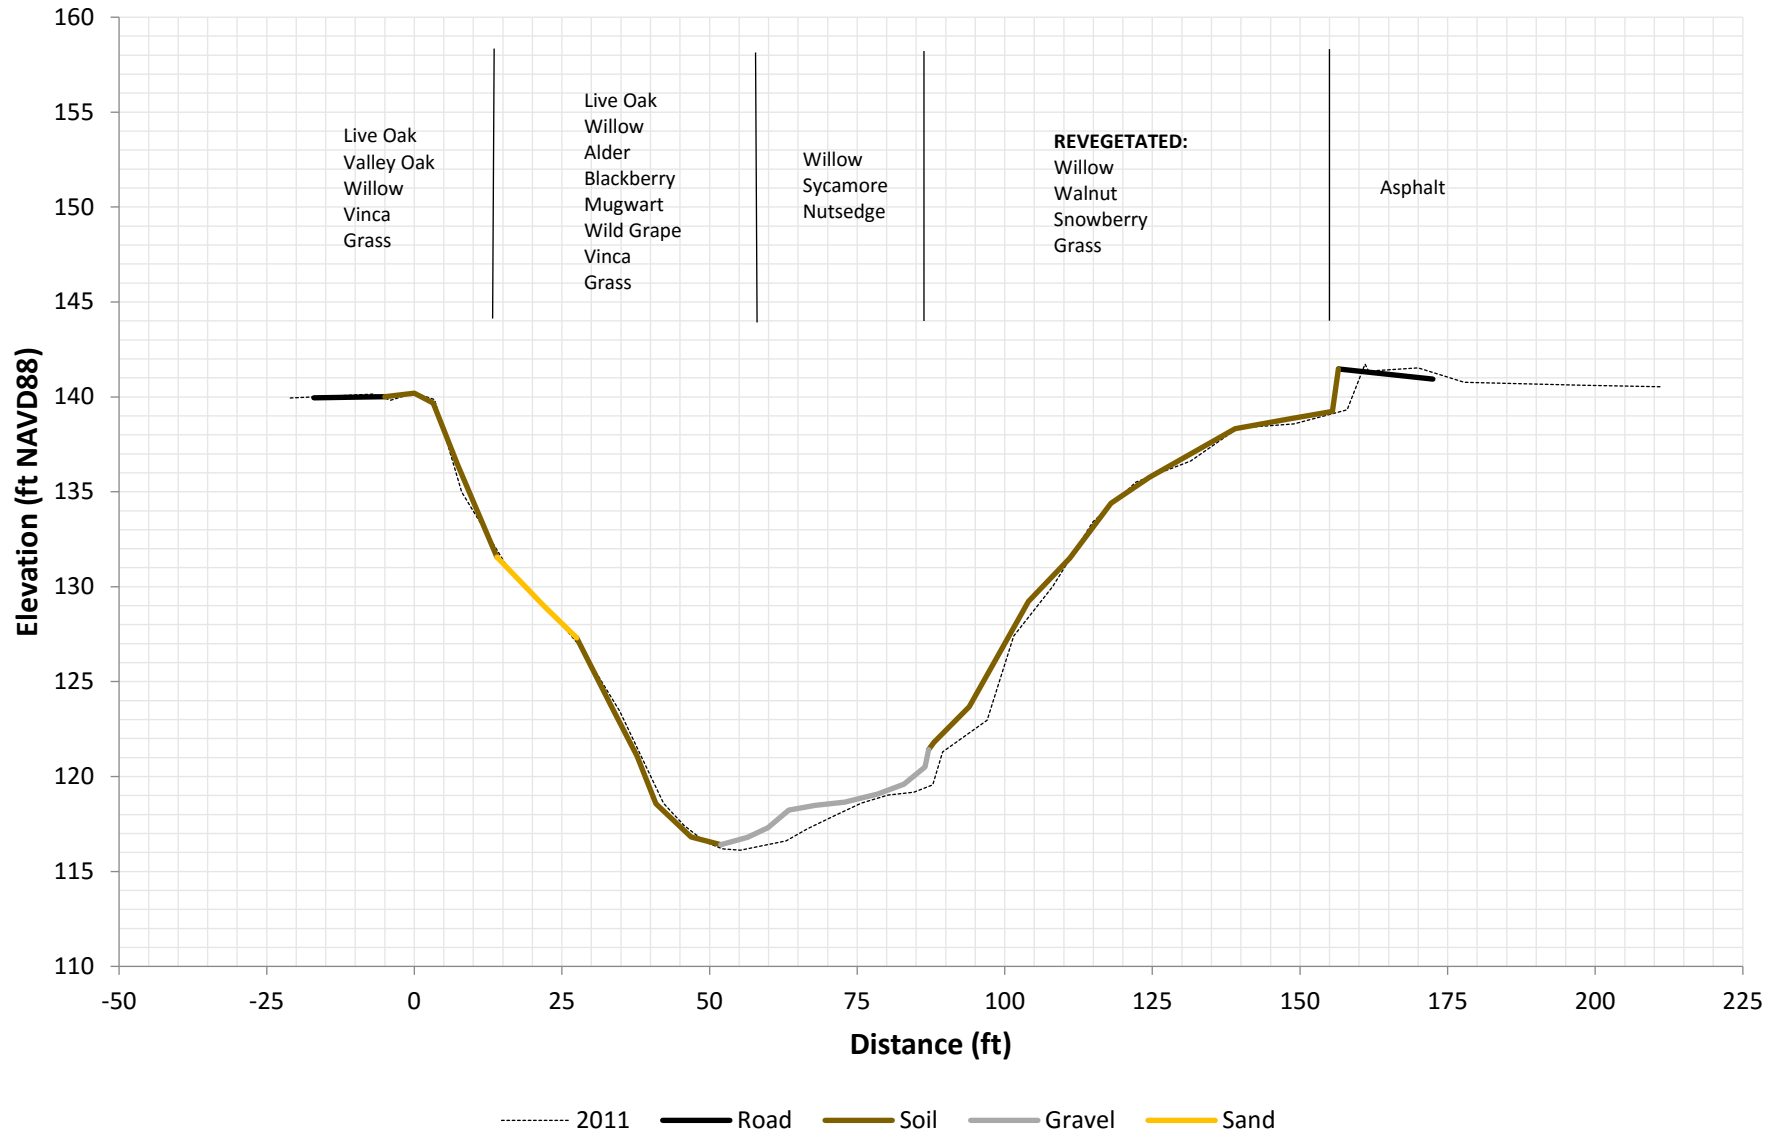
2015 Cross Section RS 4475

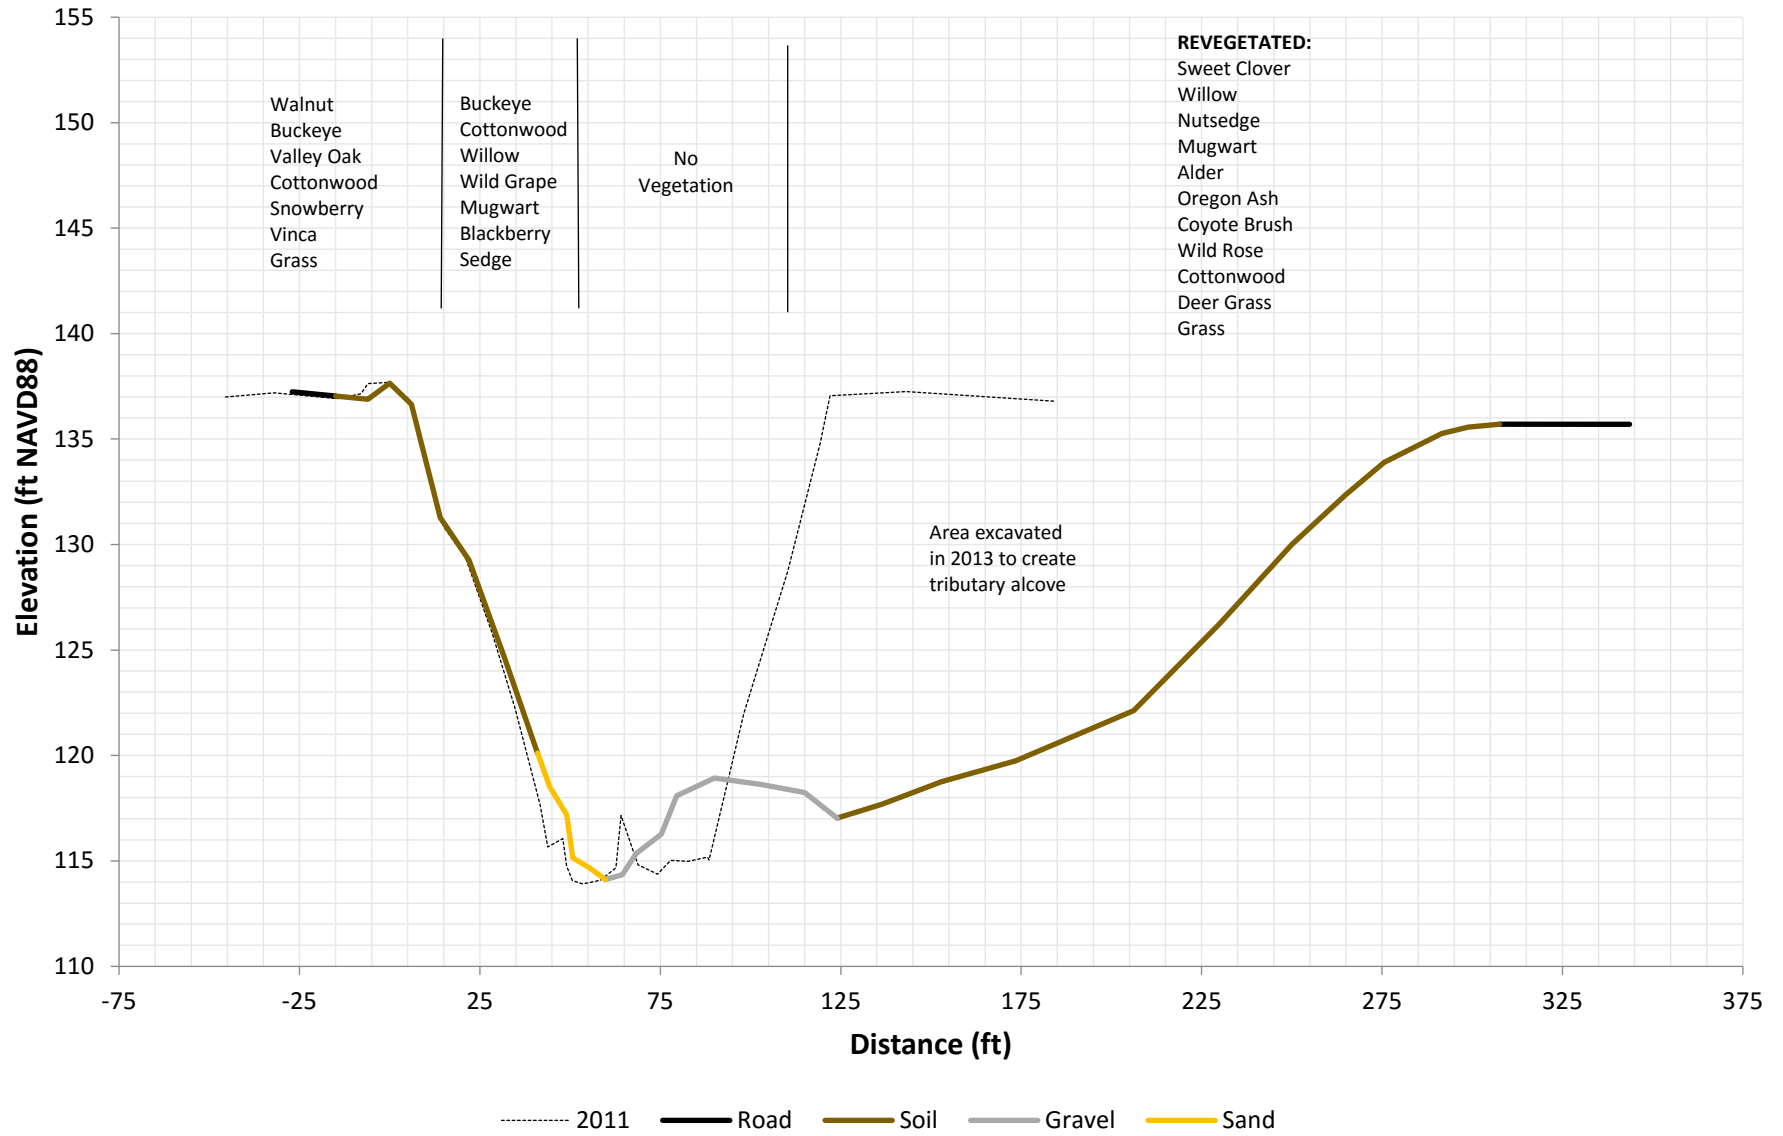
2015 Cross Section RS 3450

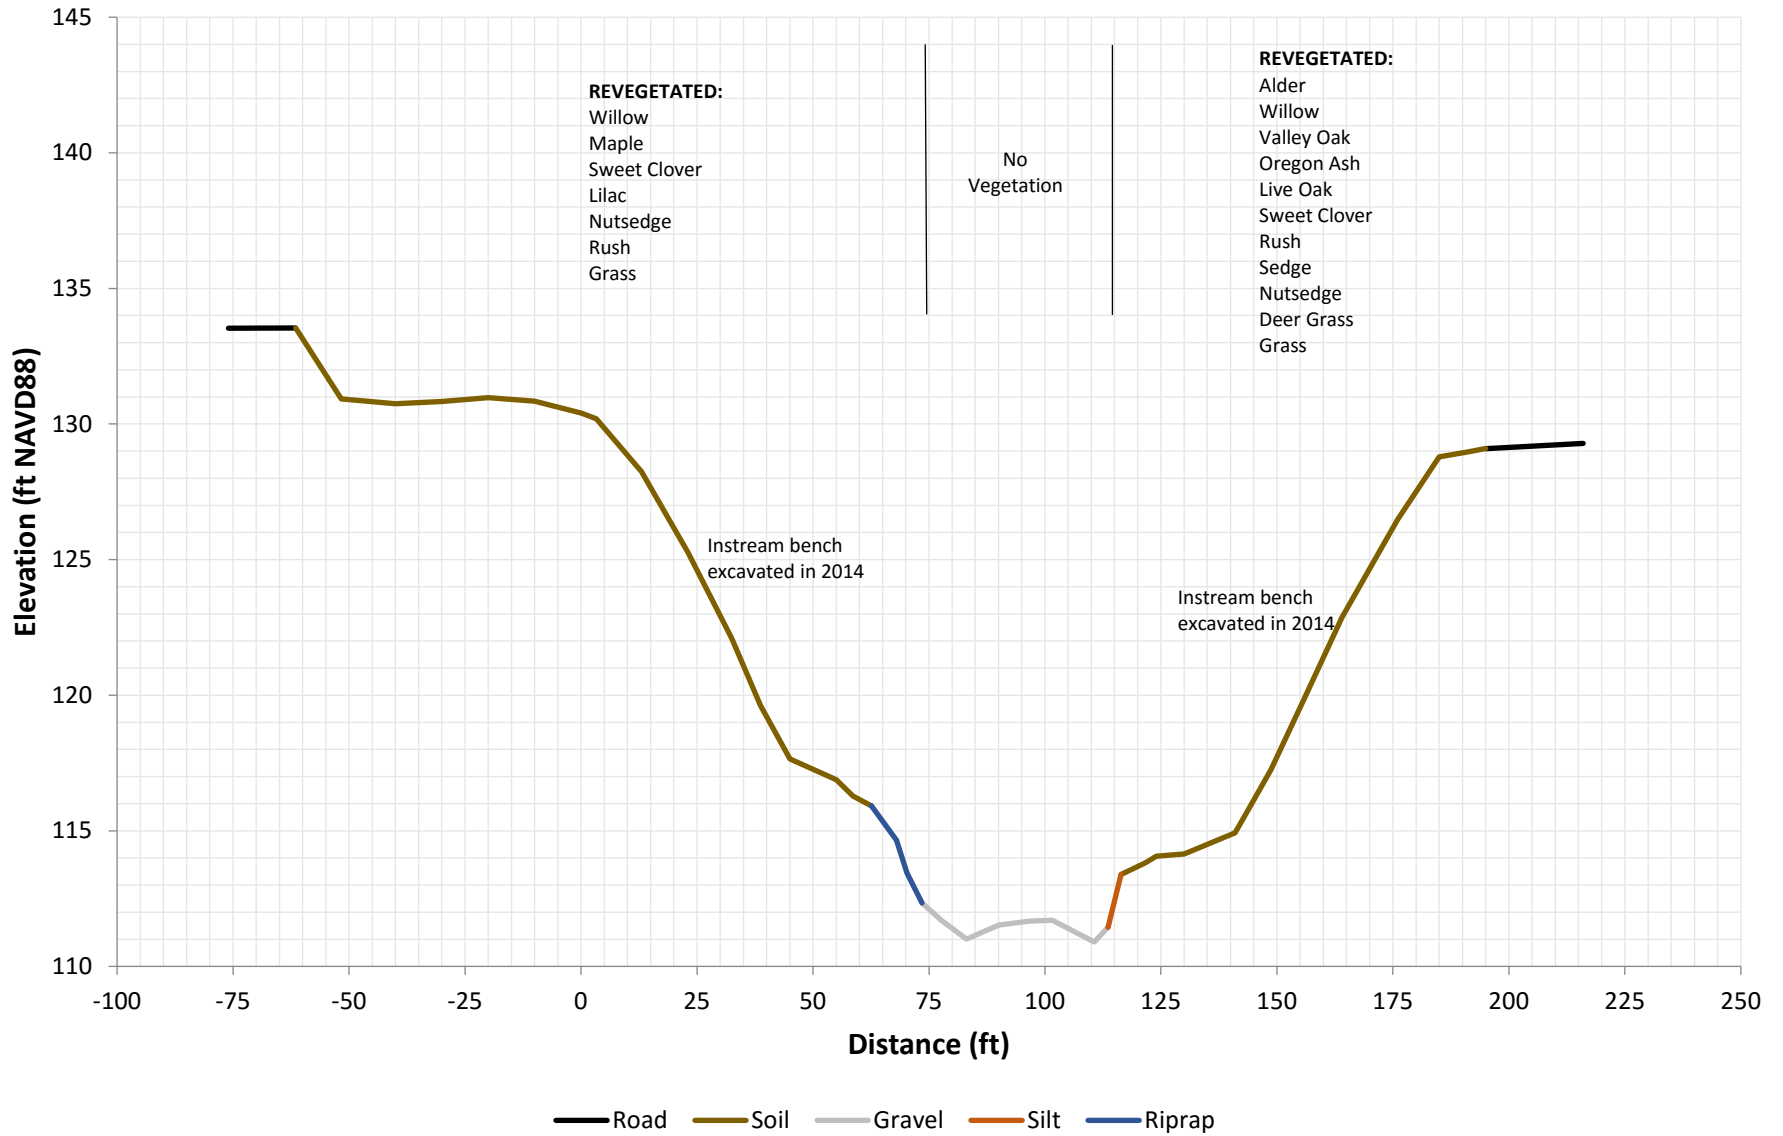
2015 Cross Section RS 790

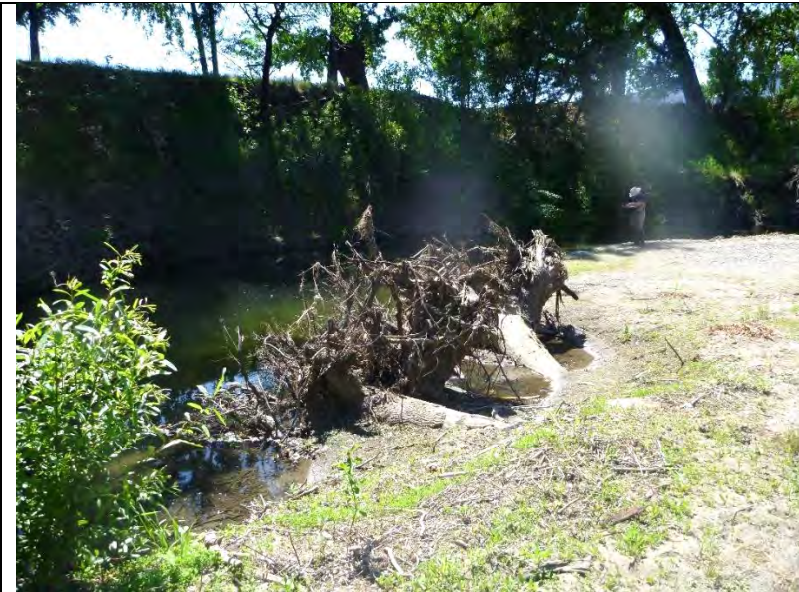
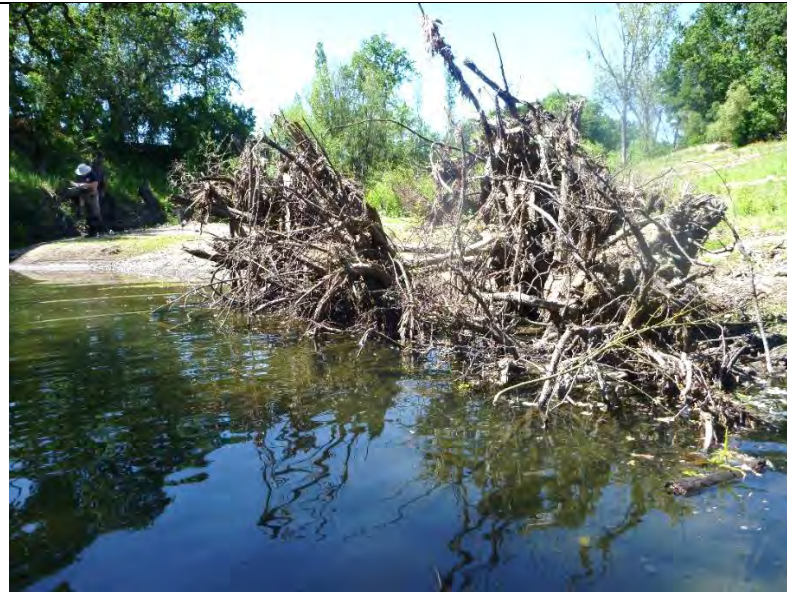
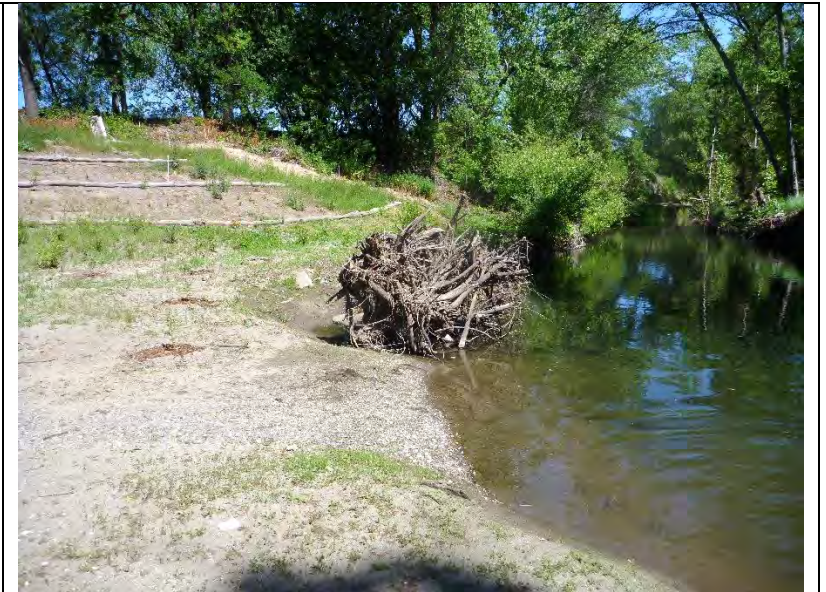
Photo 244 (WD-2020-L)

Bench 1 – United Wineries (4/14/2015)

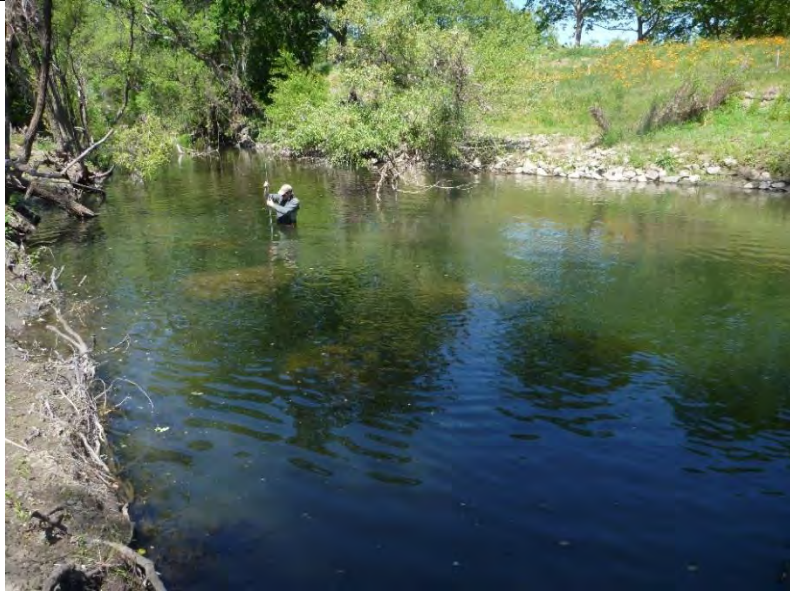
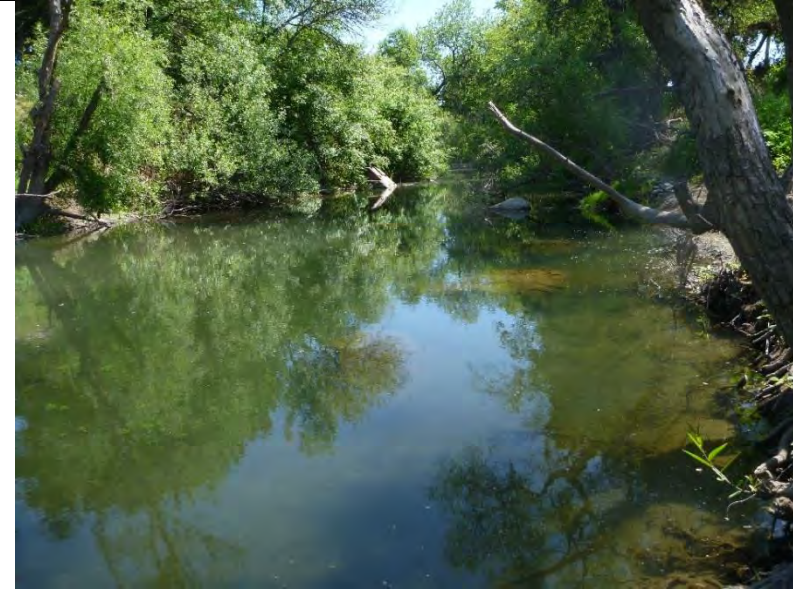
Photo 236 (BC-765-M)

Bench 3 – Opus One (4/14/2015)

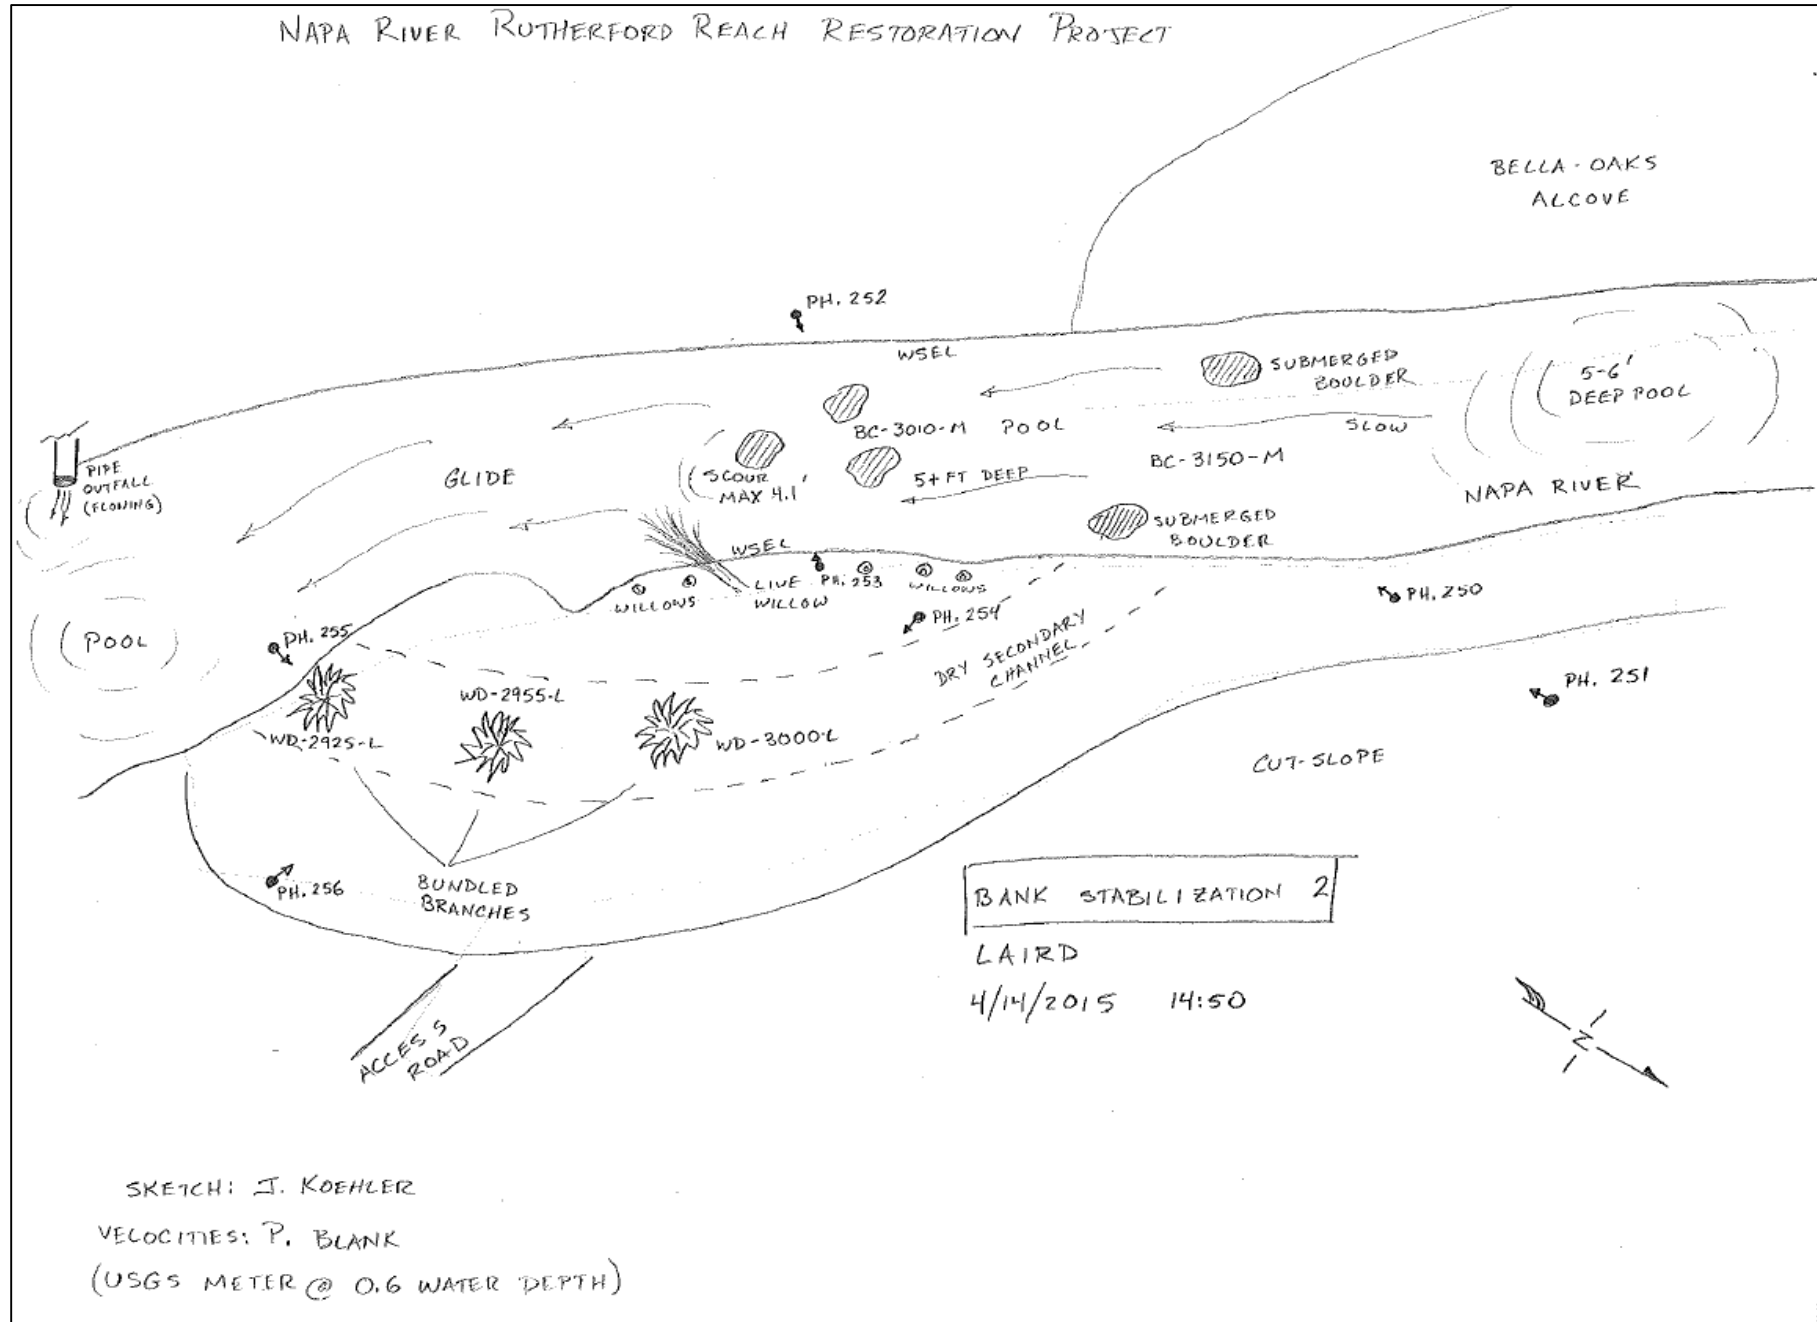
Bank Stabilization 2 – Laird (4/14/2015)

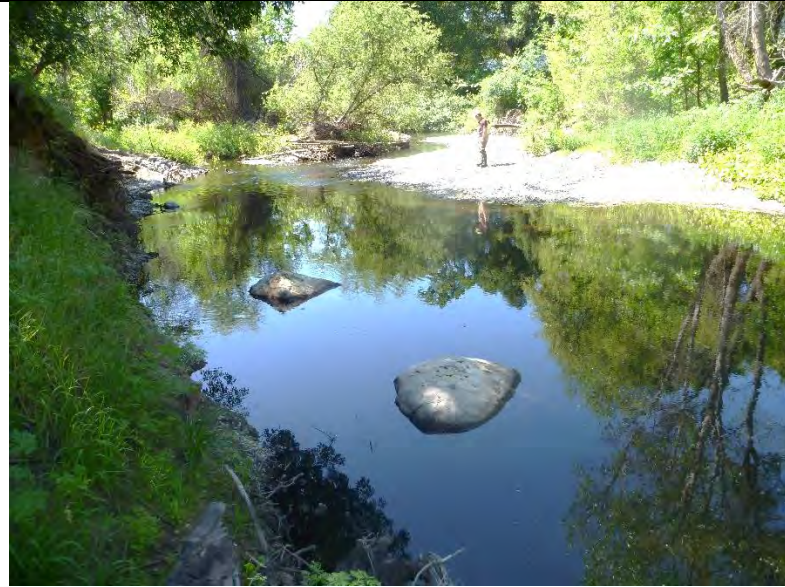
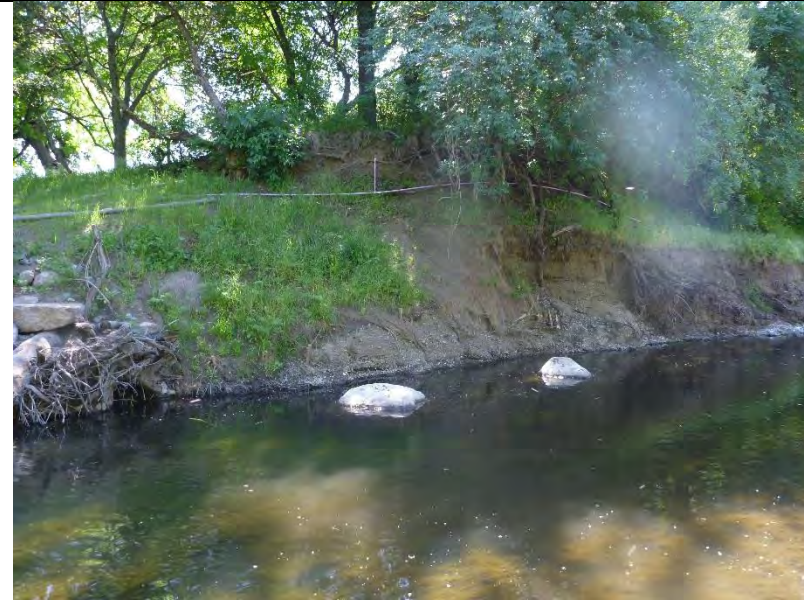
Photo 224 (BC-10380-L)

Crossing – Round Pond (4/14/2015)

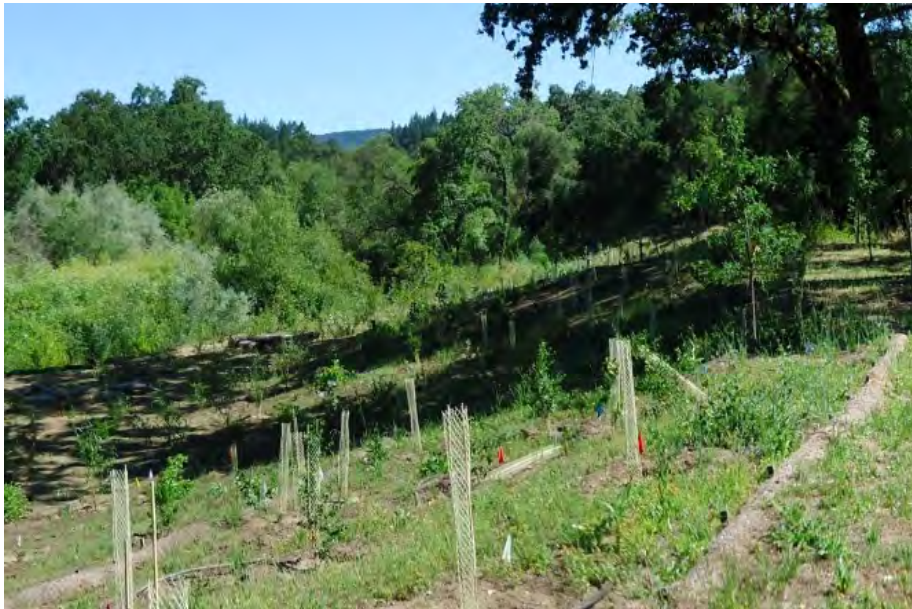
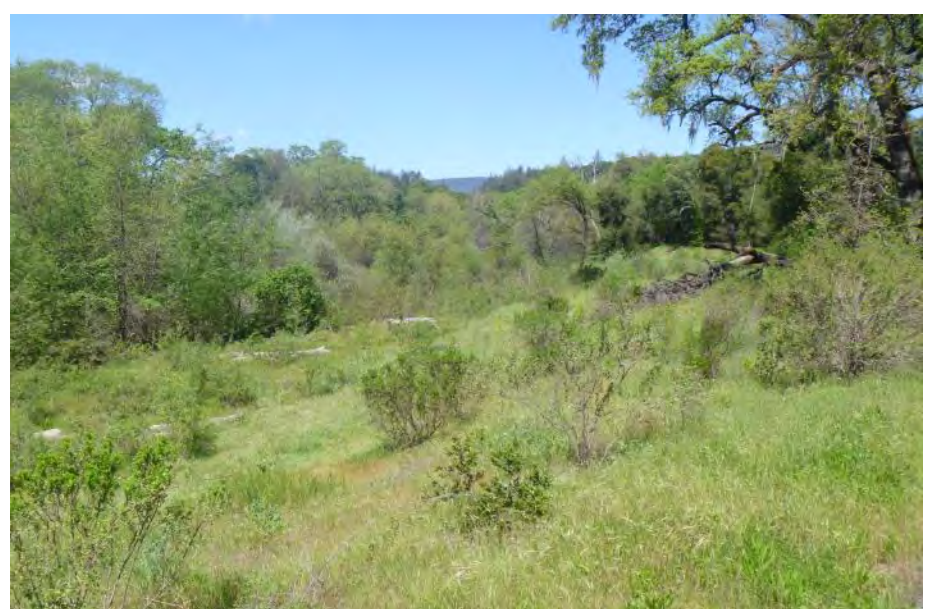
River Station 195+50
Benches: Quintessa, East Bank

October 2009

June 2011

March 2016

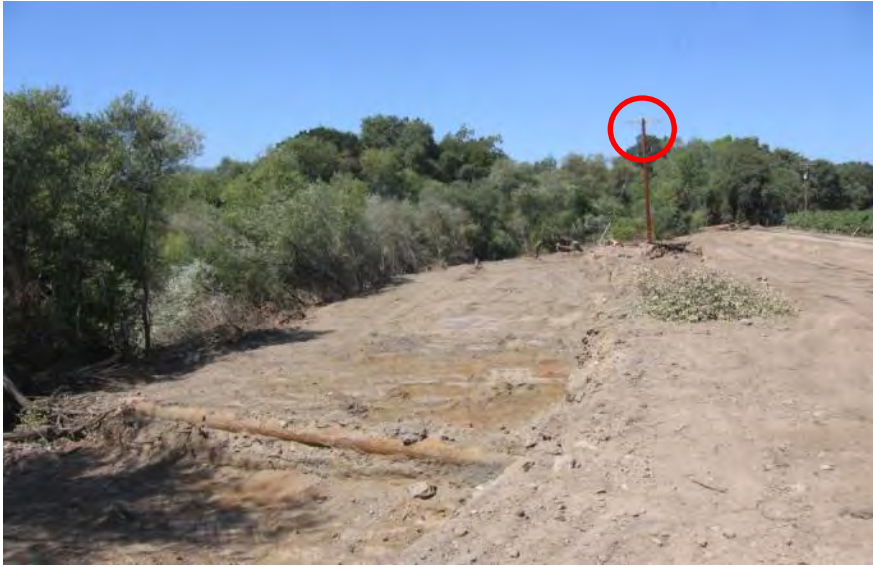
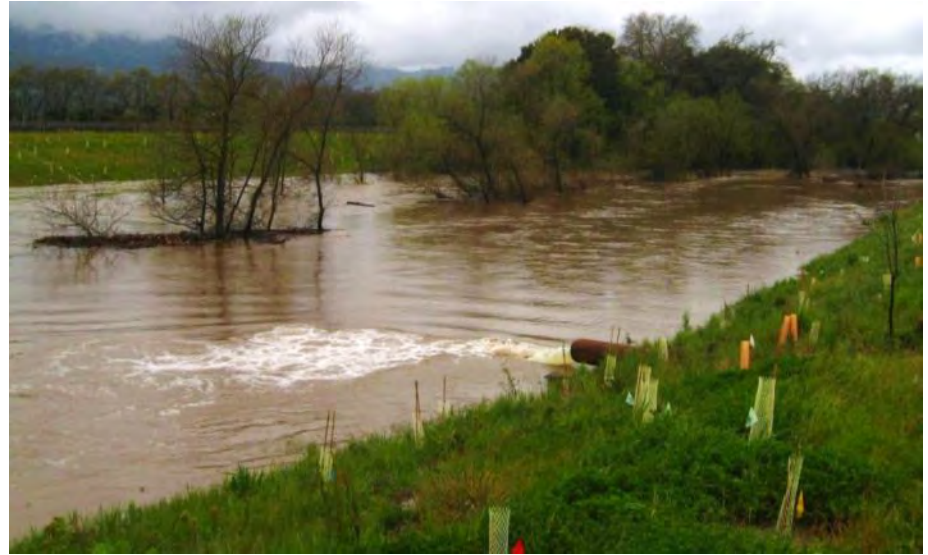
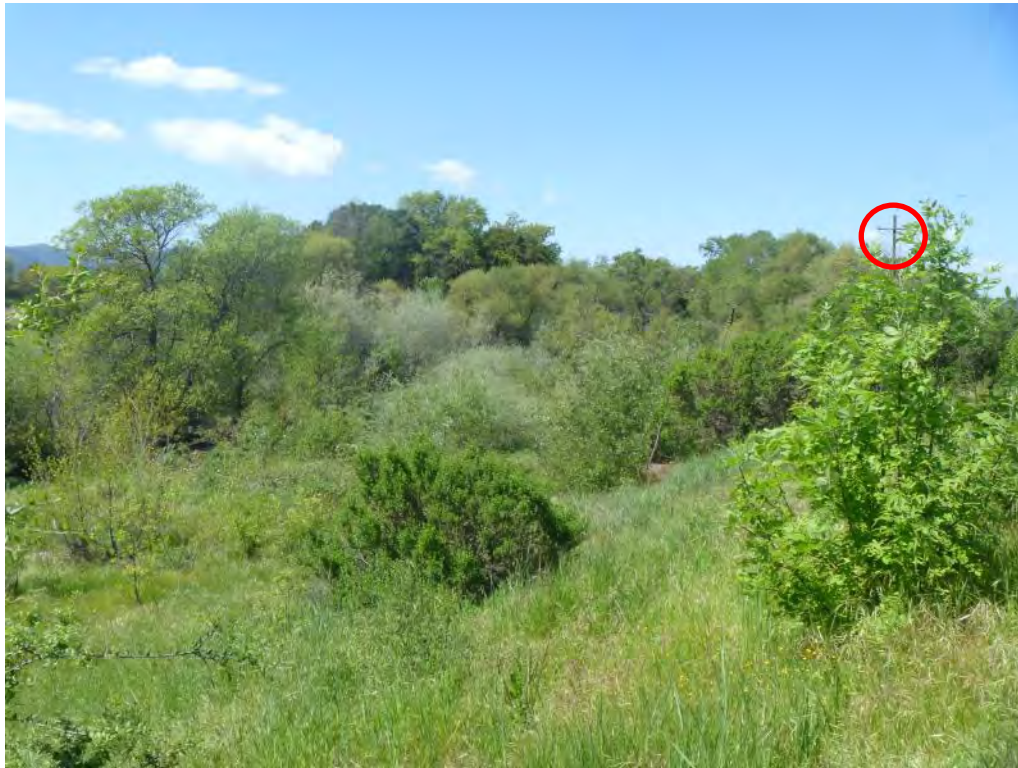
River Station 19,550
Benches: Quintessa, East Bank to West Bank

June 2009

March 2011

March 2016

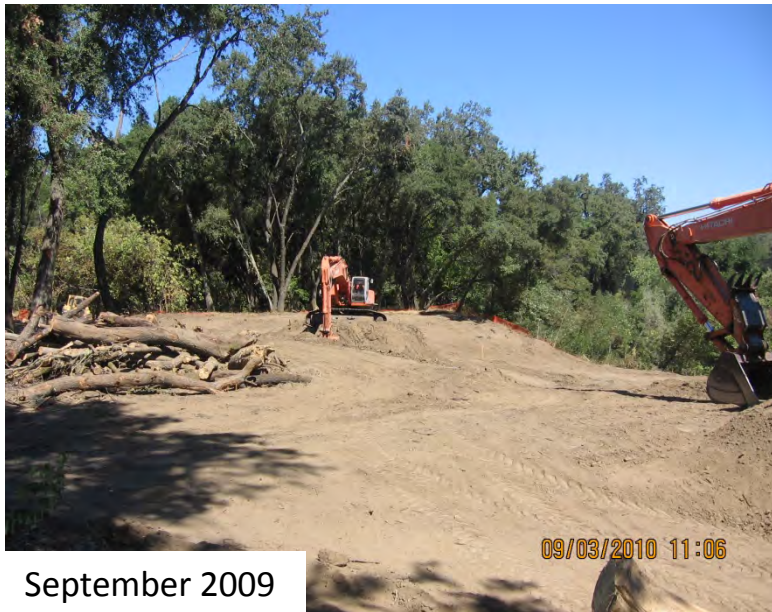
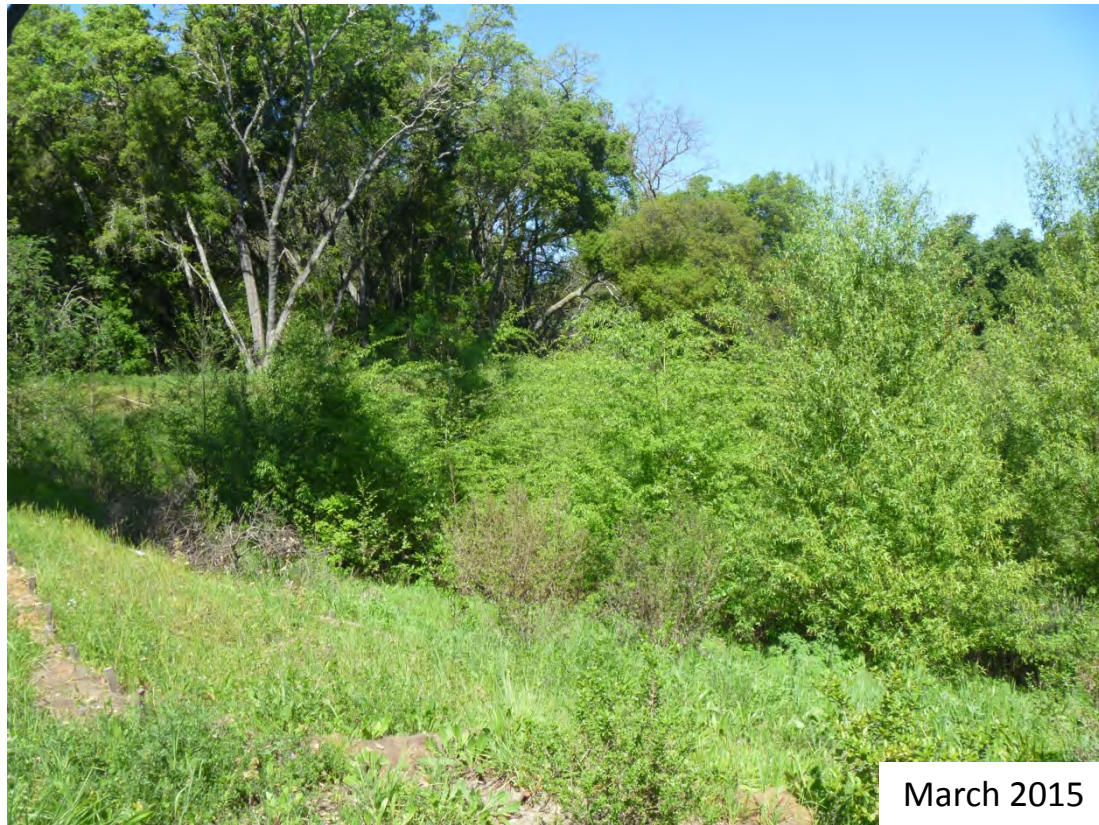
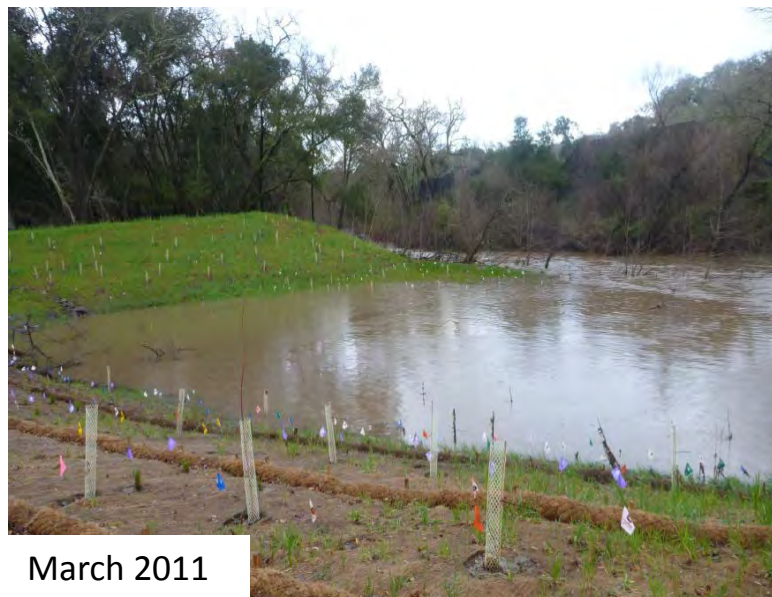
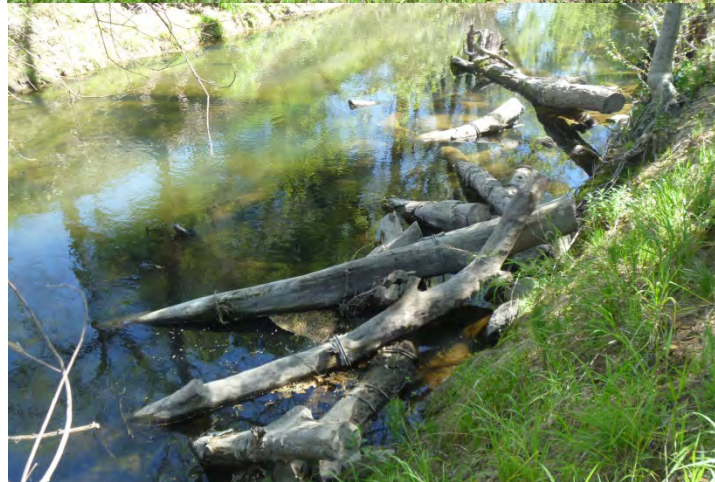
River Station 219+50
Alcove: The Ranch Winery / Sutter Home, West Bank

September 2009

March 2015

March 2011

LWD, Ranch Winery,
March 2015

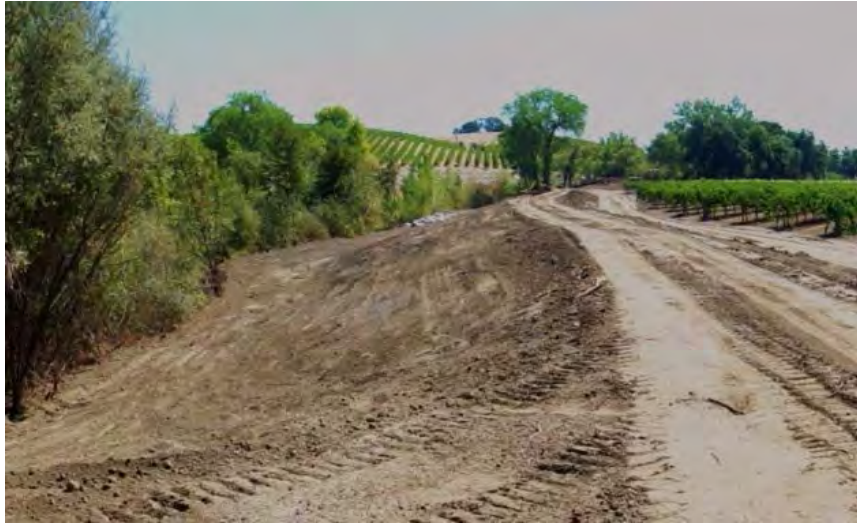
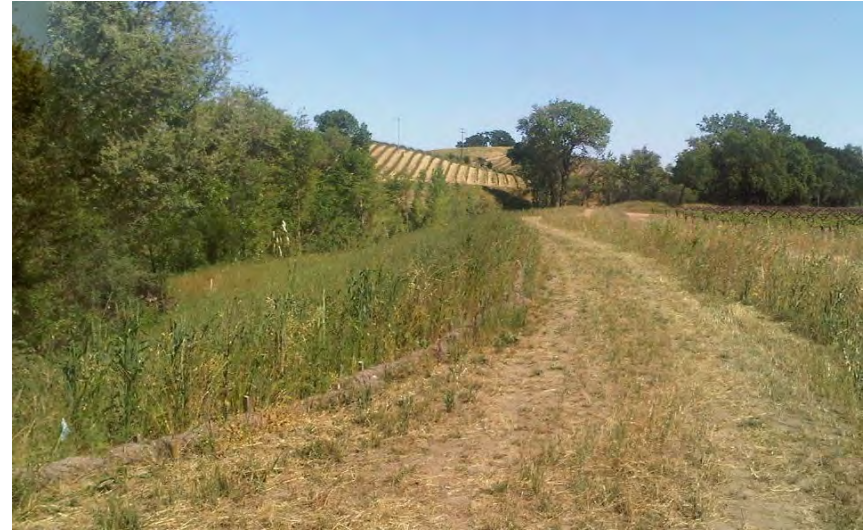
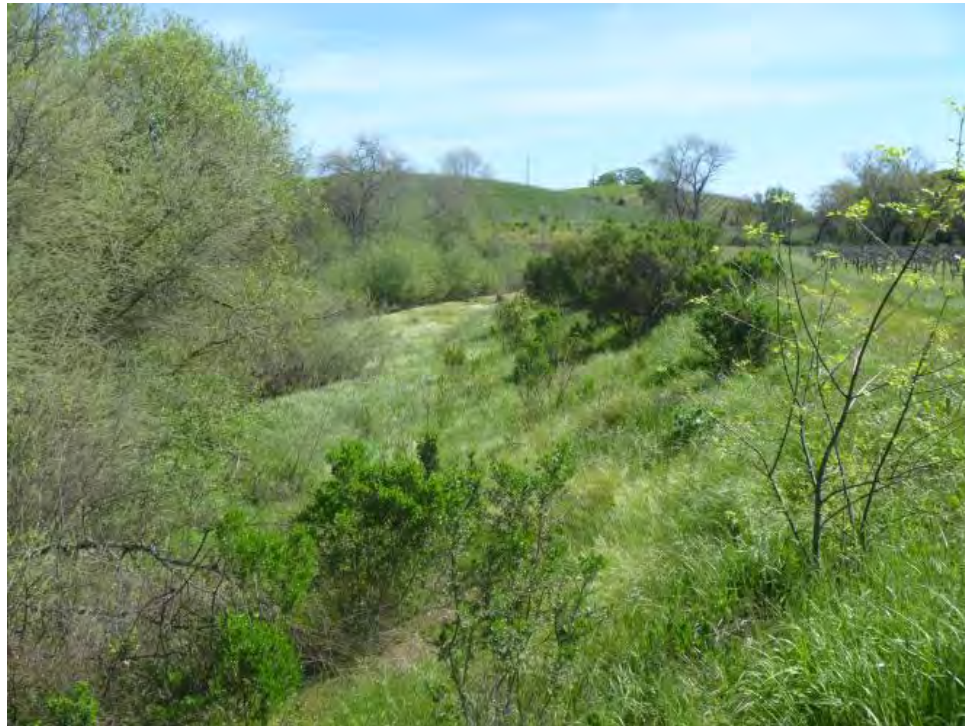
River Station 198+50
Bench: Frog's Leap, West Bank

August 2010

April 2011

March 2016

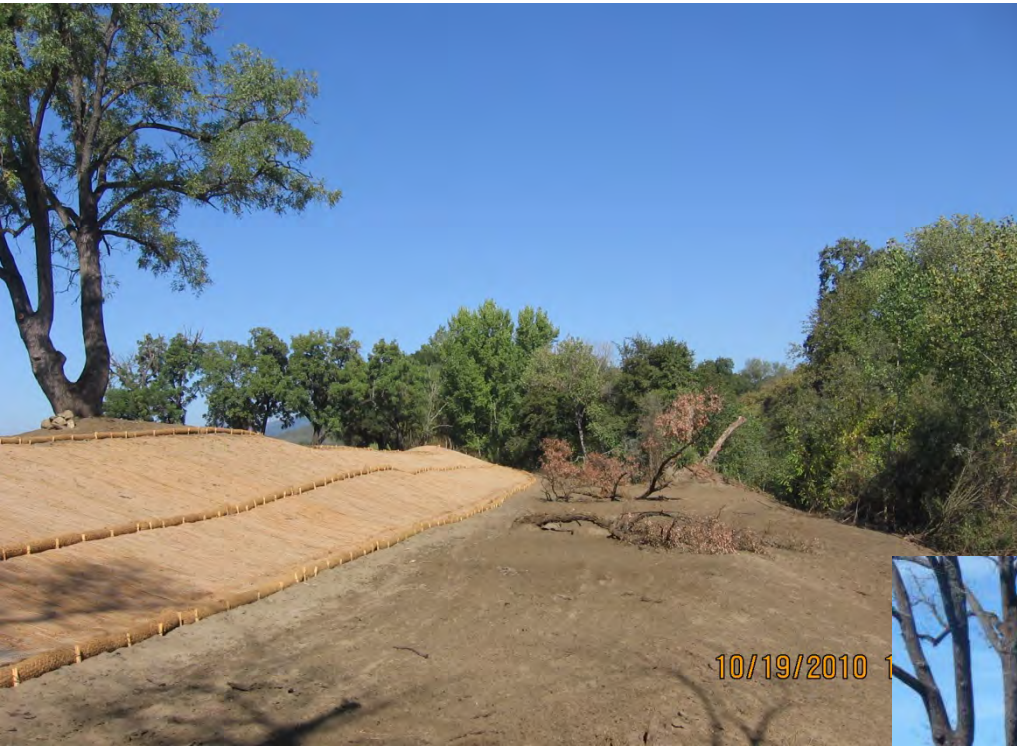
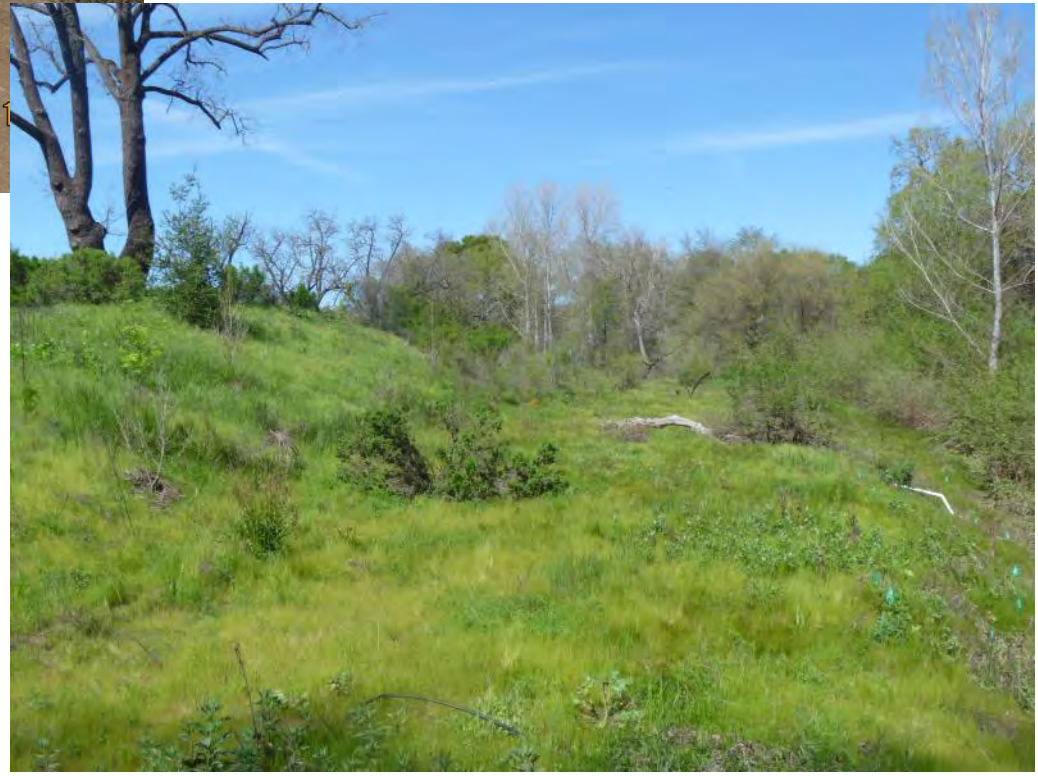
River Station 181+00
Setback Berm: Caymus Bench, West Bank

December 2010

March 2016

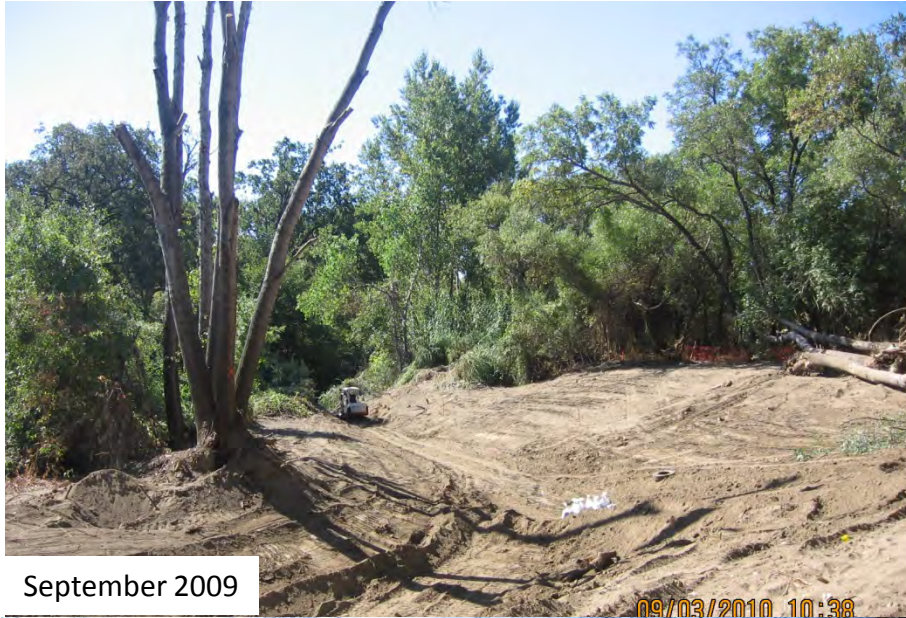
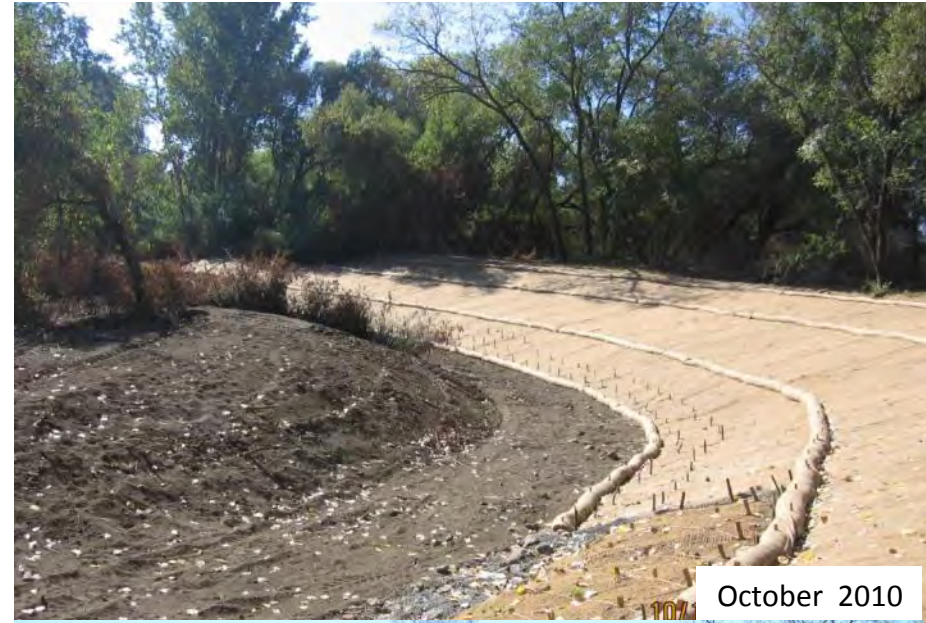
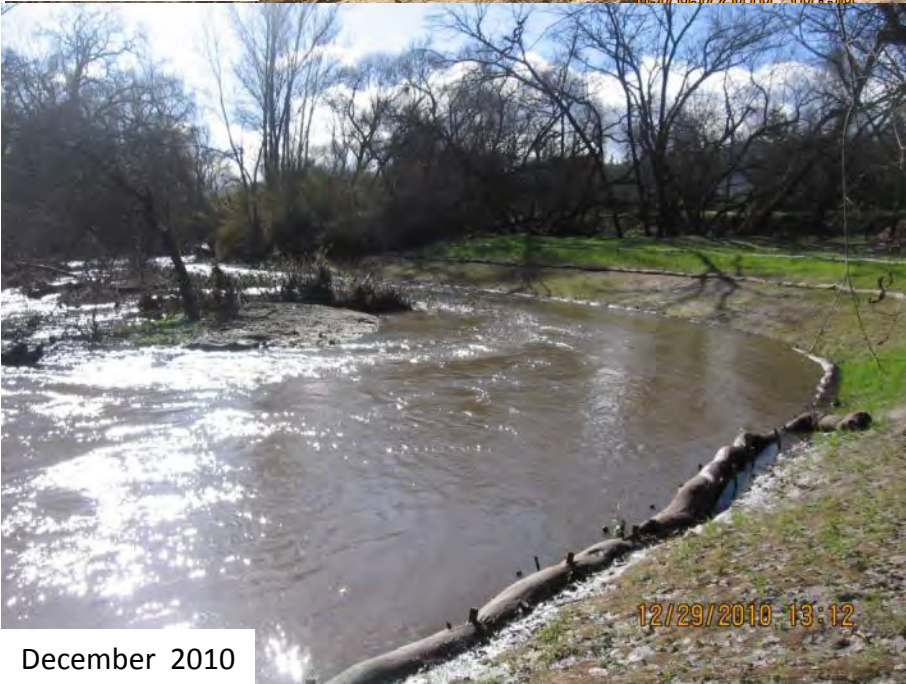
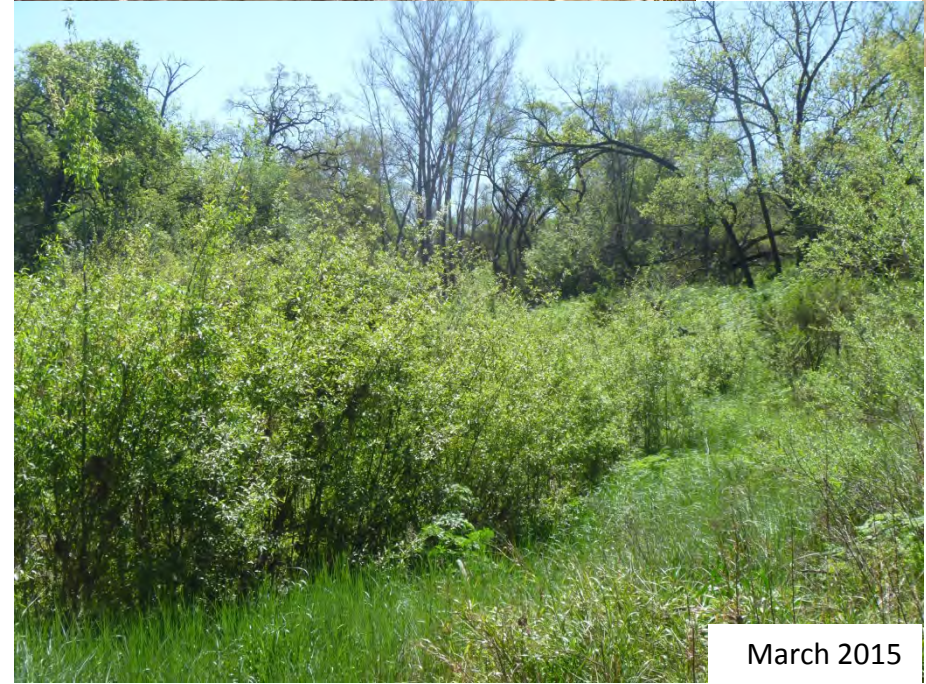
River Station 176+50
Bench 1: Caymus, West Bank

September 2009

October 2010

December 2010

March 2015
