NAPA RIVER RUTHERFORD REACH RESTORATION PROJECT ANNUAL MONITORING REPORT- 2015

Napa County Flood Control and Water Conservation District
804 First Street
Napa, California, 94559
Contact: Jeremy Sarrow
(707) 259-8204

Napa County Resource Conservation District
1303 Jefferson Street, Suite 500 B
Napa, California, 94558
Contact: Paul Blank/Jonathan Koehler
(707) 252-4188

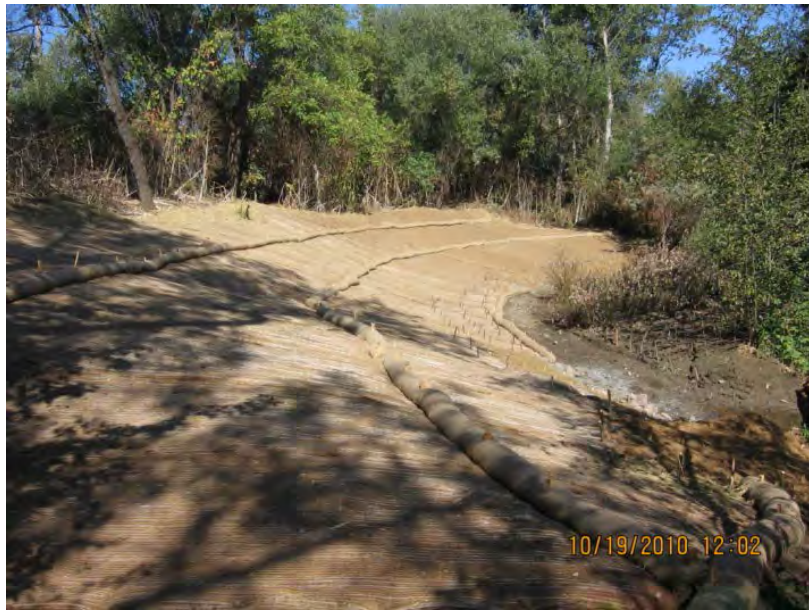
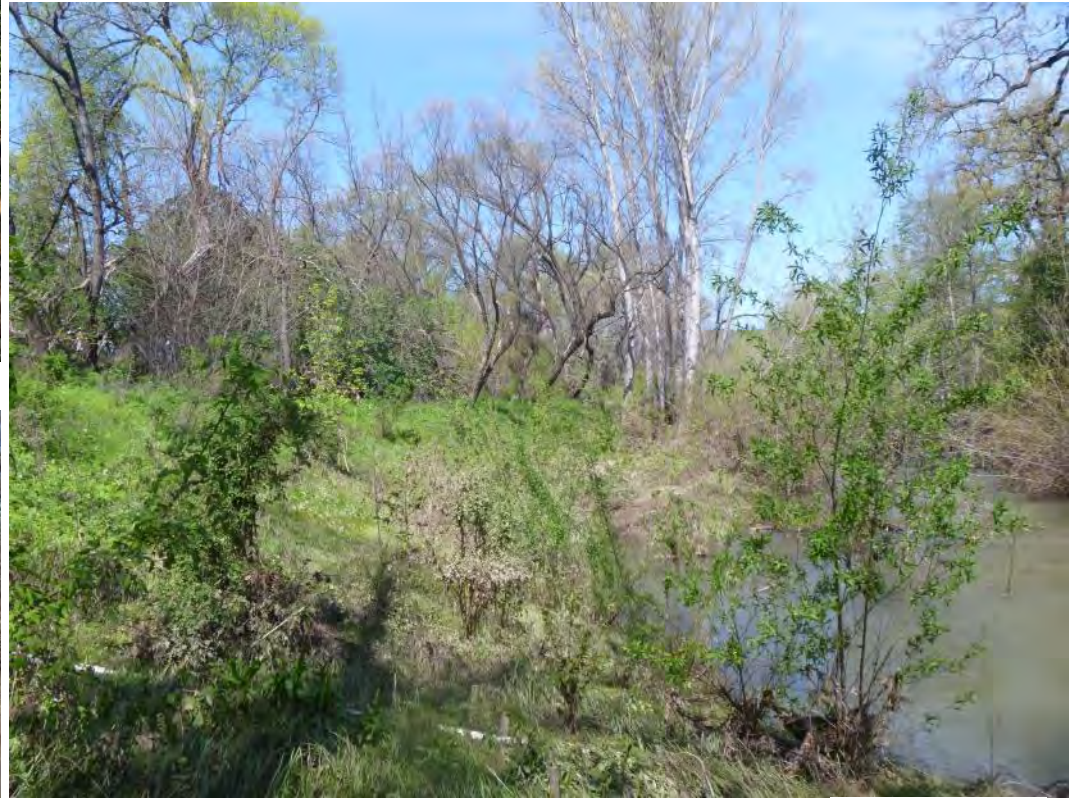
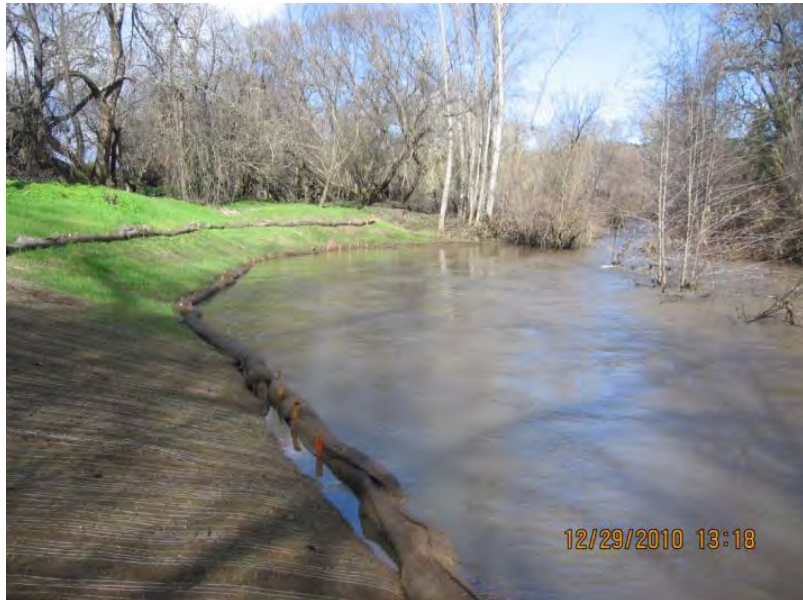
River Station 172+00
Bench 2: Caymus, West Bank

October 2010

March 2016

December 2010

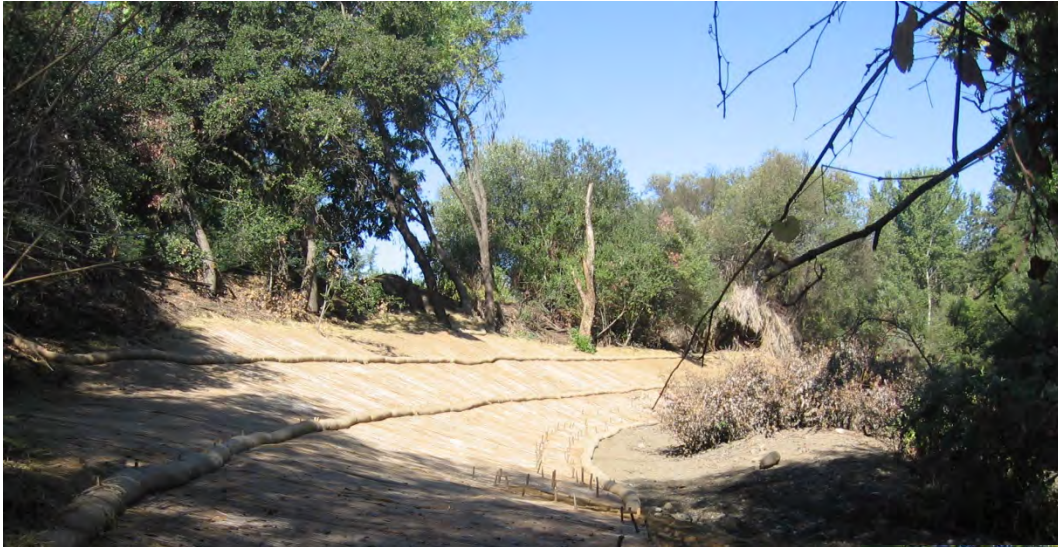
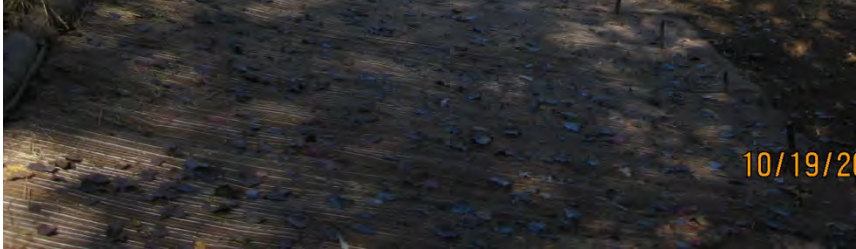
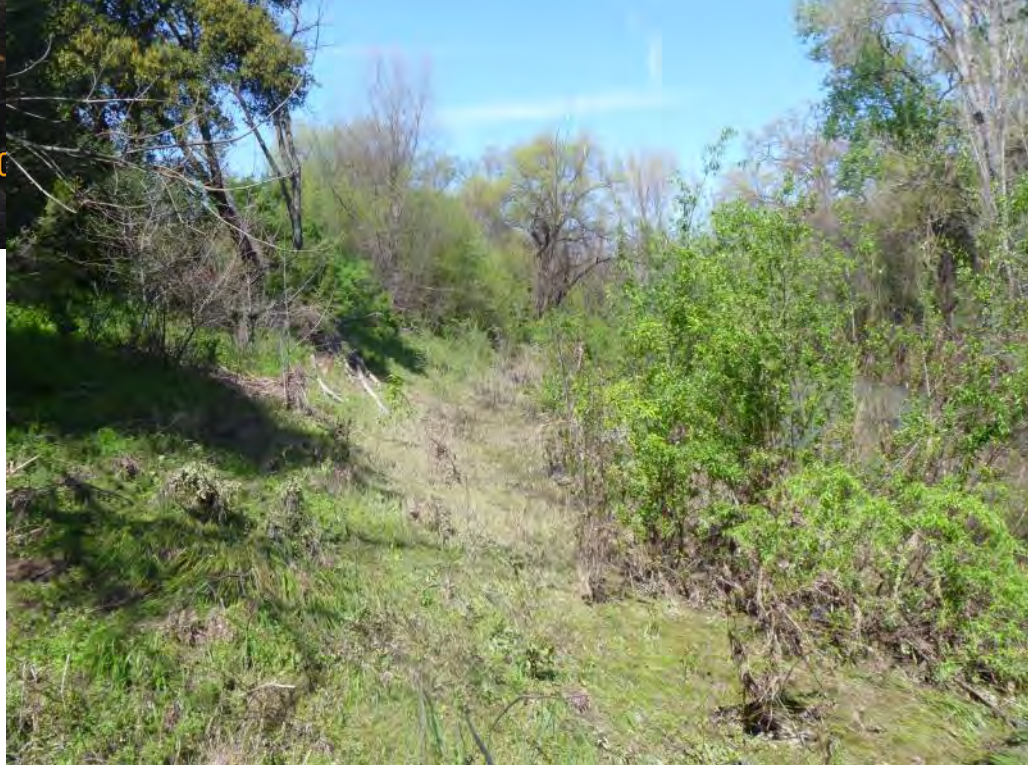
River Station 168+50
Bench 3: Caymus, Downstream to Upstream

October 2010

March 2016

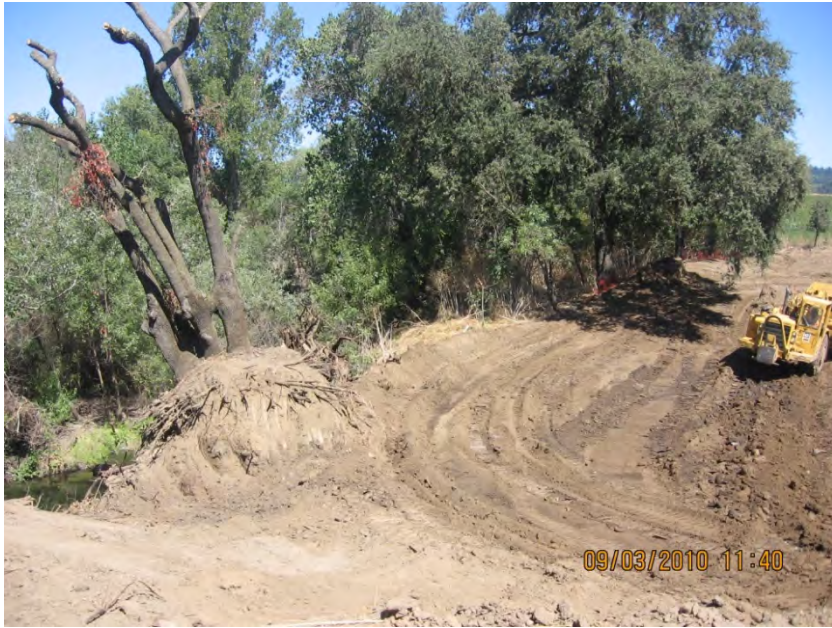
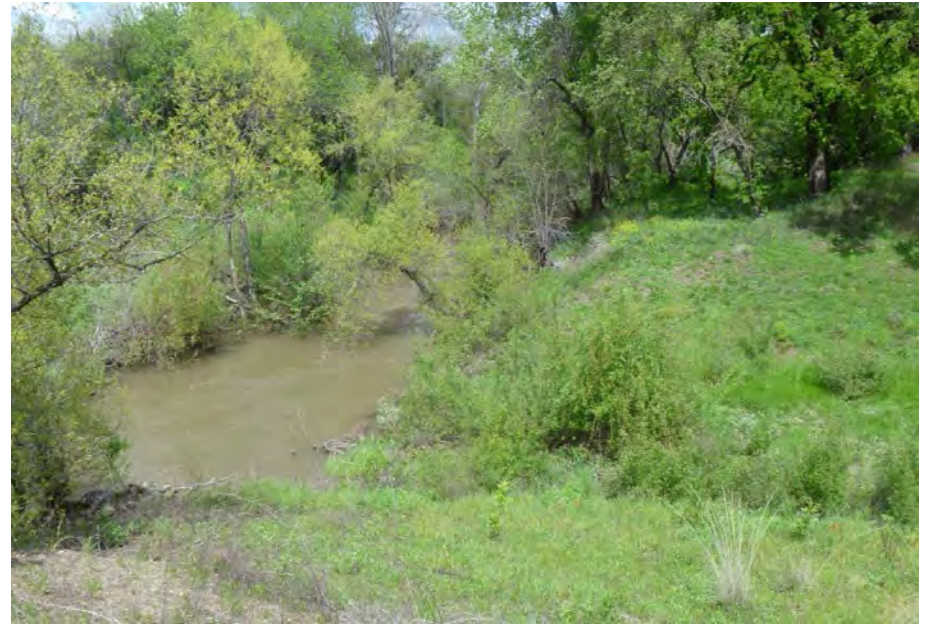
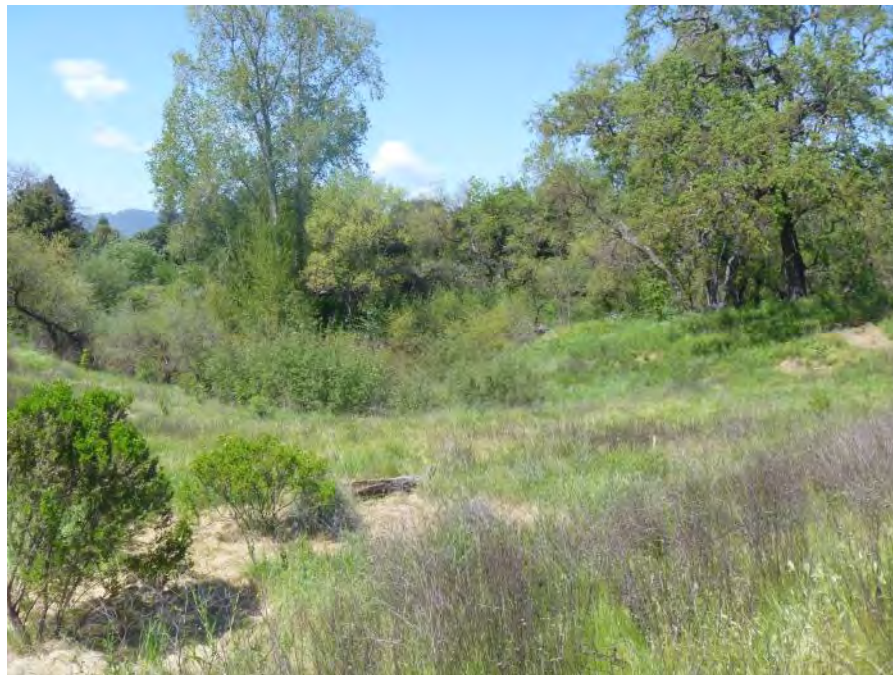
River Station 164+20
Bench 4: Carpy Conolly, East Bank

September 2010

November 2011

March 2016

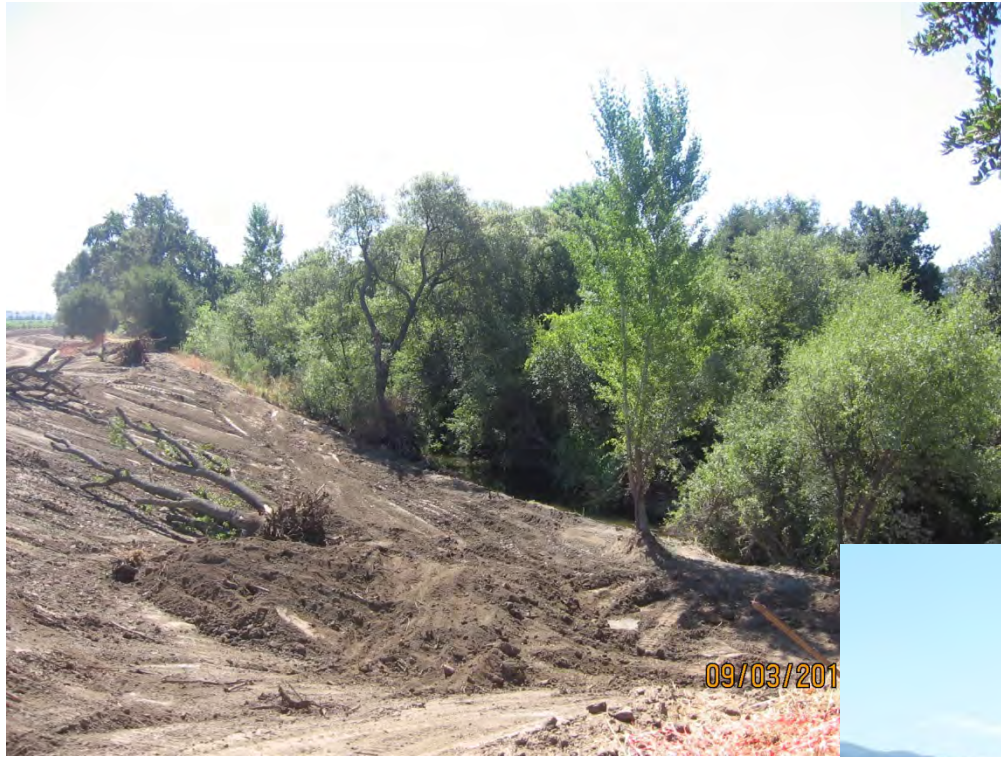
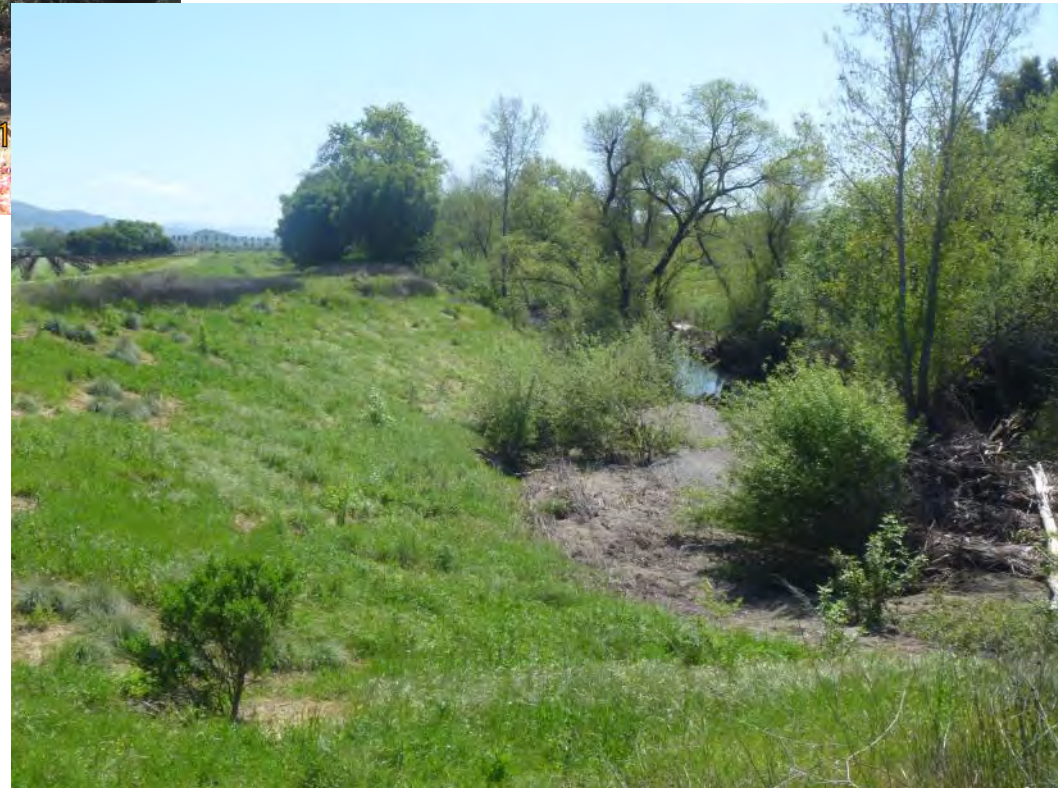
River Station 162+00
Carpy Conolly Bench 5, East Bank

September 2010

March 2016

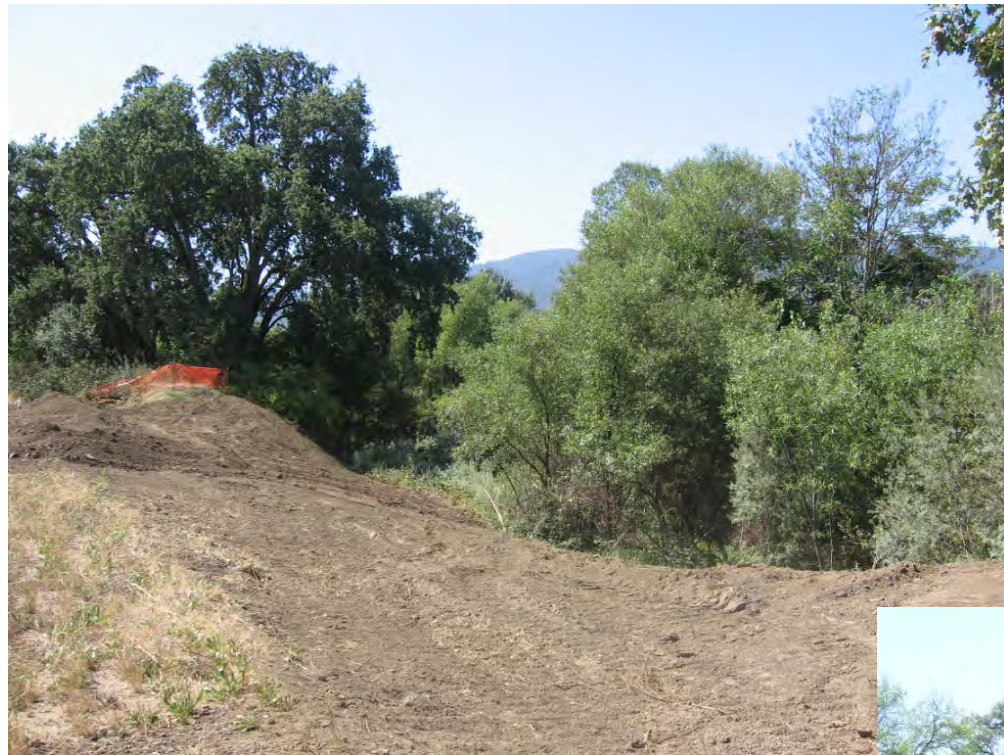
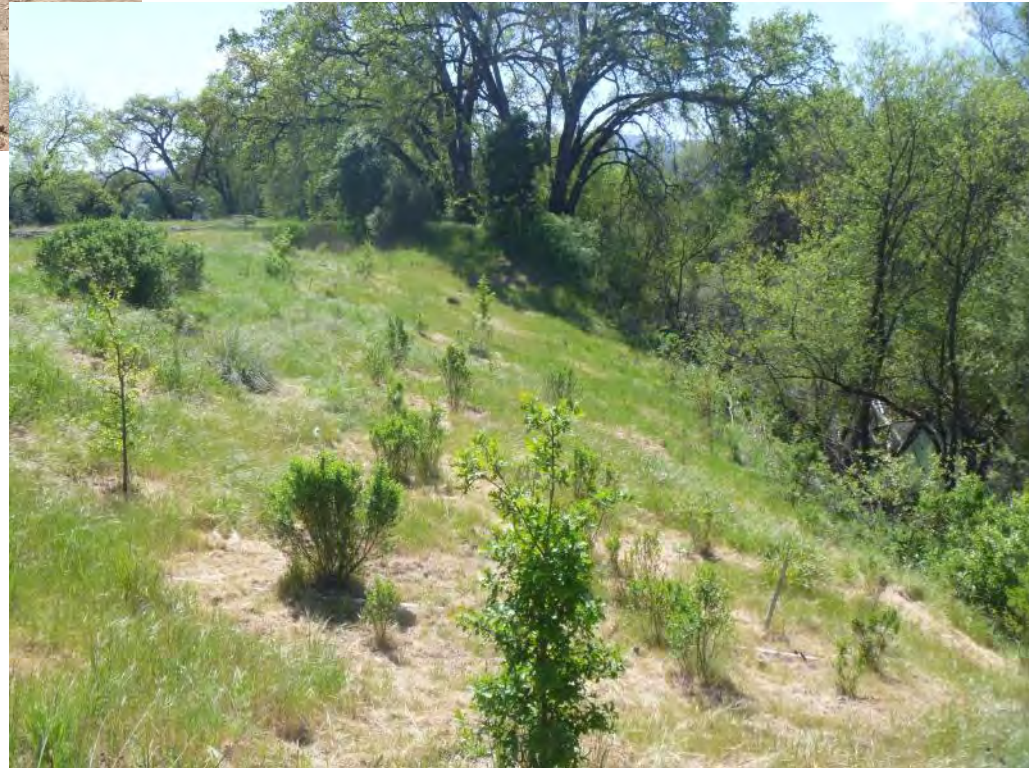
River Station 144+00 Carpy Conolly Bench 6, East Bank

August 2011

March 2016

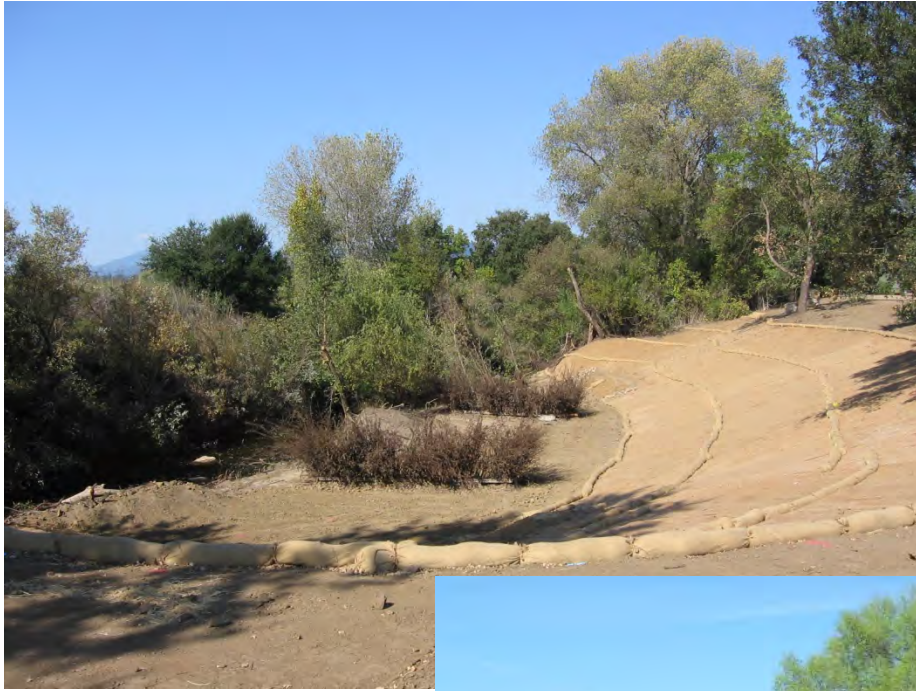
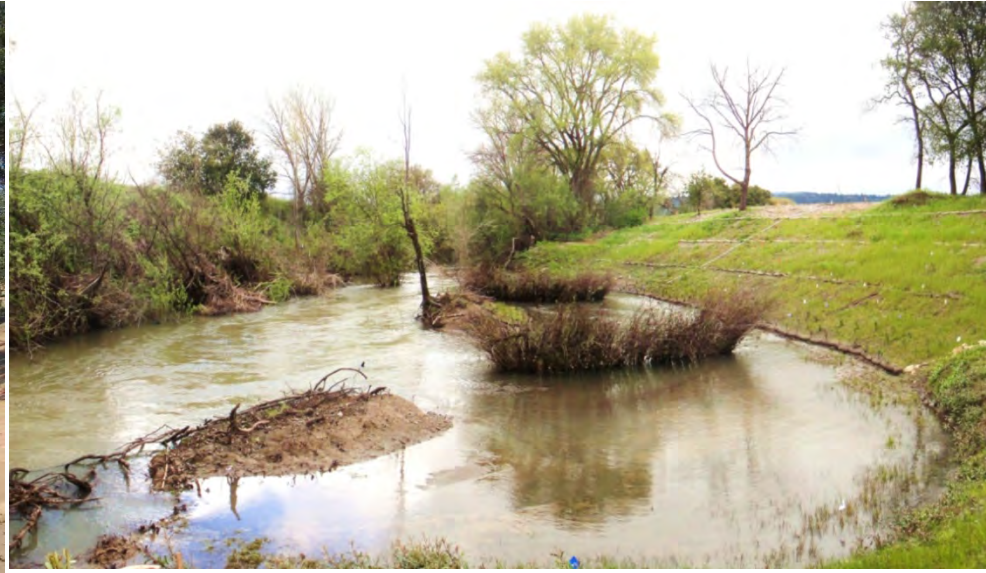
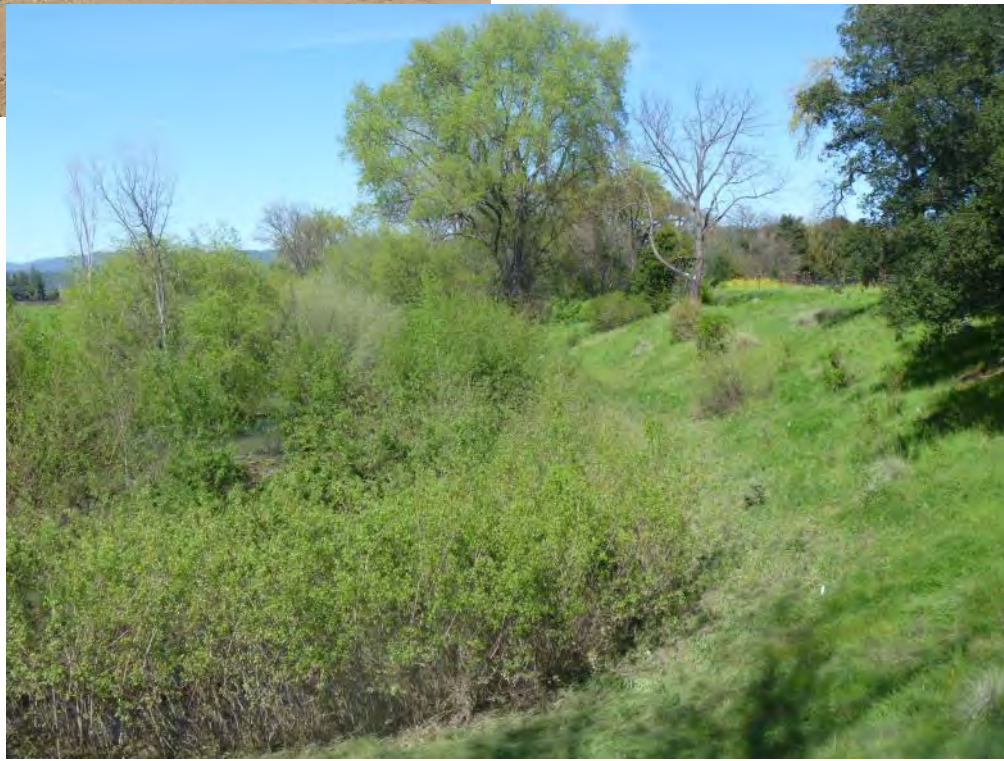
River Station 135+40
Bench 11: Honig, East Bank

October 2011

March 2012

March 2016

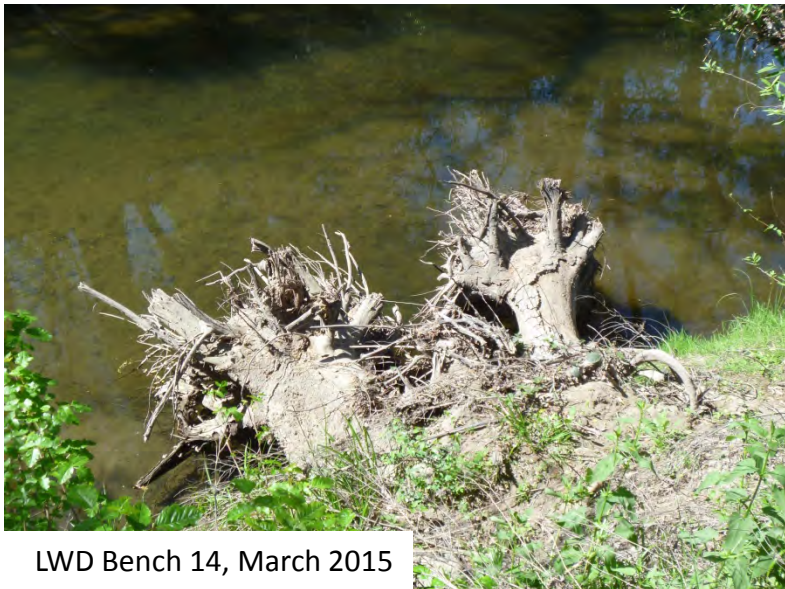
LWD Bench 14, March 2015

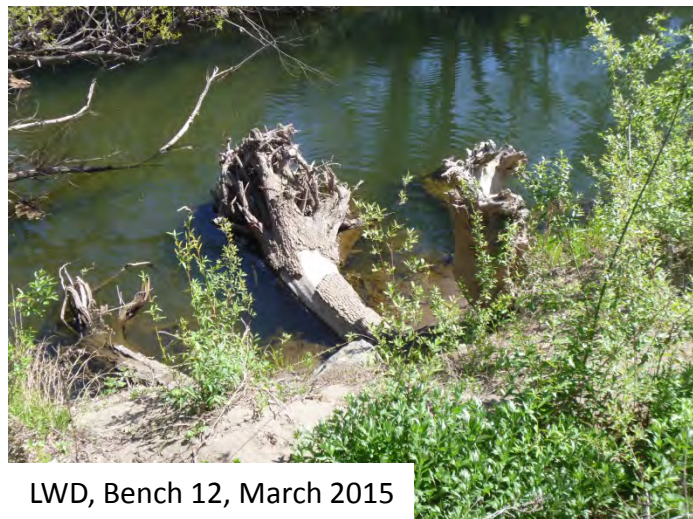
LWD, Bench 12, March 2015

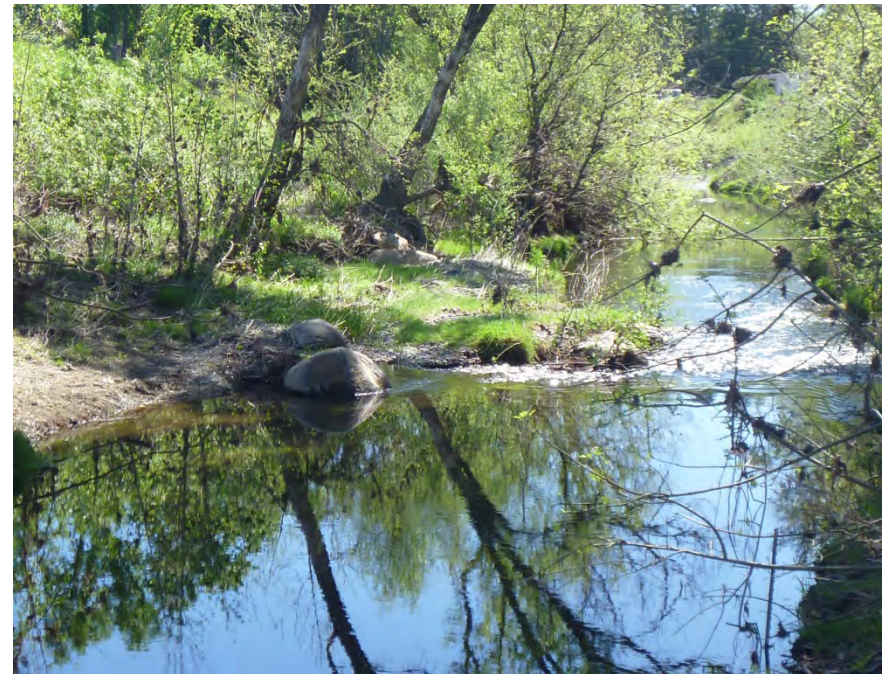
Boulder Cluster, Reach 4, March 2015

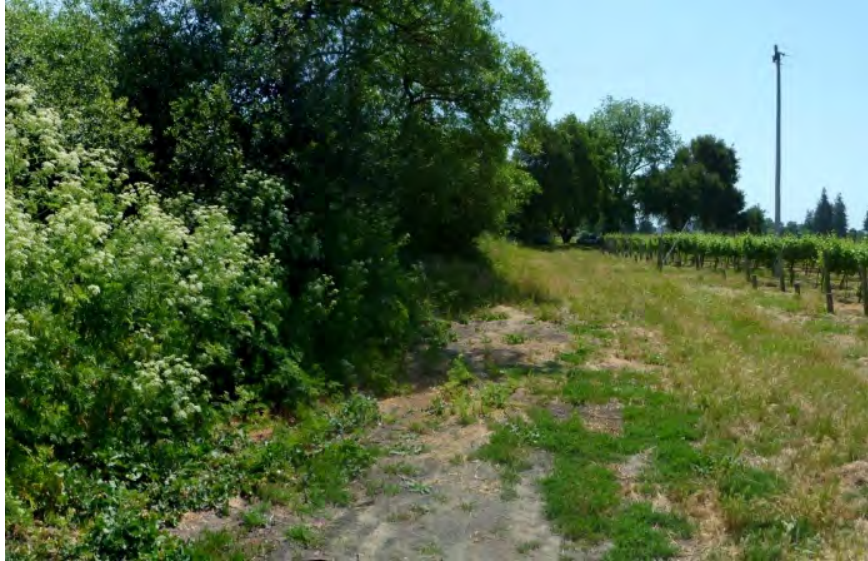
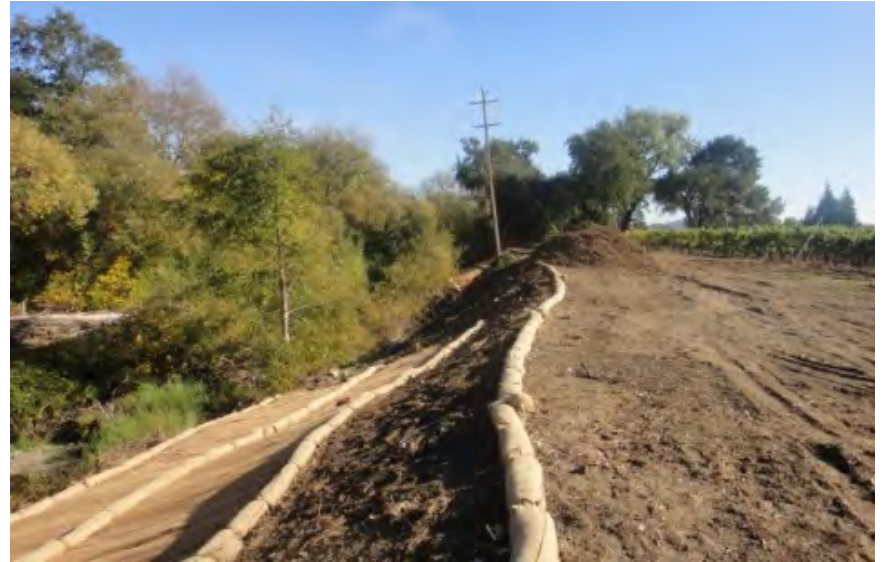
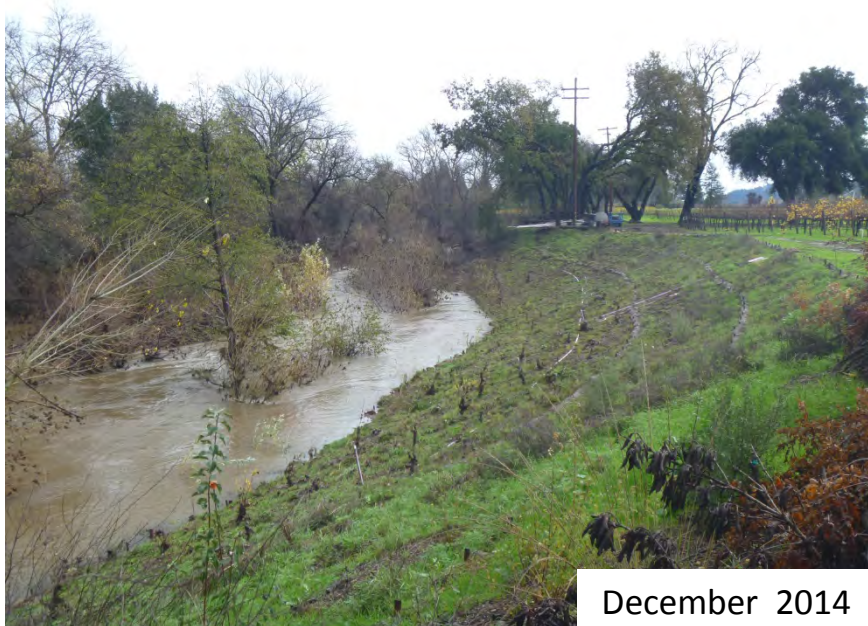
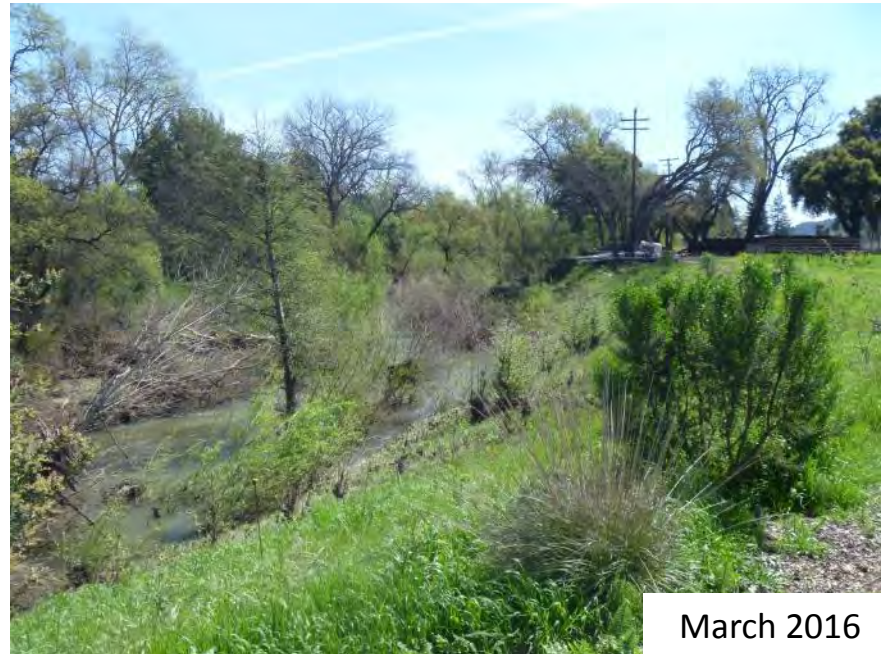
**Ritz Carlton Hotel Linear Wetland Mitigation
(Part of Secondary Channel on Bench 1 on Wilsey)**

Station 73+30
Reach 8 North, West Bank, Foley Johnson (Sawyer) West Bank

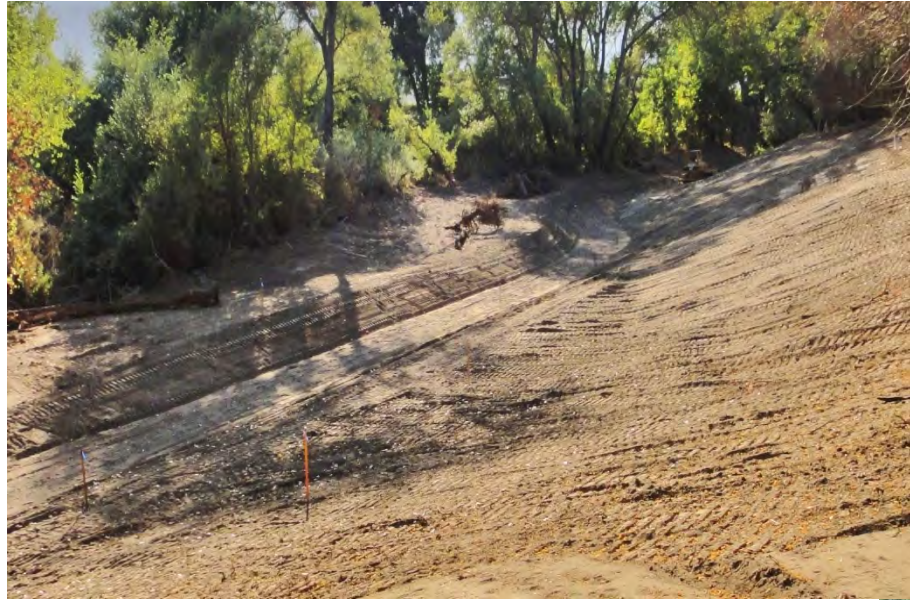
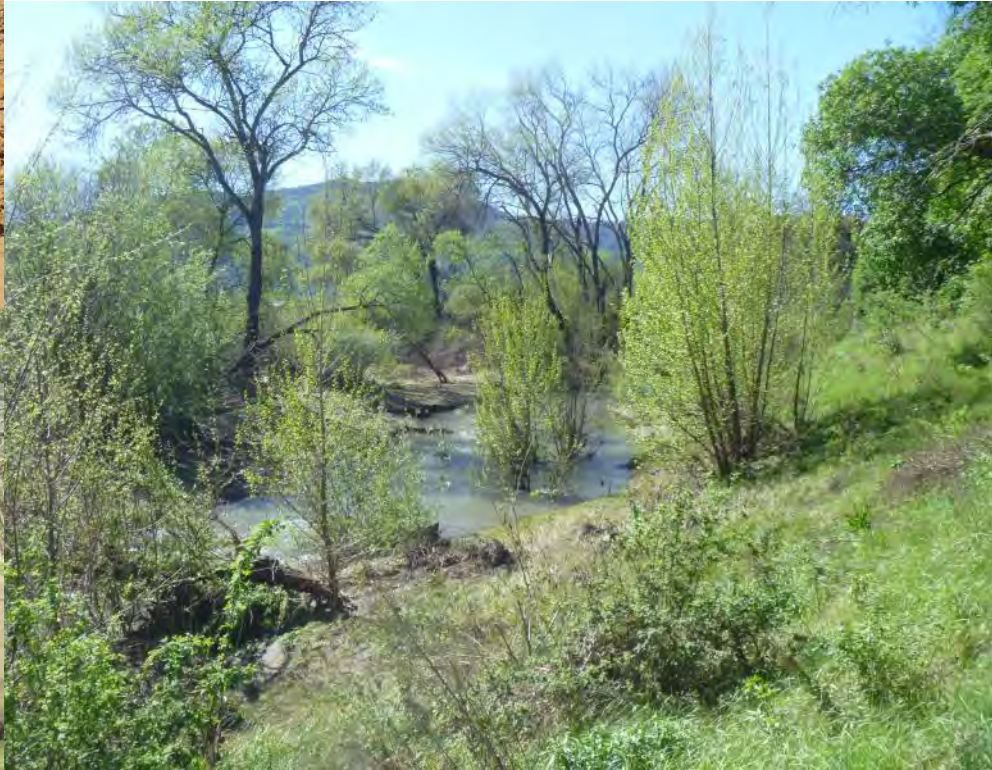
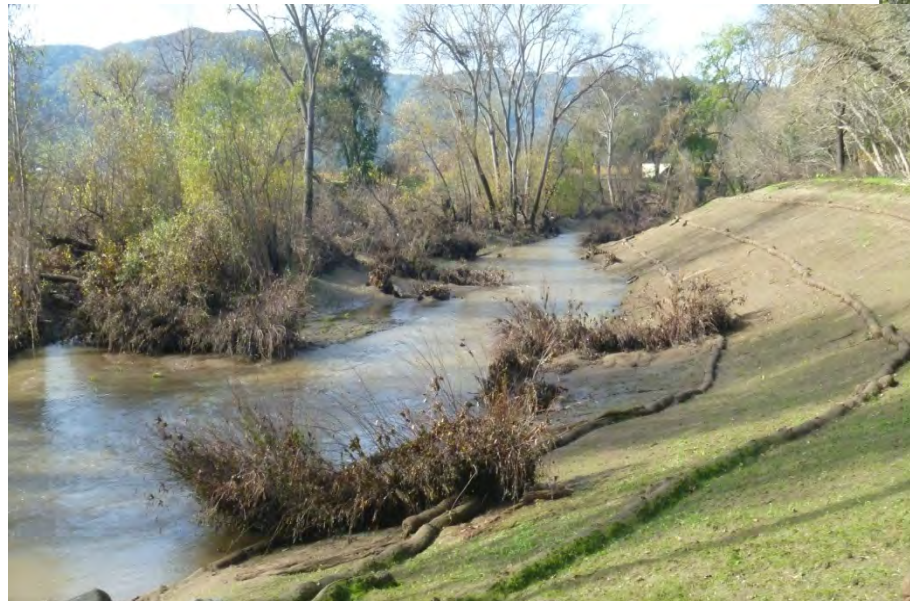
**Part of Phase 4a: Reach 8 North
Secondary Channel on Bench 1 on Wilsey**

River Station 65+50
Bench 1: Wilsey, Secondary Channel Looking Upstream

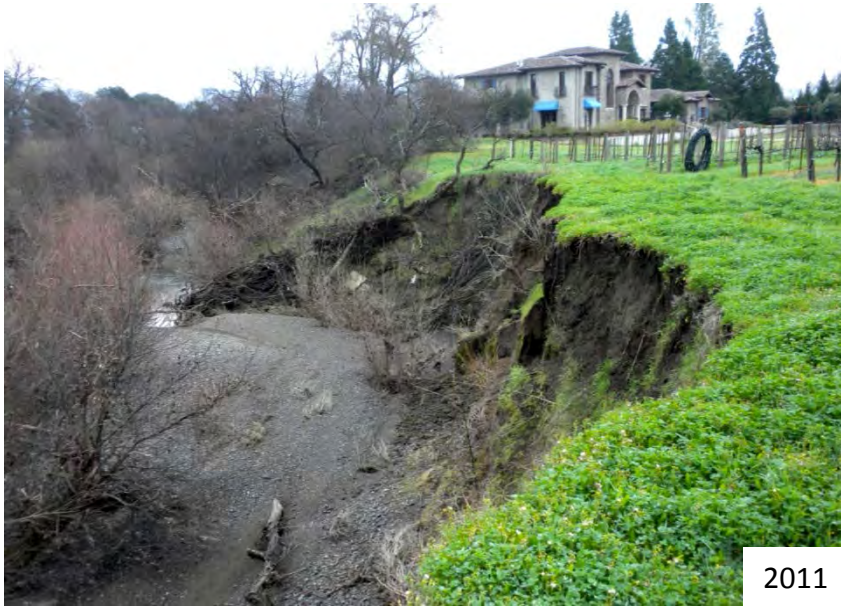
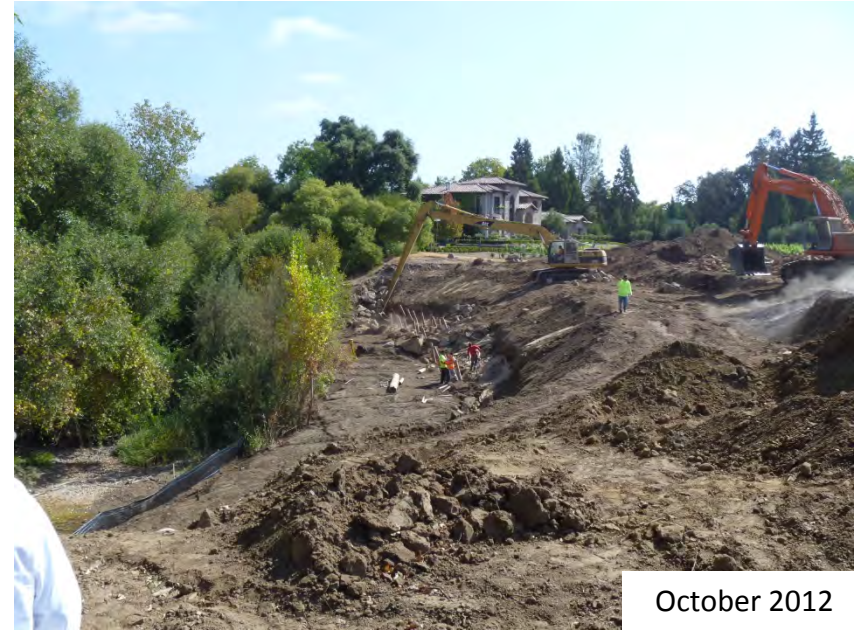
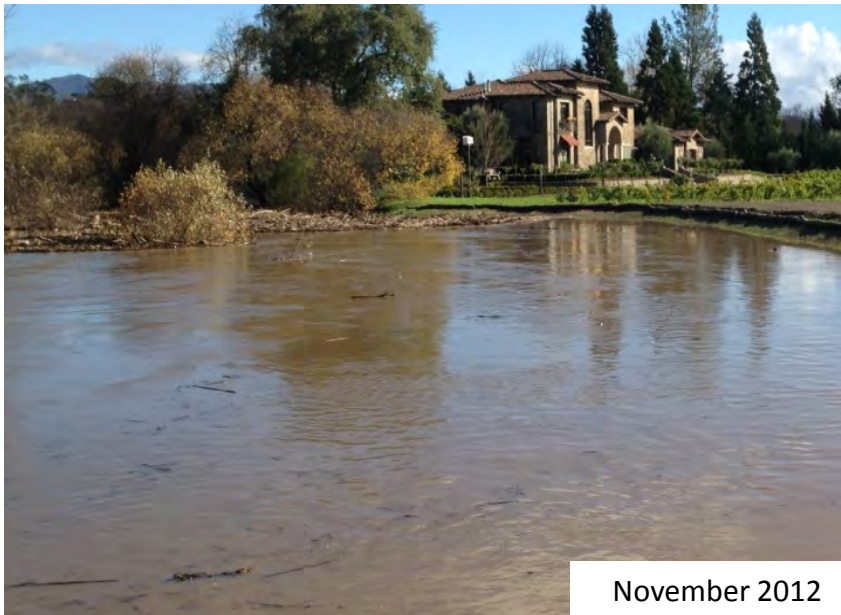
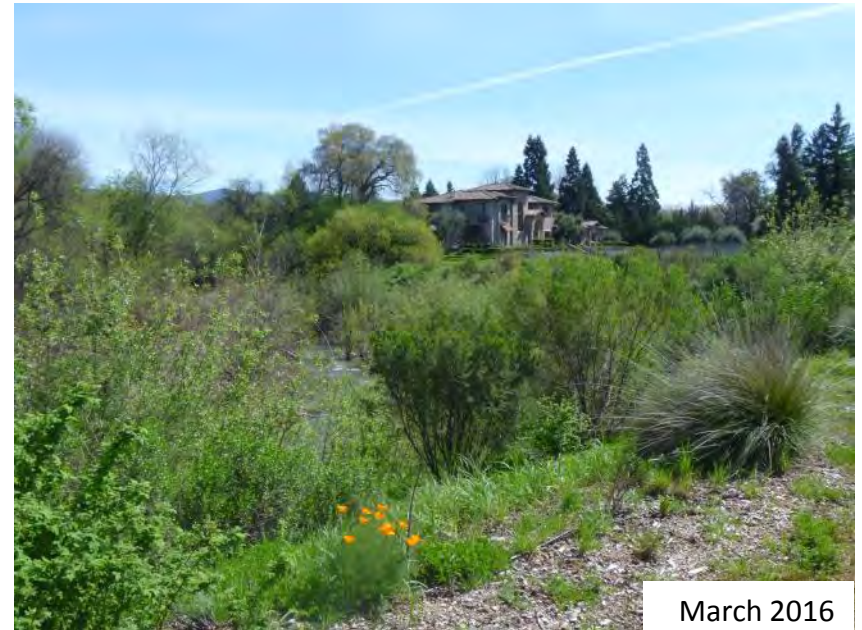
River Station 66+30
Bank Stabilization 2: Sequoia Grove, West Bank

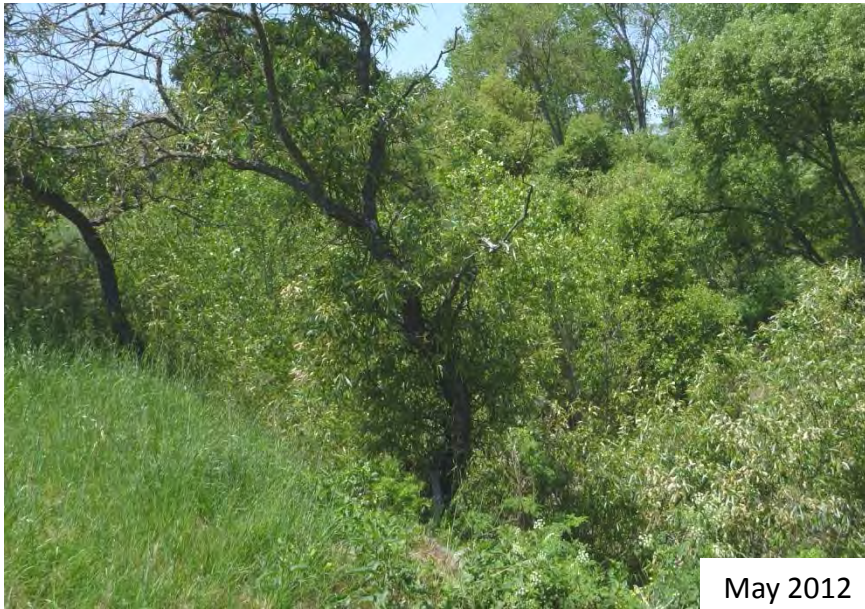
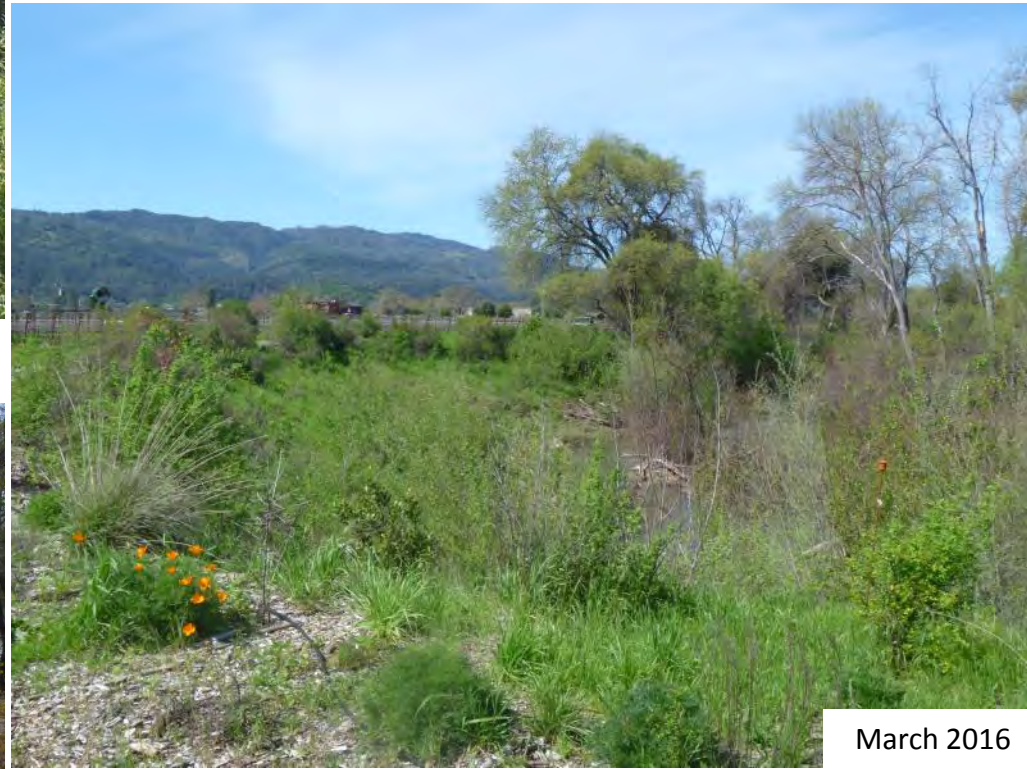
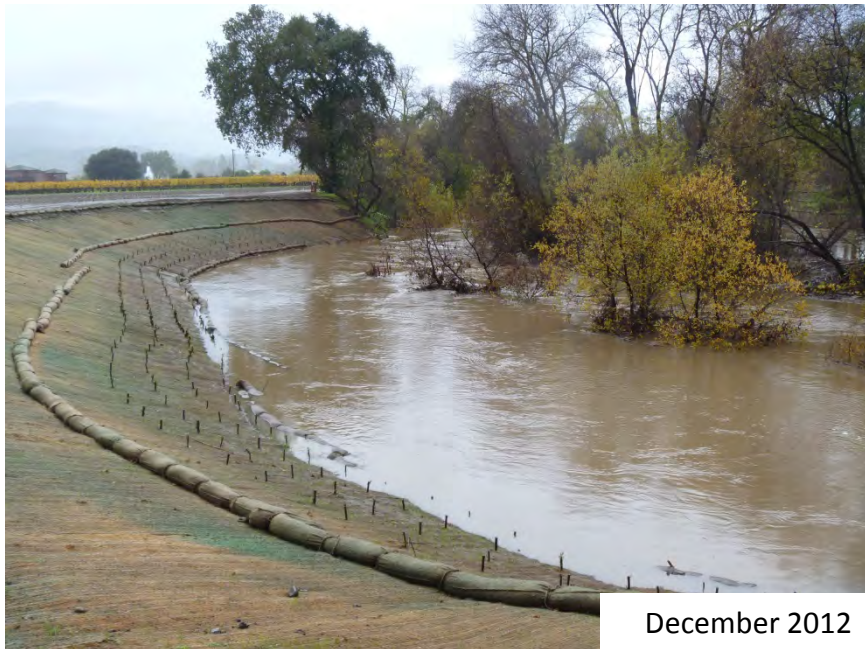
River Station 66+30

Bank Stabilization 2: Sequoia Grove, West Bank to Upstream

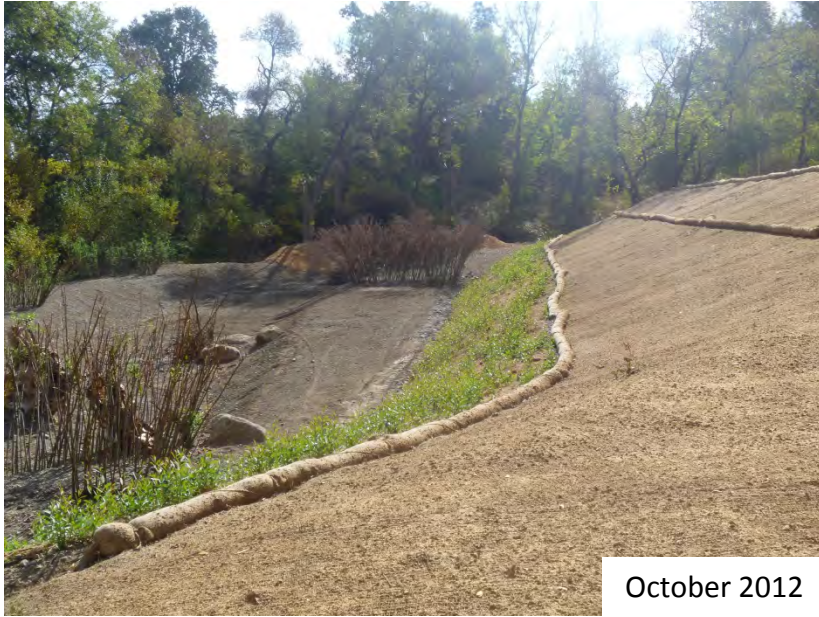
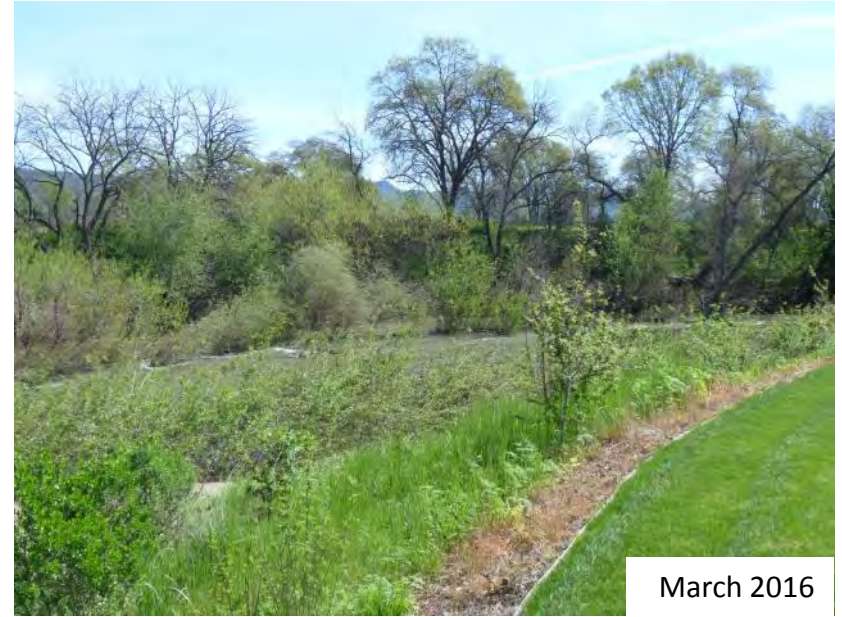
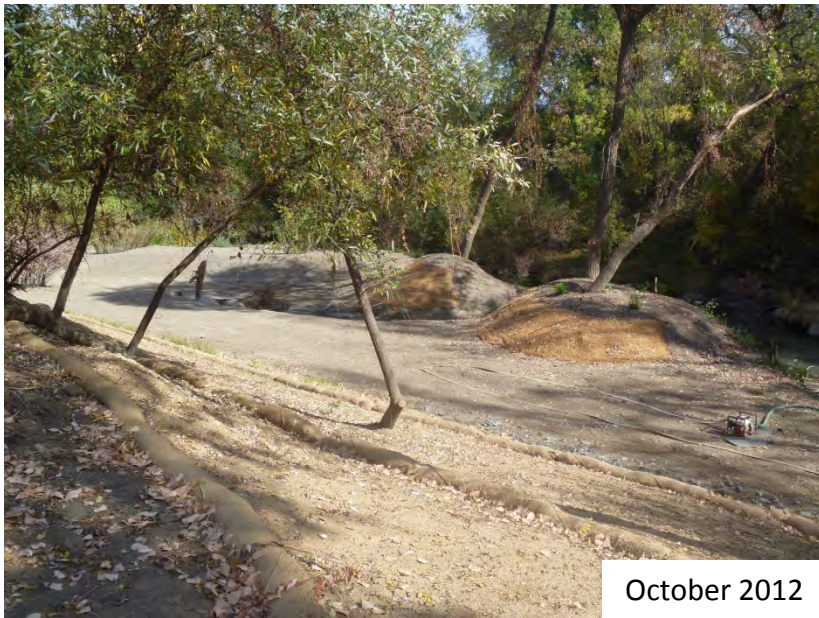
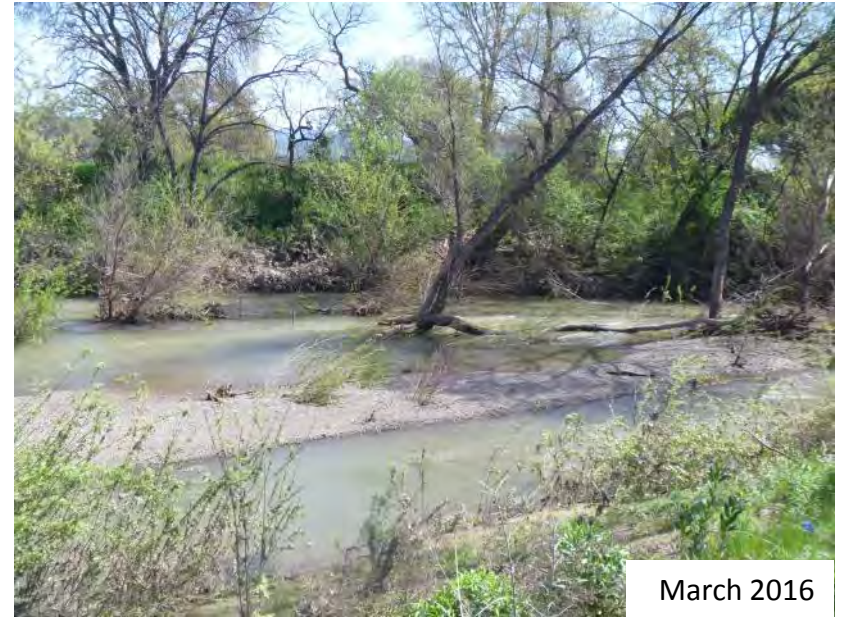
River Station 61 +00
Reach 8 South, Bench 1: Upstream to Downstream
