NAPA RIVER RUTHERFORD REACH RESTORATION PROJECT ANNUAL MONITORING REPORT- 2015

Napa County Flood Control and Water Conservation District
804 First Street
Napa, California, 94559
Contact: Jeremy Sarrow
(707) 259-8204

Napa County Resource Conservation District
1303 Jefferson Street, Suite 500 B
Napa, California, 94558
Contact: Paul Blank/Jonathan Koehler
(707) 252-4188

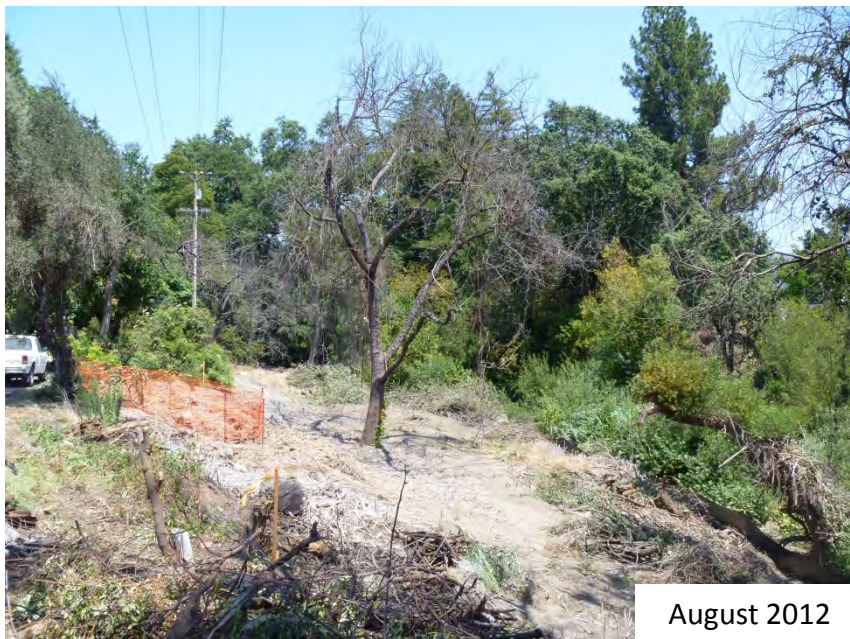
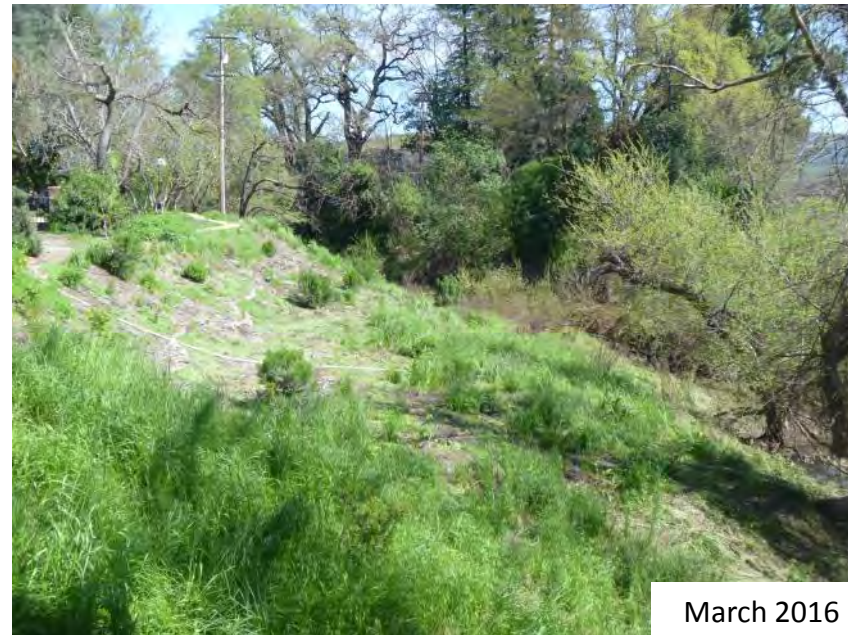
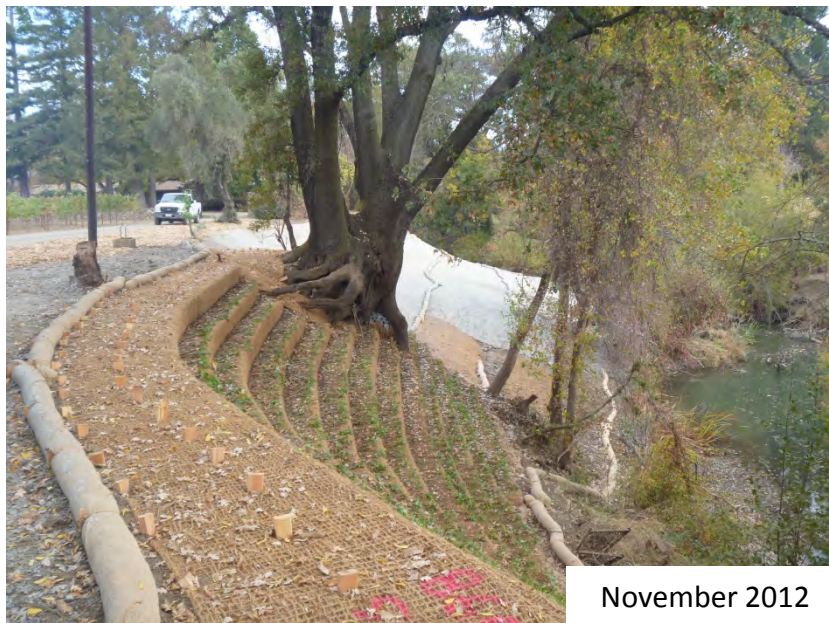
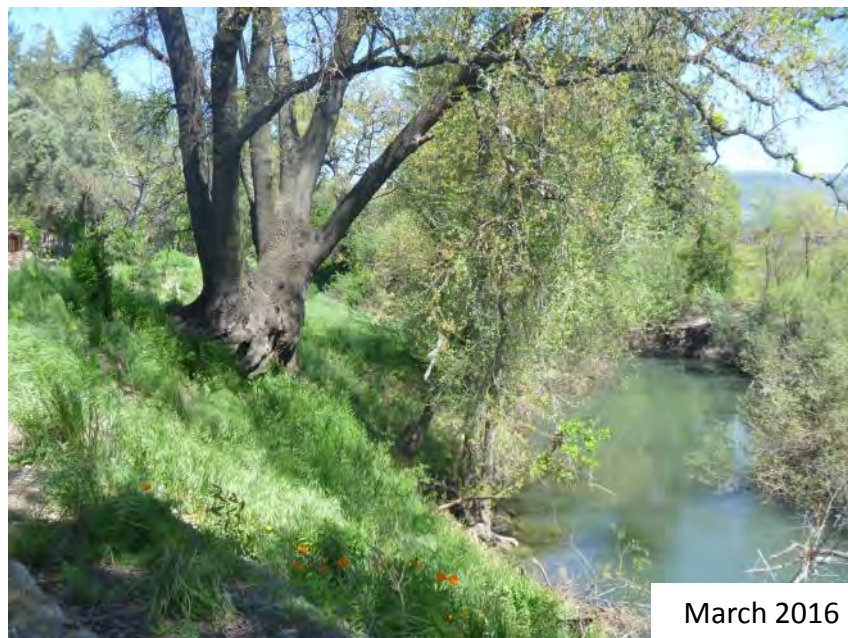
River Station 53+00
Reach 8 South, Bank Stabilization 1: Downstream to Upstream

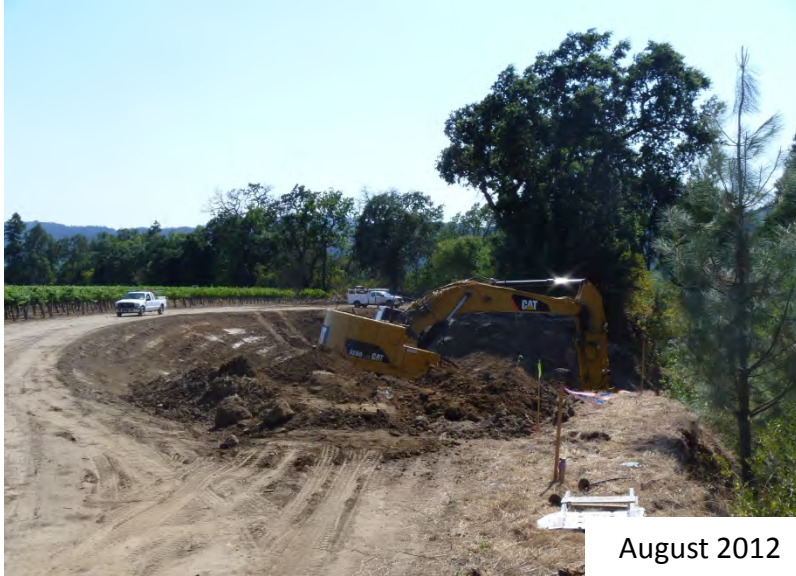
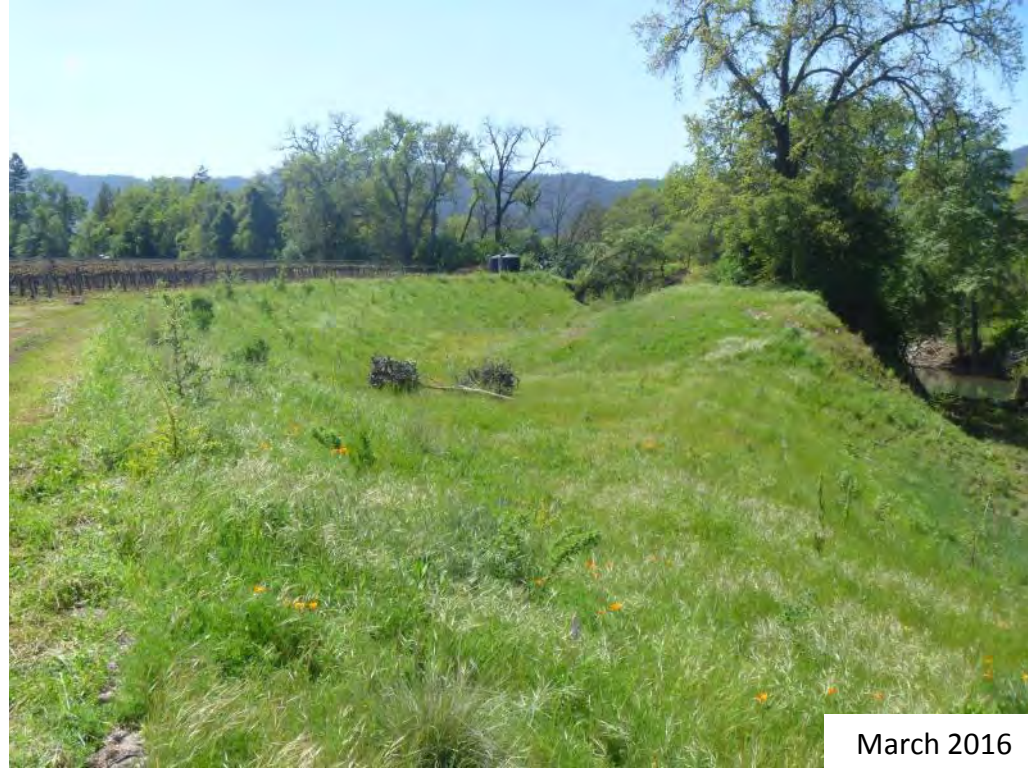
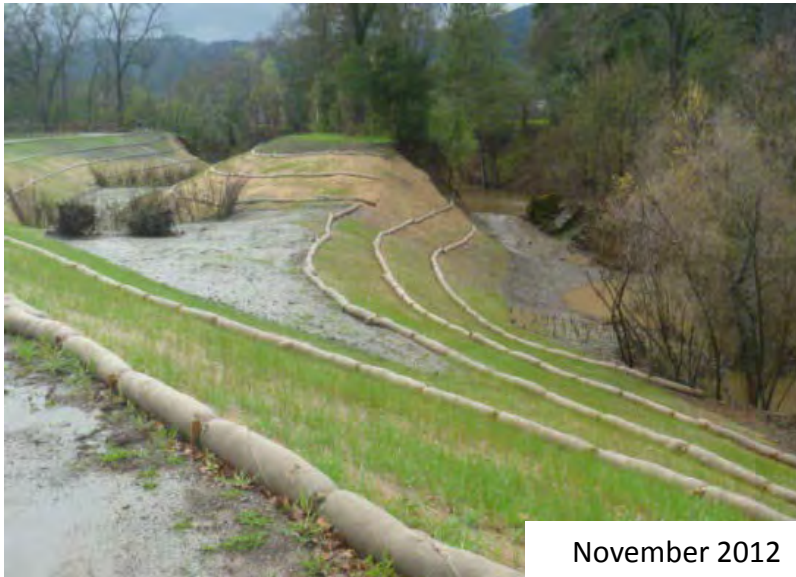
River Station 53+00
Reach 8 South, Bench 2: Upstream to Downstream

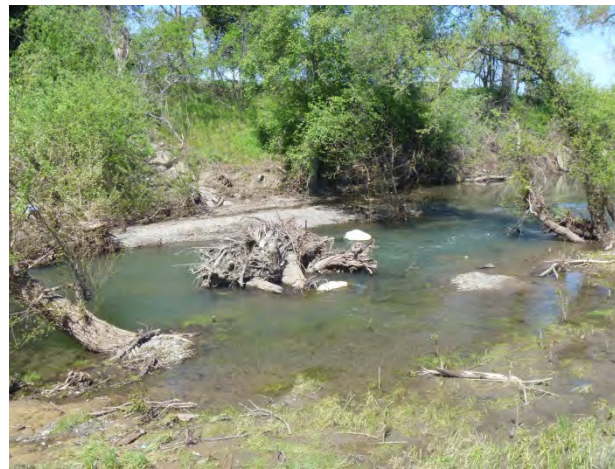
Boulder/LWD Cluster,
Bench 2, March 2016

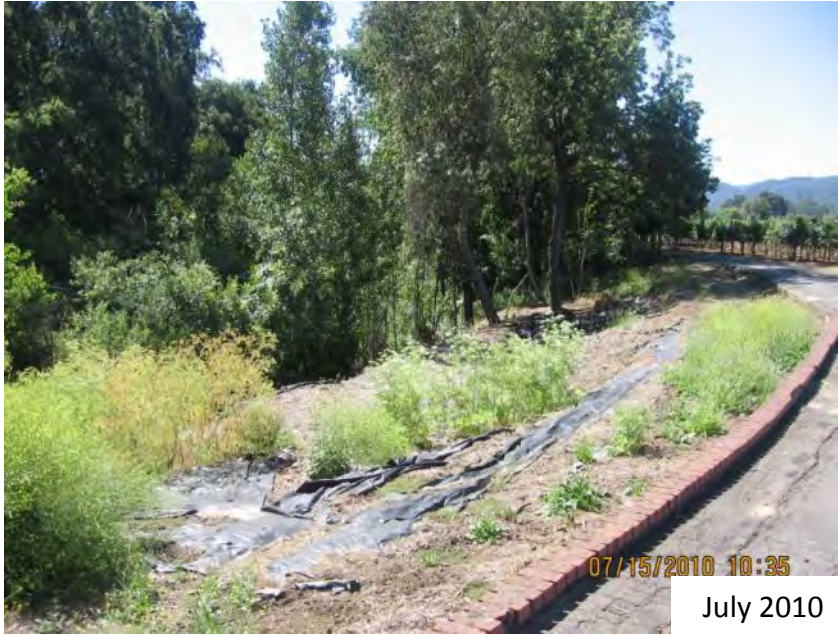
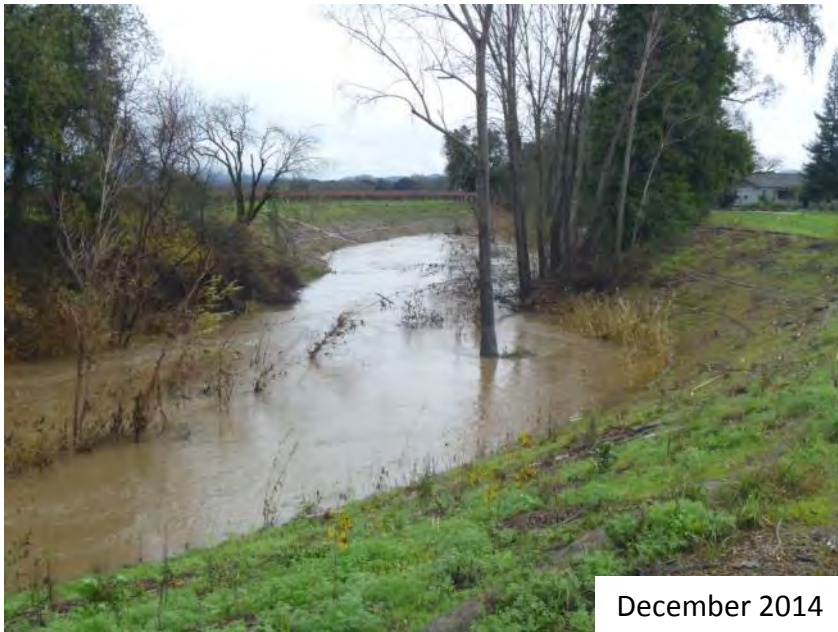
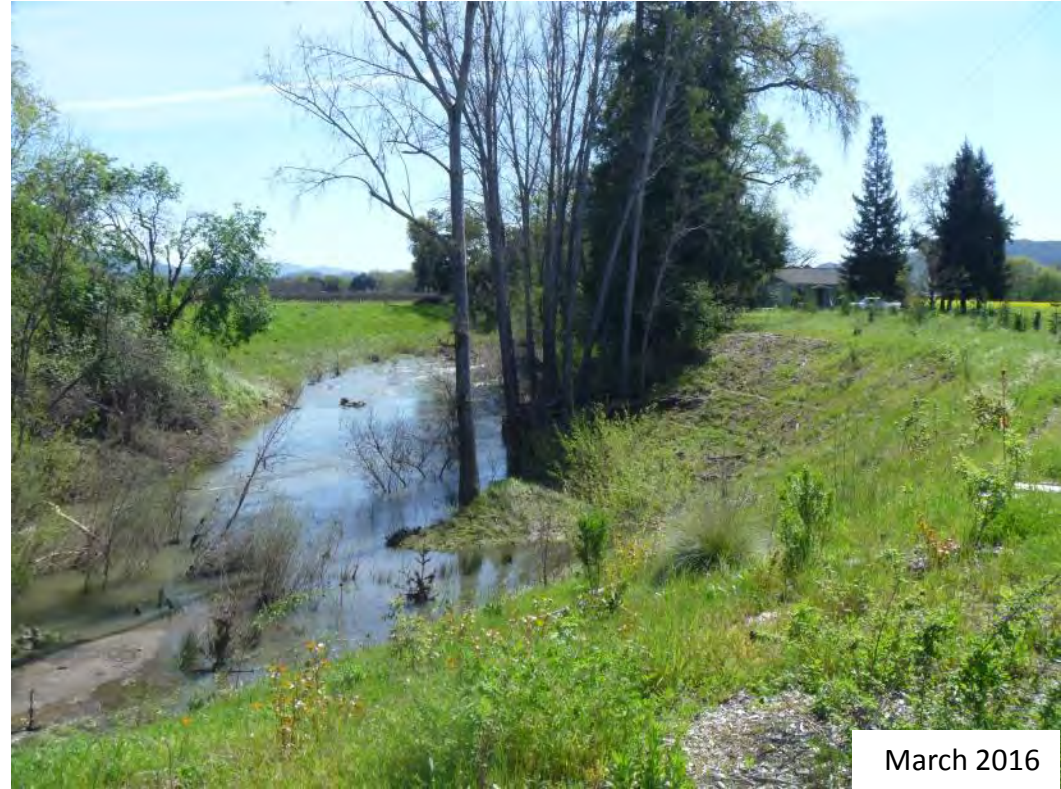
River Station 44+00

Reach 8 South, Bank Stabilization 3 to Bench 3: Upstream to Downstream

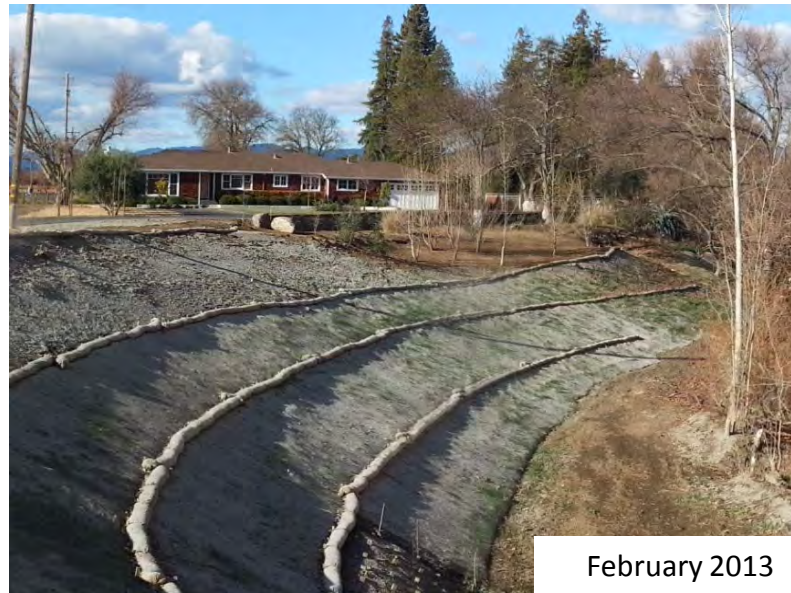
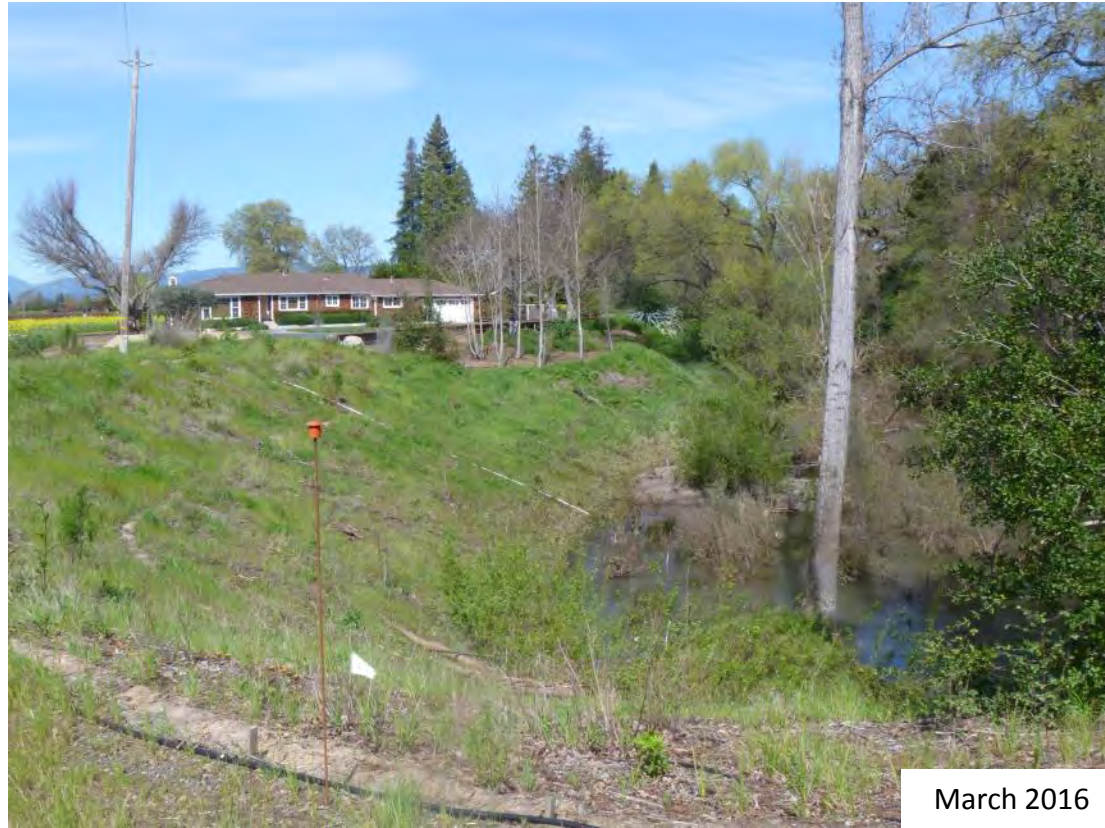
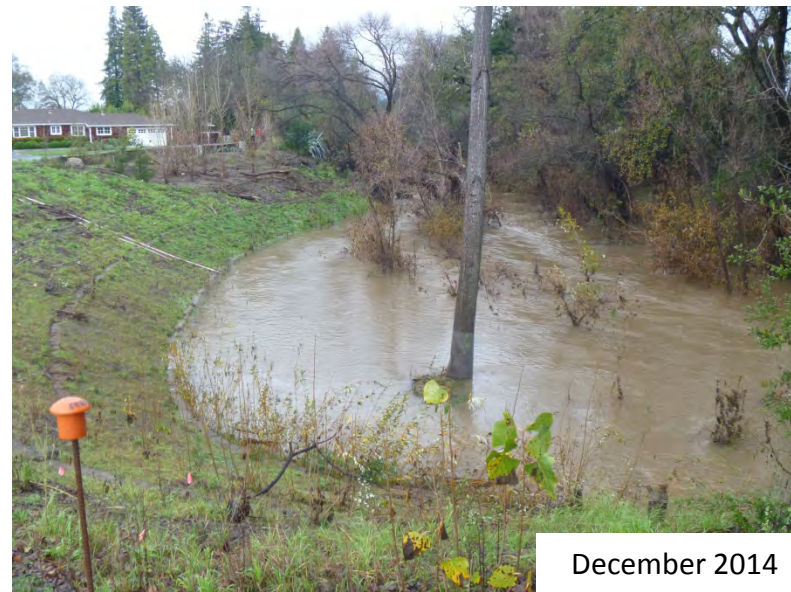
River Station 43+00

Reach 8 South, Bank Stabilization 3: Downstream to Upstream

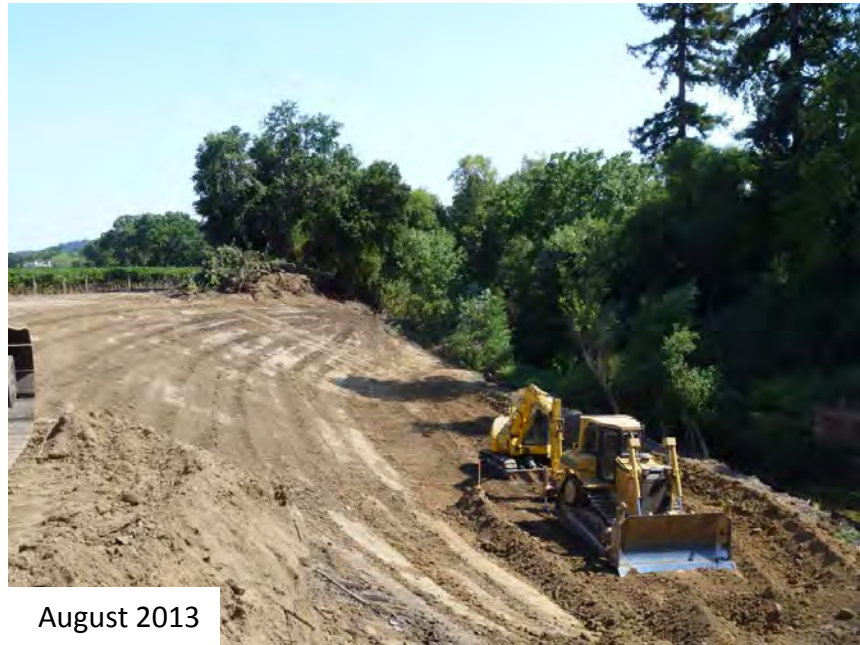
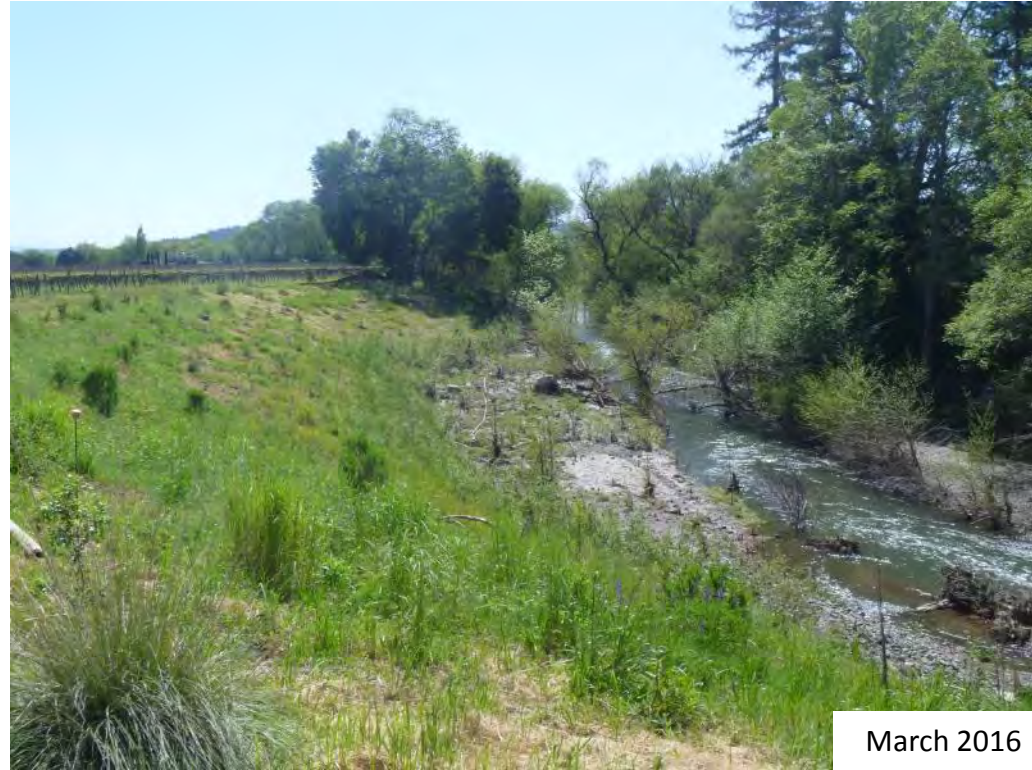
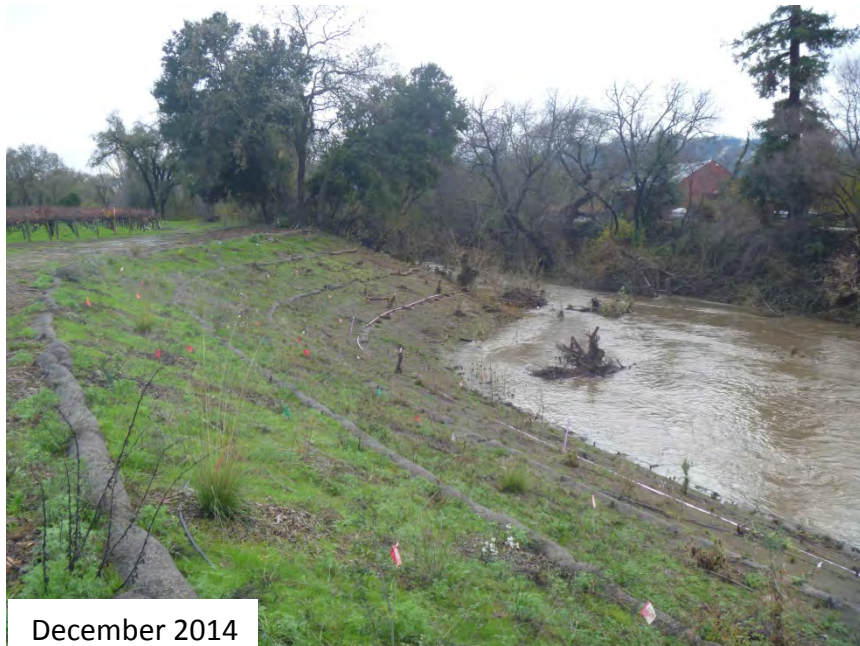
River Station 42+00
Reach 8 South, Bench 3: Upstream to Downstream

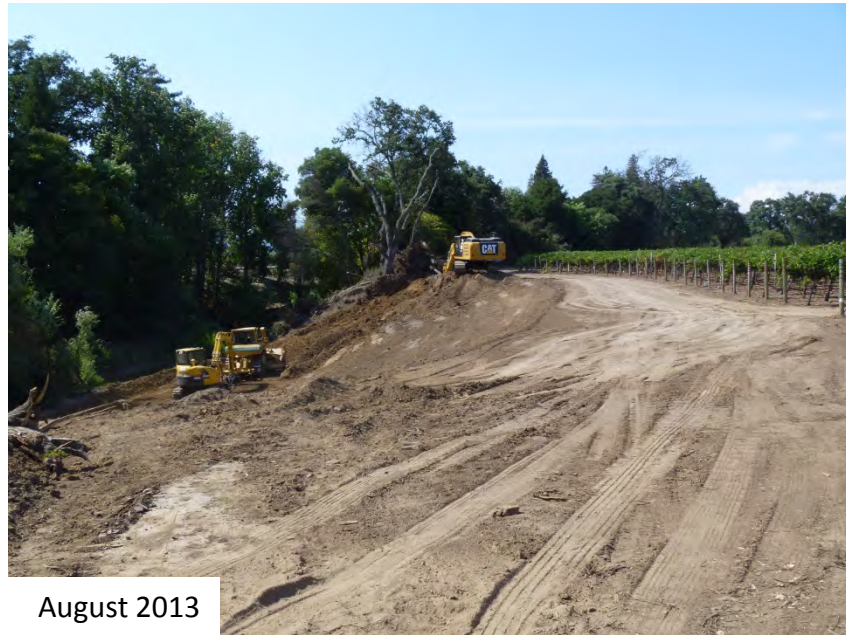
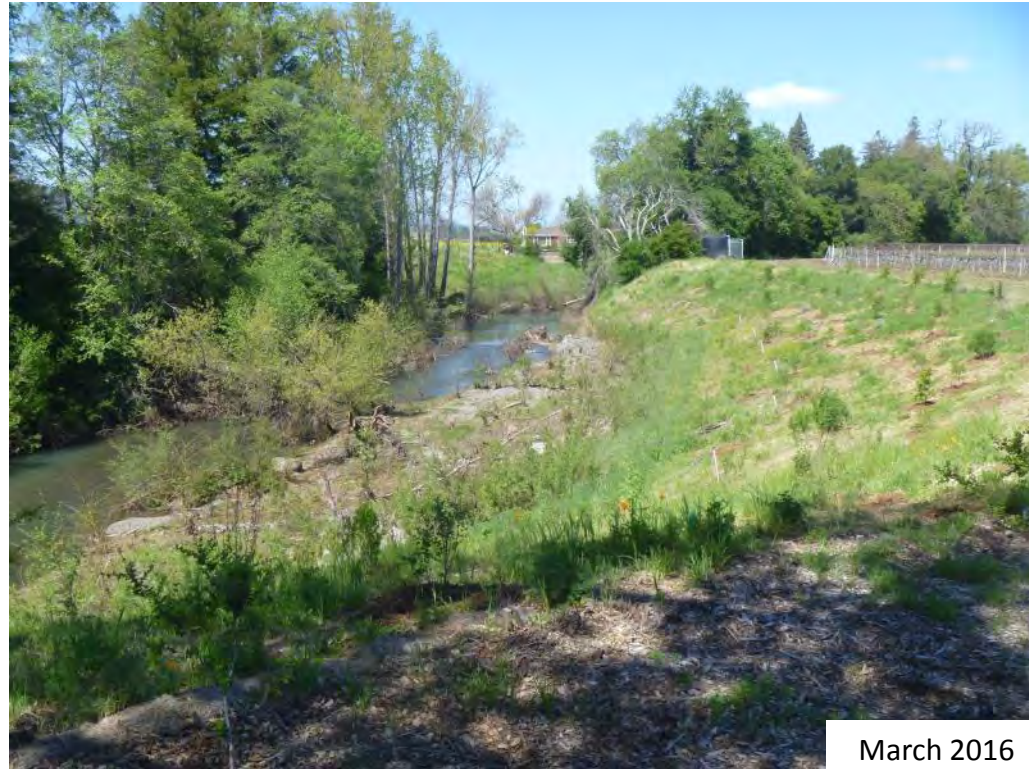
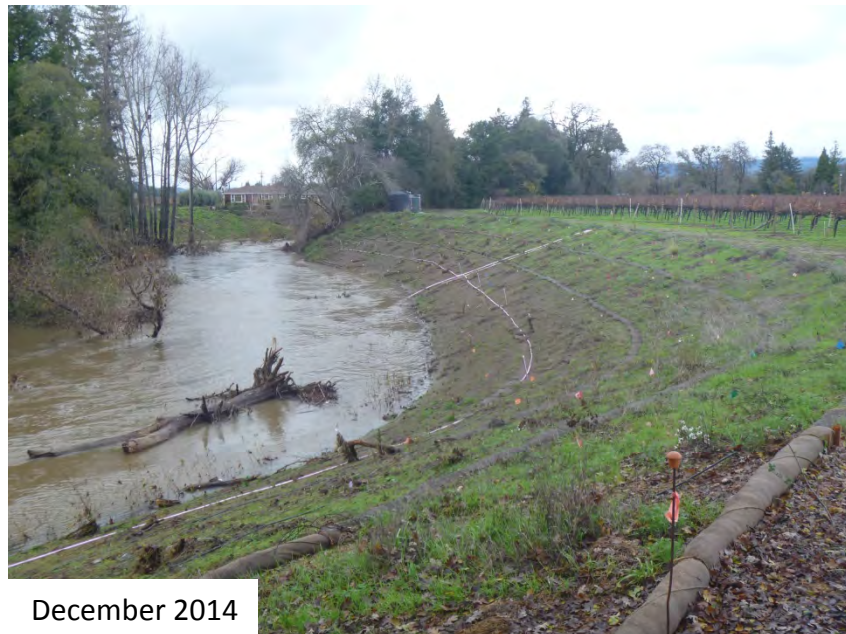
River Station 40+00
Reach 8 South, Bench 3: Downstream to Upstream

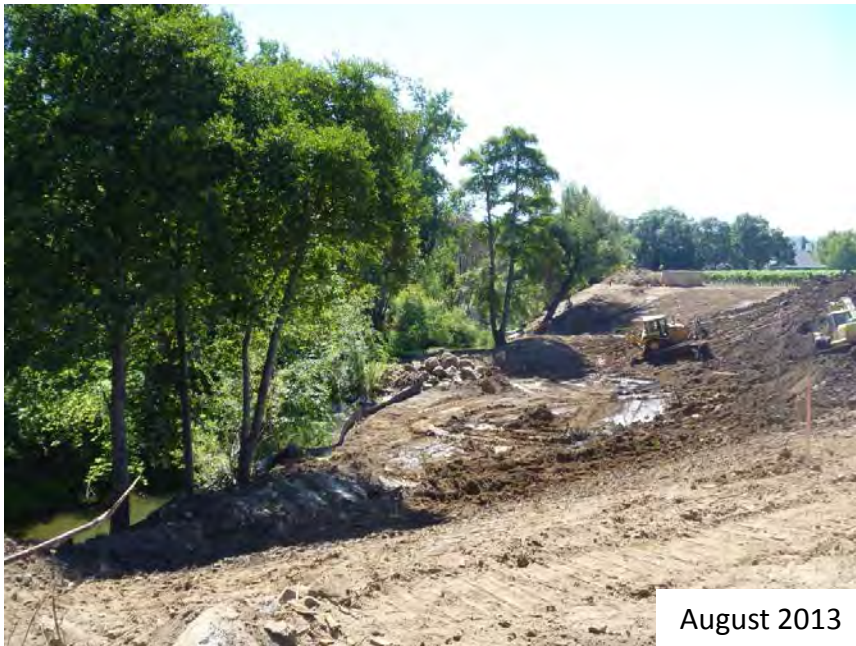
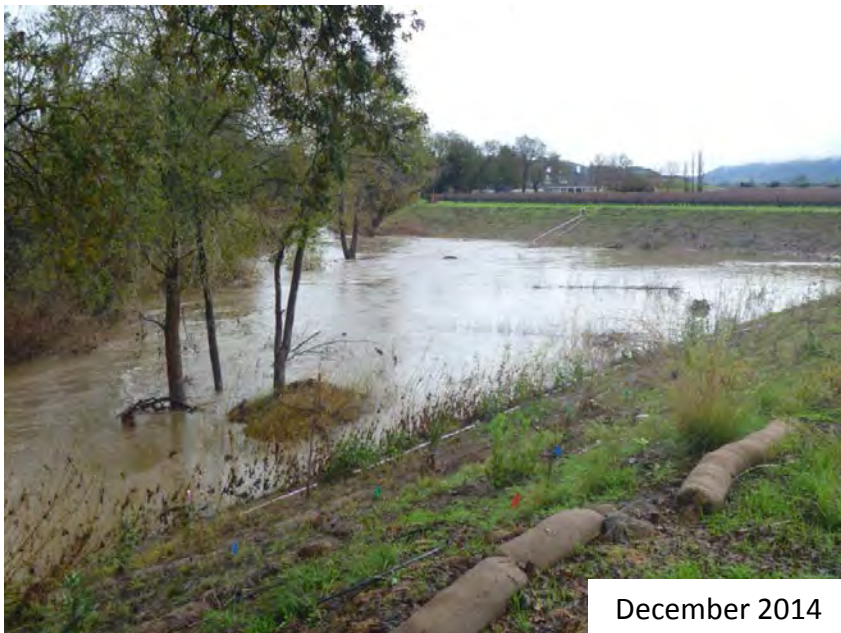
River Station 36+00, Reach 8 South, Bella Oaks Tributary Alcove: Upstream to Downstream

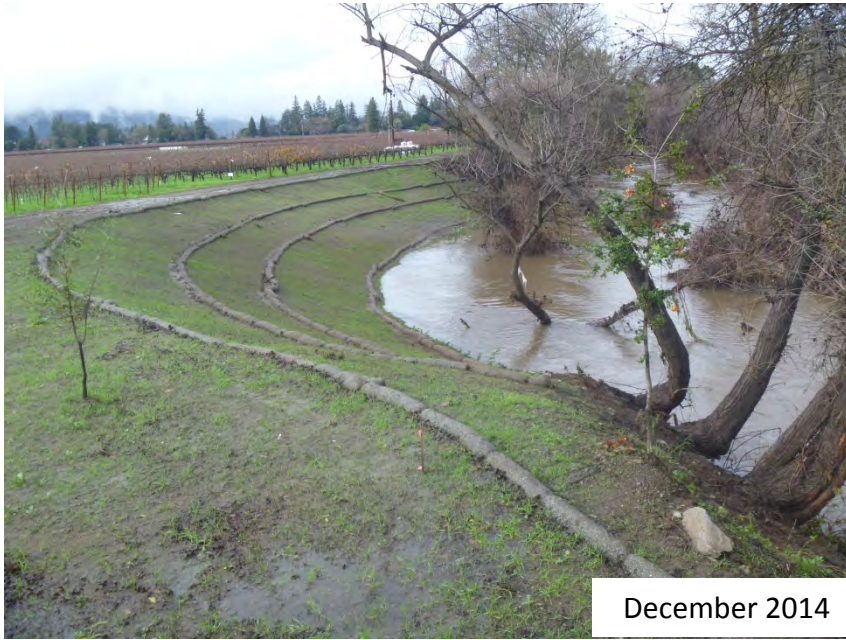
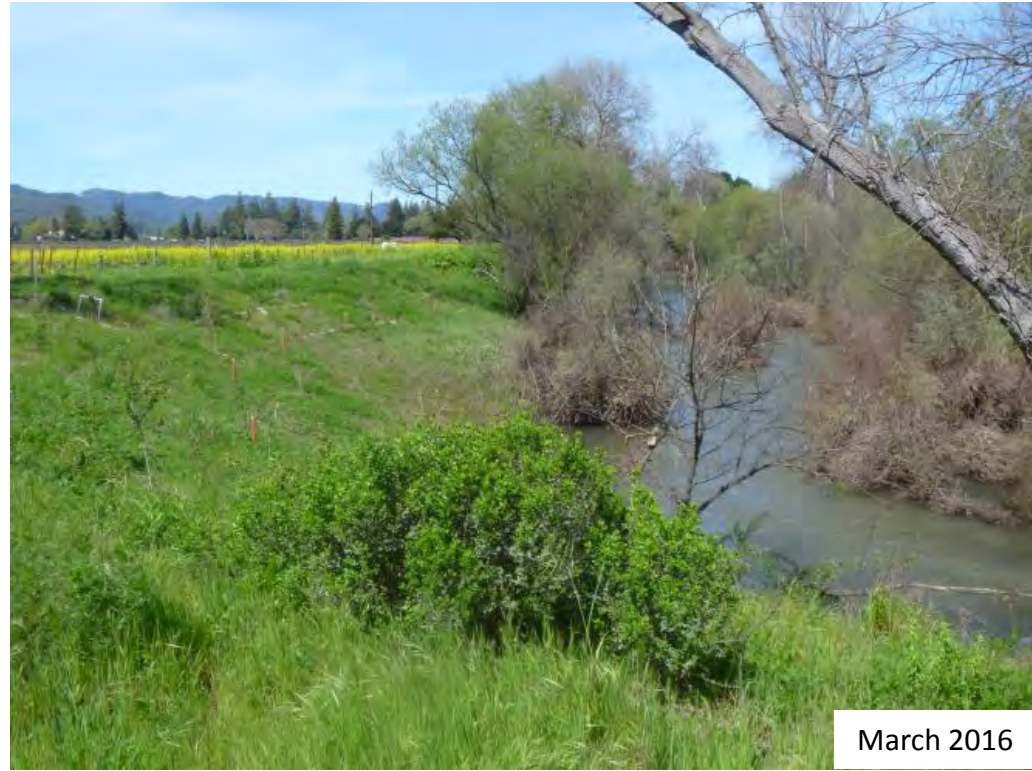
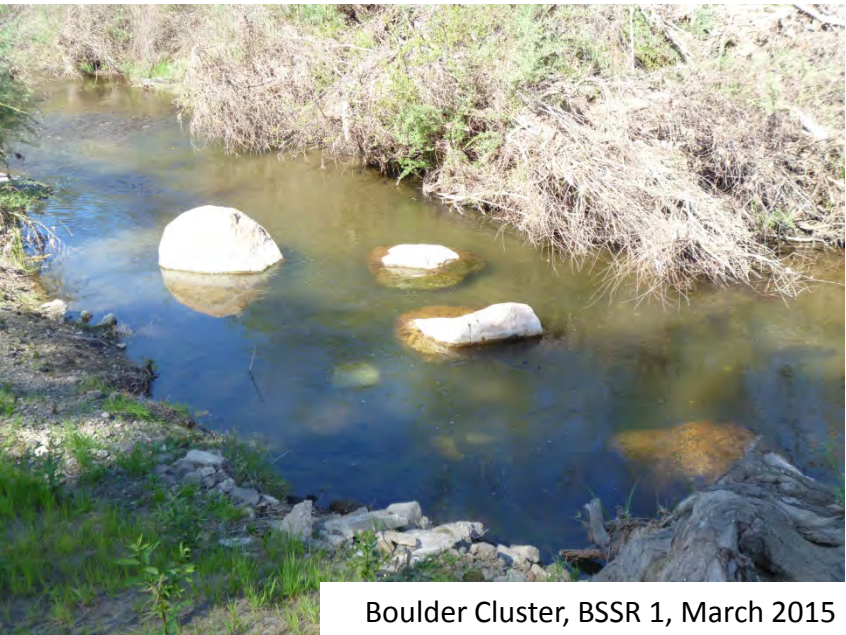
River Station 92+00, Reach 6, Peju-St. Supery Bank Stabilization Area 1, West Bank

Boulder Cluster, BSSR 1, March 2015

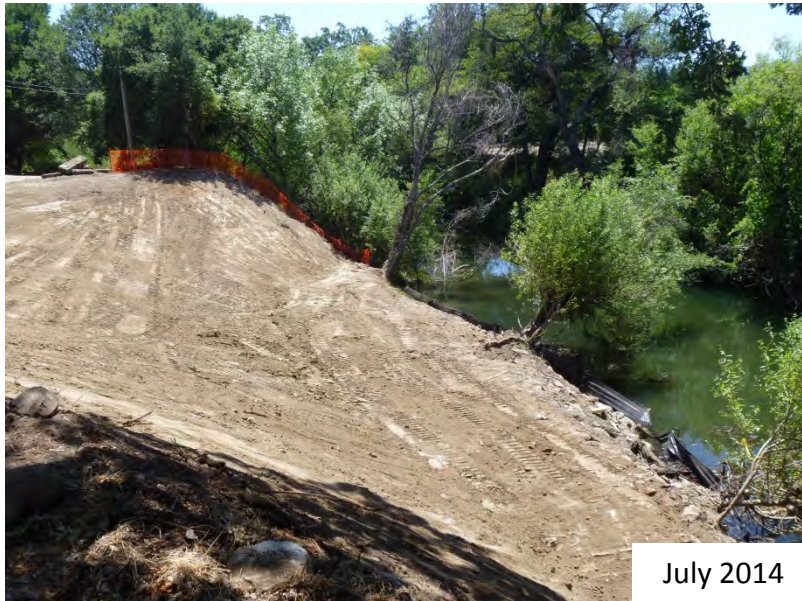
July 2014

River Station 9+00, Reach 9, Swanson Bench 2, Upstream to Downstream, East Bank

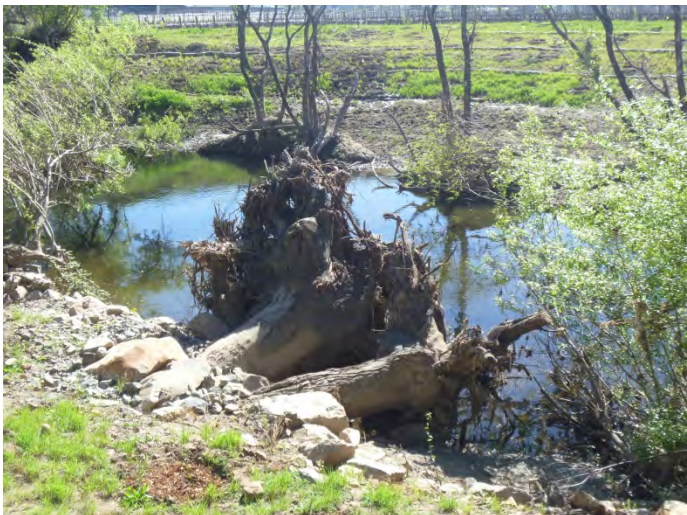
LWD, Bench 2,
March 2015

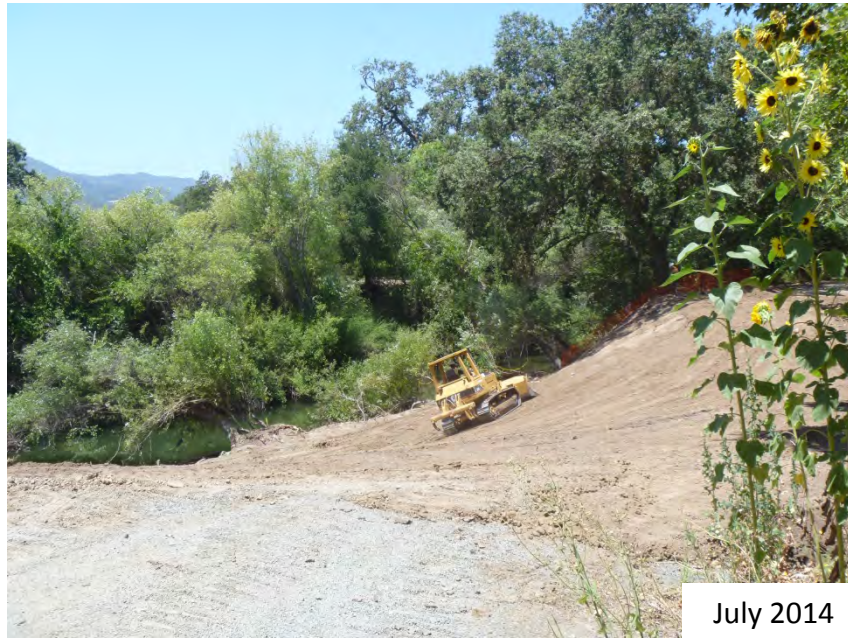
July 2014

River Station 7+50, Reach 9, Swanson Bench 2, Downstream to Upstream, East Bank

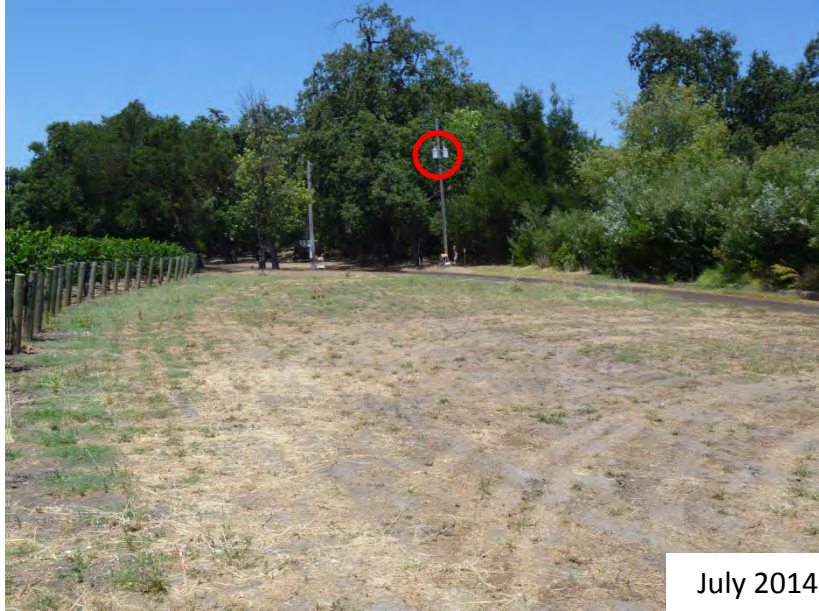
July 2014

River Station 7+50, Reach 9, Opus One Bench 3, Downstream to Upstream, West Bank

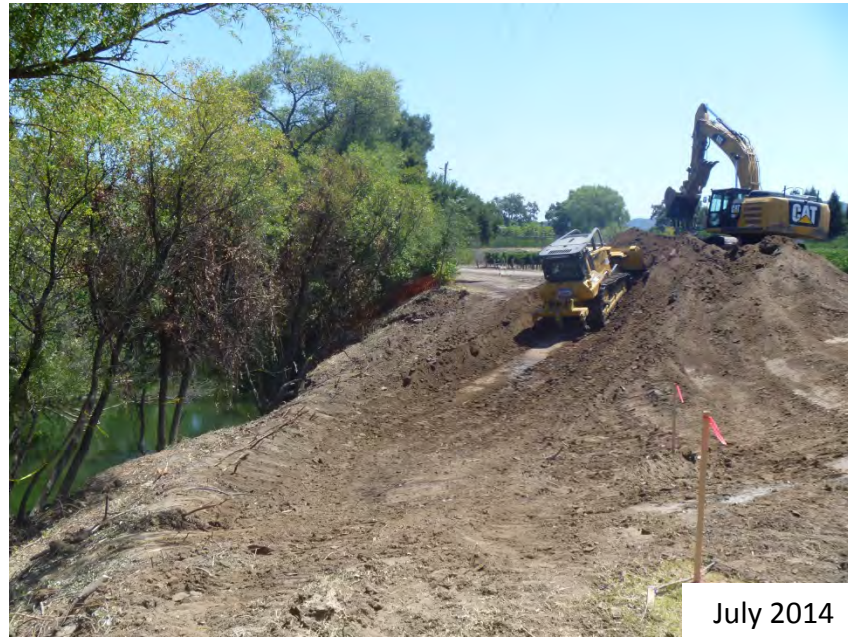
July 2014

River Station 9+00, Reach 9, Opus One Bench 3, Upstream to Downstream, West Bank
