# NAPA RIVER RUTHERFORD REACH RESTORATION PROJECT ANNUAL MONITORING REPORT - 2017

Napa County Flood Control and Water Conservation District  
804 First Street  
Napa, California, 94559  
Contact: Jeremy Sarrow  
(707) 259-8204

Napa County Resource Conservation District  
1303 Jefferson Street, Suite 500 B  
Napa, California, 94558  
Contact: Paul Blank/Jonathan Koehler  
(707) 252-4189

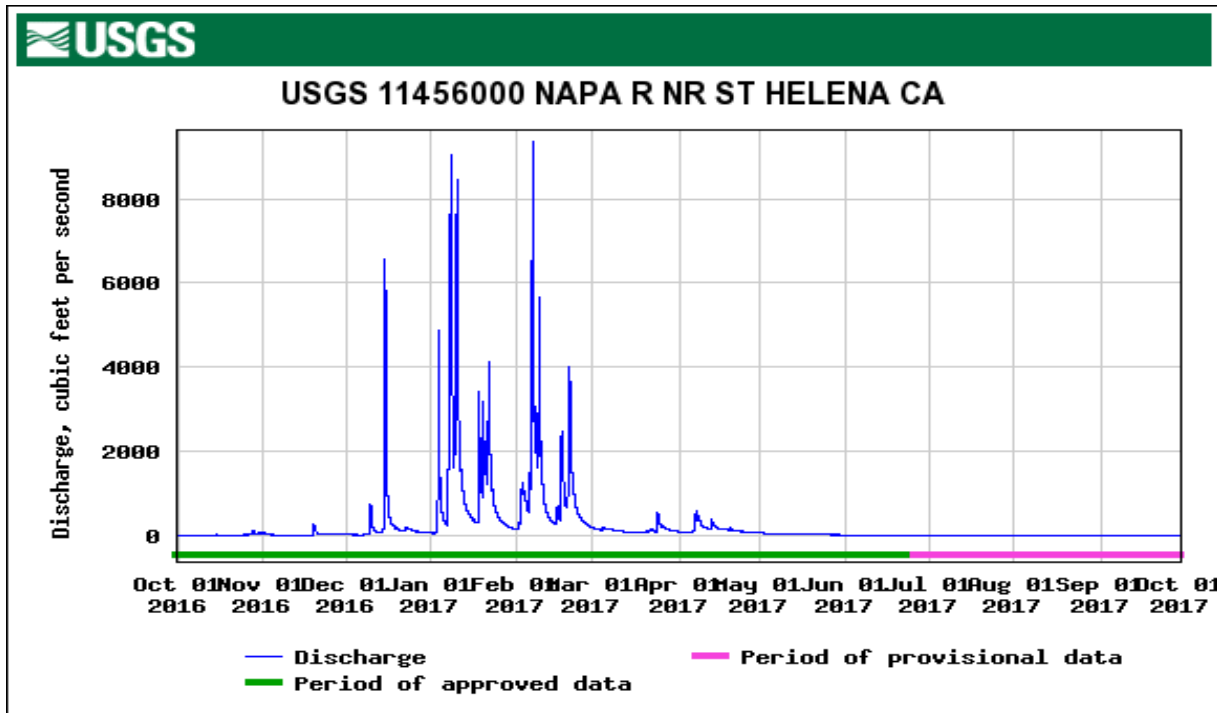
Figure 6. 2016-2017 streamflow, Napa River Rutherford Restoration Reach, USGS Station 11456000.

During the 2016-17 water year (October 1, 2016 through September 30, 2017), measurable streamflow began at Station 11456000 on October 24, 2016 and continued through early August. The peak flow of the season occurred on February 7, 2017, and was measured to be 9,340 cfs, an approximate 4-year peak flood. Following the last significant storm of the season in mid-April, flows in the river receded until streamflow ended on August 1, 2017. A plot of streamflow measured at Station 11456000 during the 2016-17 water year is included as **Figure 6**.

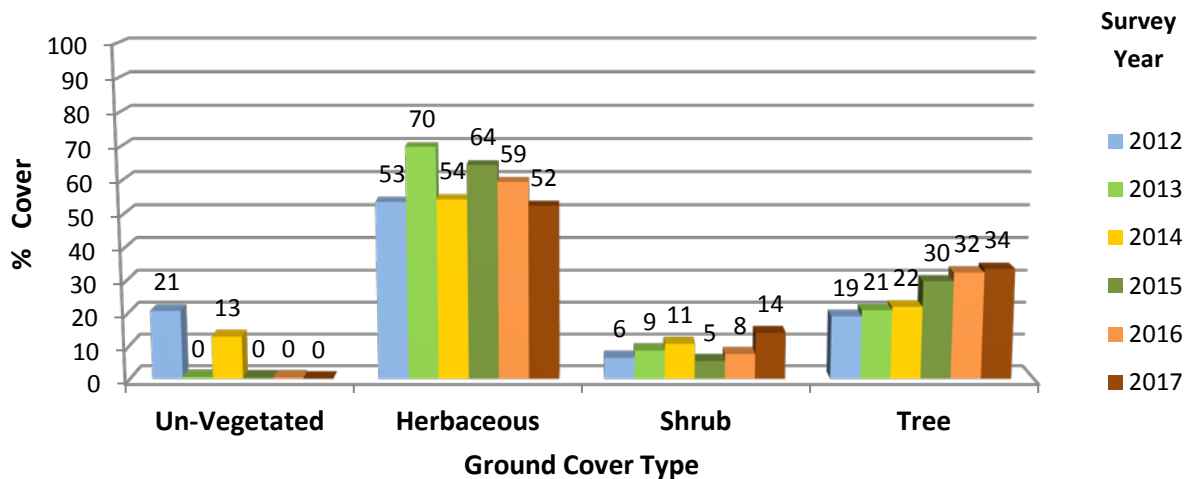
**Chart 1:** Average percent cover by ground cover type for line transect surveys (2012-2017)

Results from the line intercept surveys also indicate that cover at restoration sites, on average, is approximately 52% herbaceous, 14% woody shrub and 34% tree native cover types with 0% unvegetated areas at any given transect. Further, in 2017 approximately 53% of installed native vegetation measured between 0 feet and 3 feet in height, 44% measured 3 feet to 15 feet high, and several trees, 2.5%, now measure above 15 feet (primarily cottonwoods, willows and alders) within the restoration areas. In general, these increases in relative cover and average vegetation height represent a positive trend in vegetation establishment at the restored sites, likely providing greater habitat value within the riparian corridor of the Napa River. The installed native vegetation is expected to continue to increase at natural growth rates under typical, non-drought growing conditions.

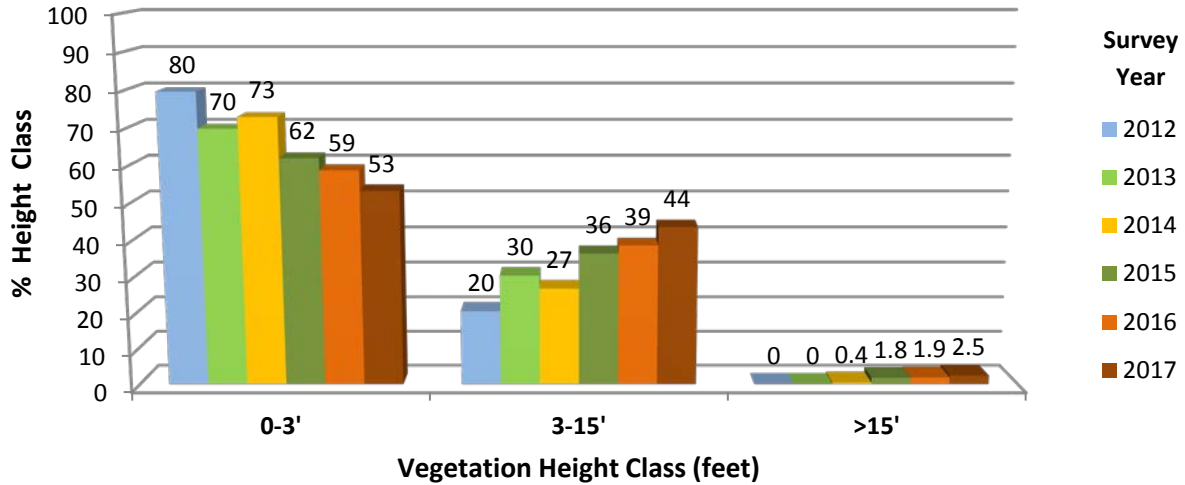
**Chart 2:** Average height class of herbaceous and woody vegetation for line transect surveys (2012-2017)

**Chart 2** below represents the average height class of measured vegetation along all surveyed transects from 2012 through 2017. Approximately 53% of the vegetation measured in 2017 at a given transect ranged between 0 and 3 feet tall, while approximately 4% of the vegetation measured in 2017 ranged between 3 and 15 feet in height. In 2017 several trees (primarily cottonwoods, willows and alders) measured along transects (G1, CAY2, SG1, CB1 and UNITED) in reaches 1, 3, 8 and 9 measured 15 feet in height or greater, providing data for the next height class and documenting maturation of the over story canopy within Project restoration areas. Representative photos of the monitoring sites are shown in **Appendix B**.

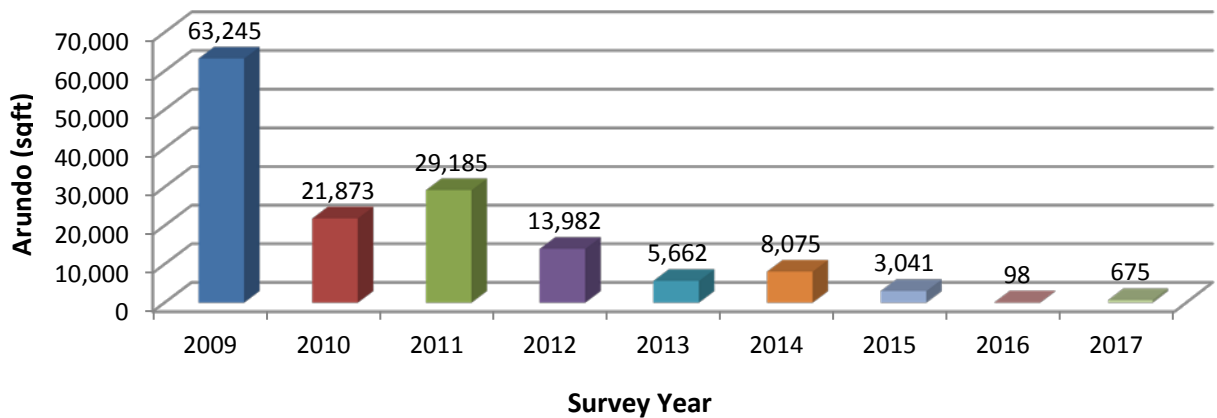
**Chart 3:** Arundo mapped and treated (2009-2017)

area since monitoring and management began in 2009. The area of Arundo documented and treated in 2017 (675 sqft) was more than the previously documented in 2016 (98 sqft). This is likely because two significant new clumps were discovered that had previously gone undetected. Areas of invasive plants that were treated in 2017 that had the potential to cause streambank erosion were replanted with willow stakes and/or broadcast seeded with native species during the winter and spring of 2017 and 2018.

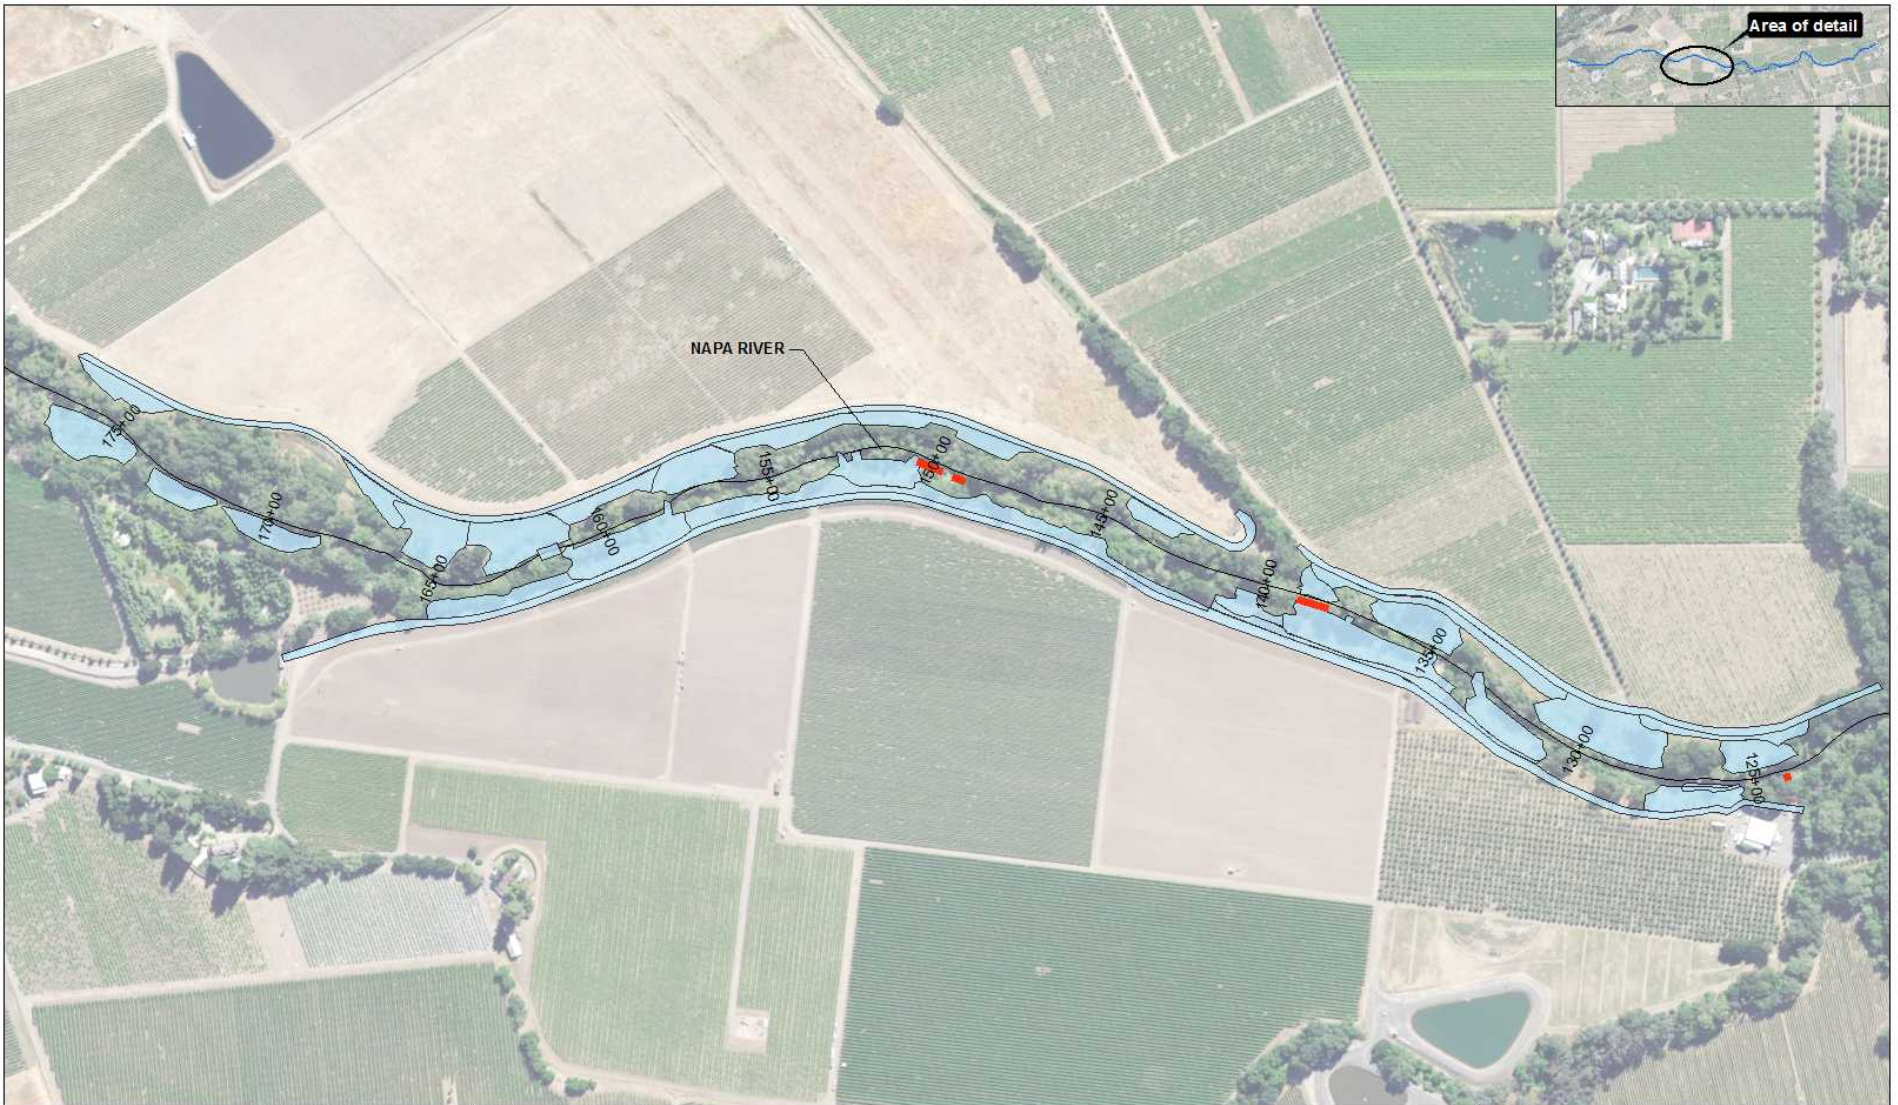
Napa River Rutherford Restoration Project Reach 1-2  
Eroding Stream Bank Survey

- Stream Bank Erosion
- Constructed Features

An eroding stream bank survey is conducted annually along the entire length of the channel every year in order to evaluate the extent of stream bank erosion within the Project area and to assess effects on fine sediment loading. During the dry season, the team walks the entire Project reach in the downstream direction and maps the start and end of erosion areas on each bank. For each erosion area, the length and average height of bank erosion is estimated and it is noted whether the erosion affects the whole bank, the top of bank, or the base of bank. In addition, it is noted whether the erosion is due to undercutting or a lack of vegetation. Project restoration efforts addressed stream bank erosion by grading over-steepened banks to a more stable profile and installing biotechnical bank stabilization features such as vegetated soil lifts (VSL's). Additional information regarding monitoring protocols and

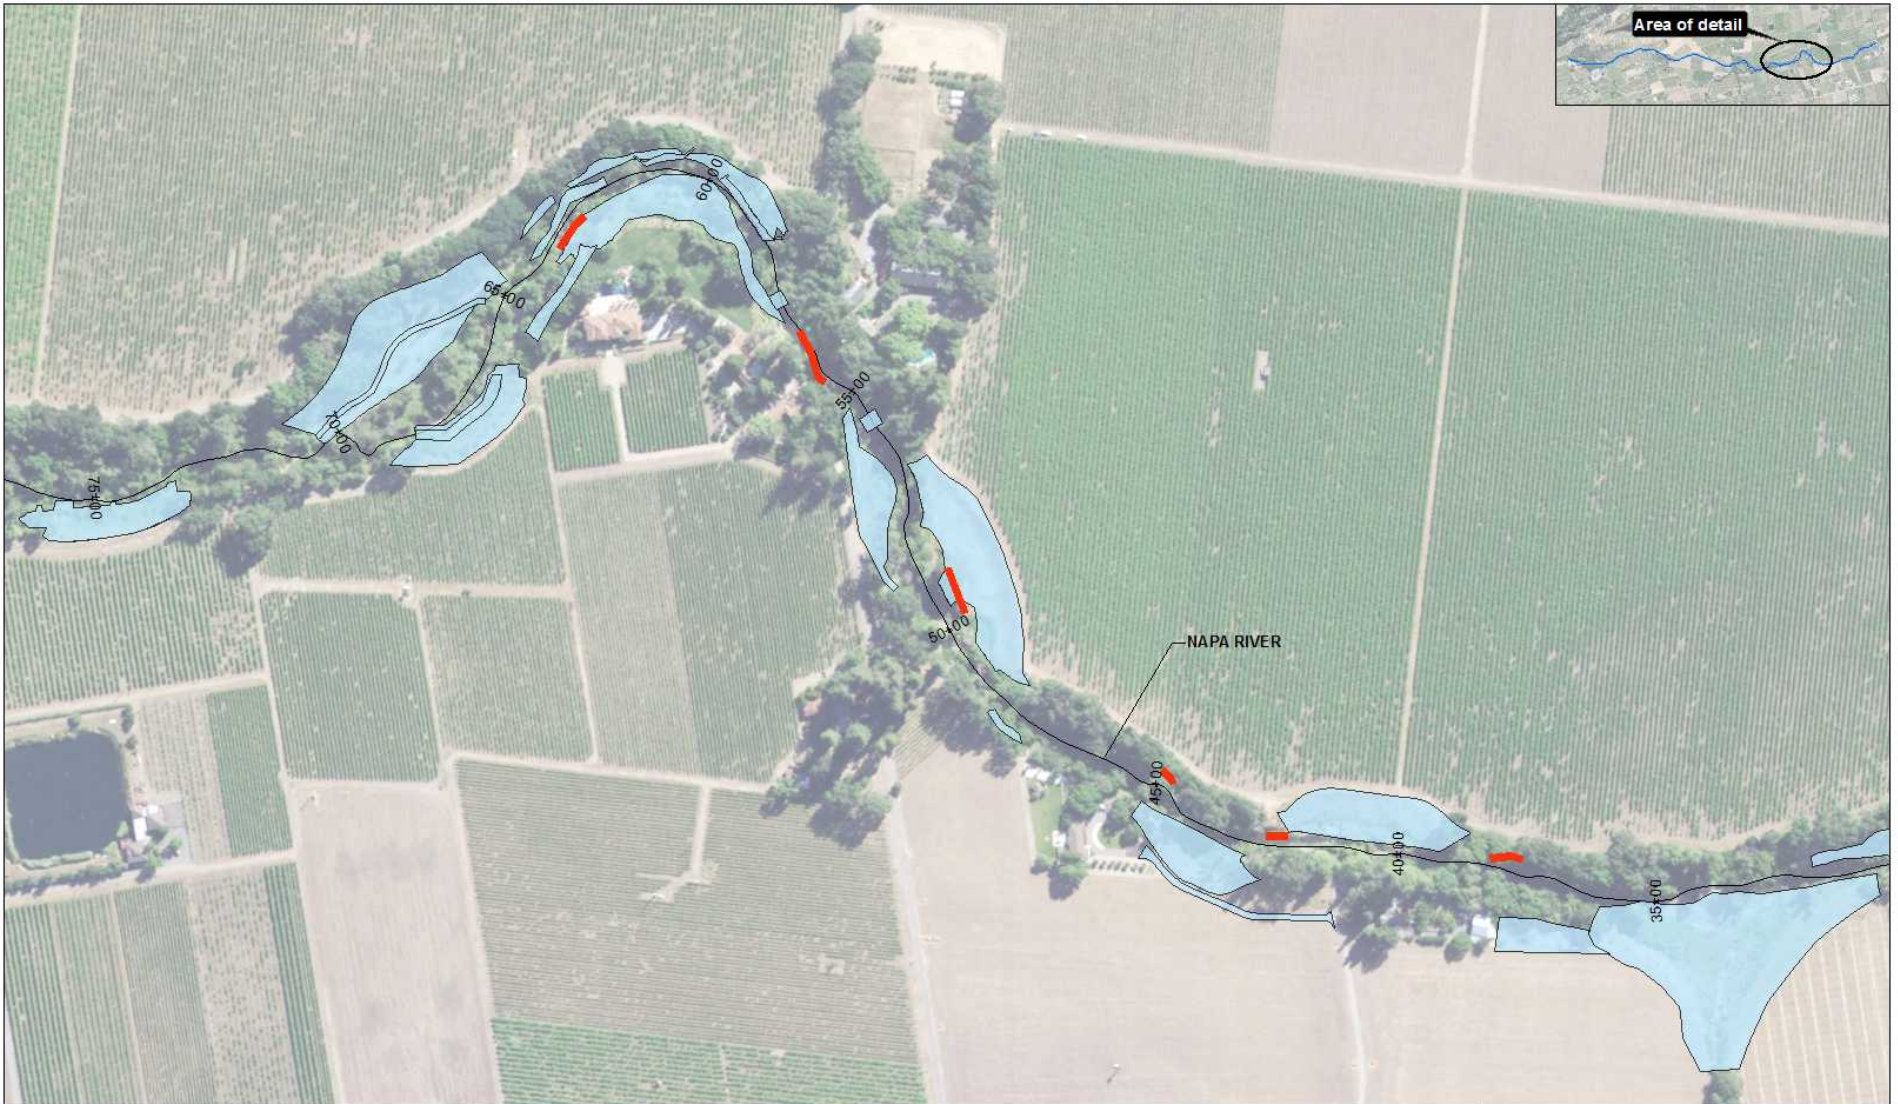
Napa River Rutherford Restoration Project Reach 5-7  
Eroding Stream Bank Survey

- Stream Bank Erosion
- Constructed Features

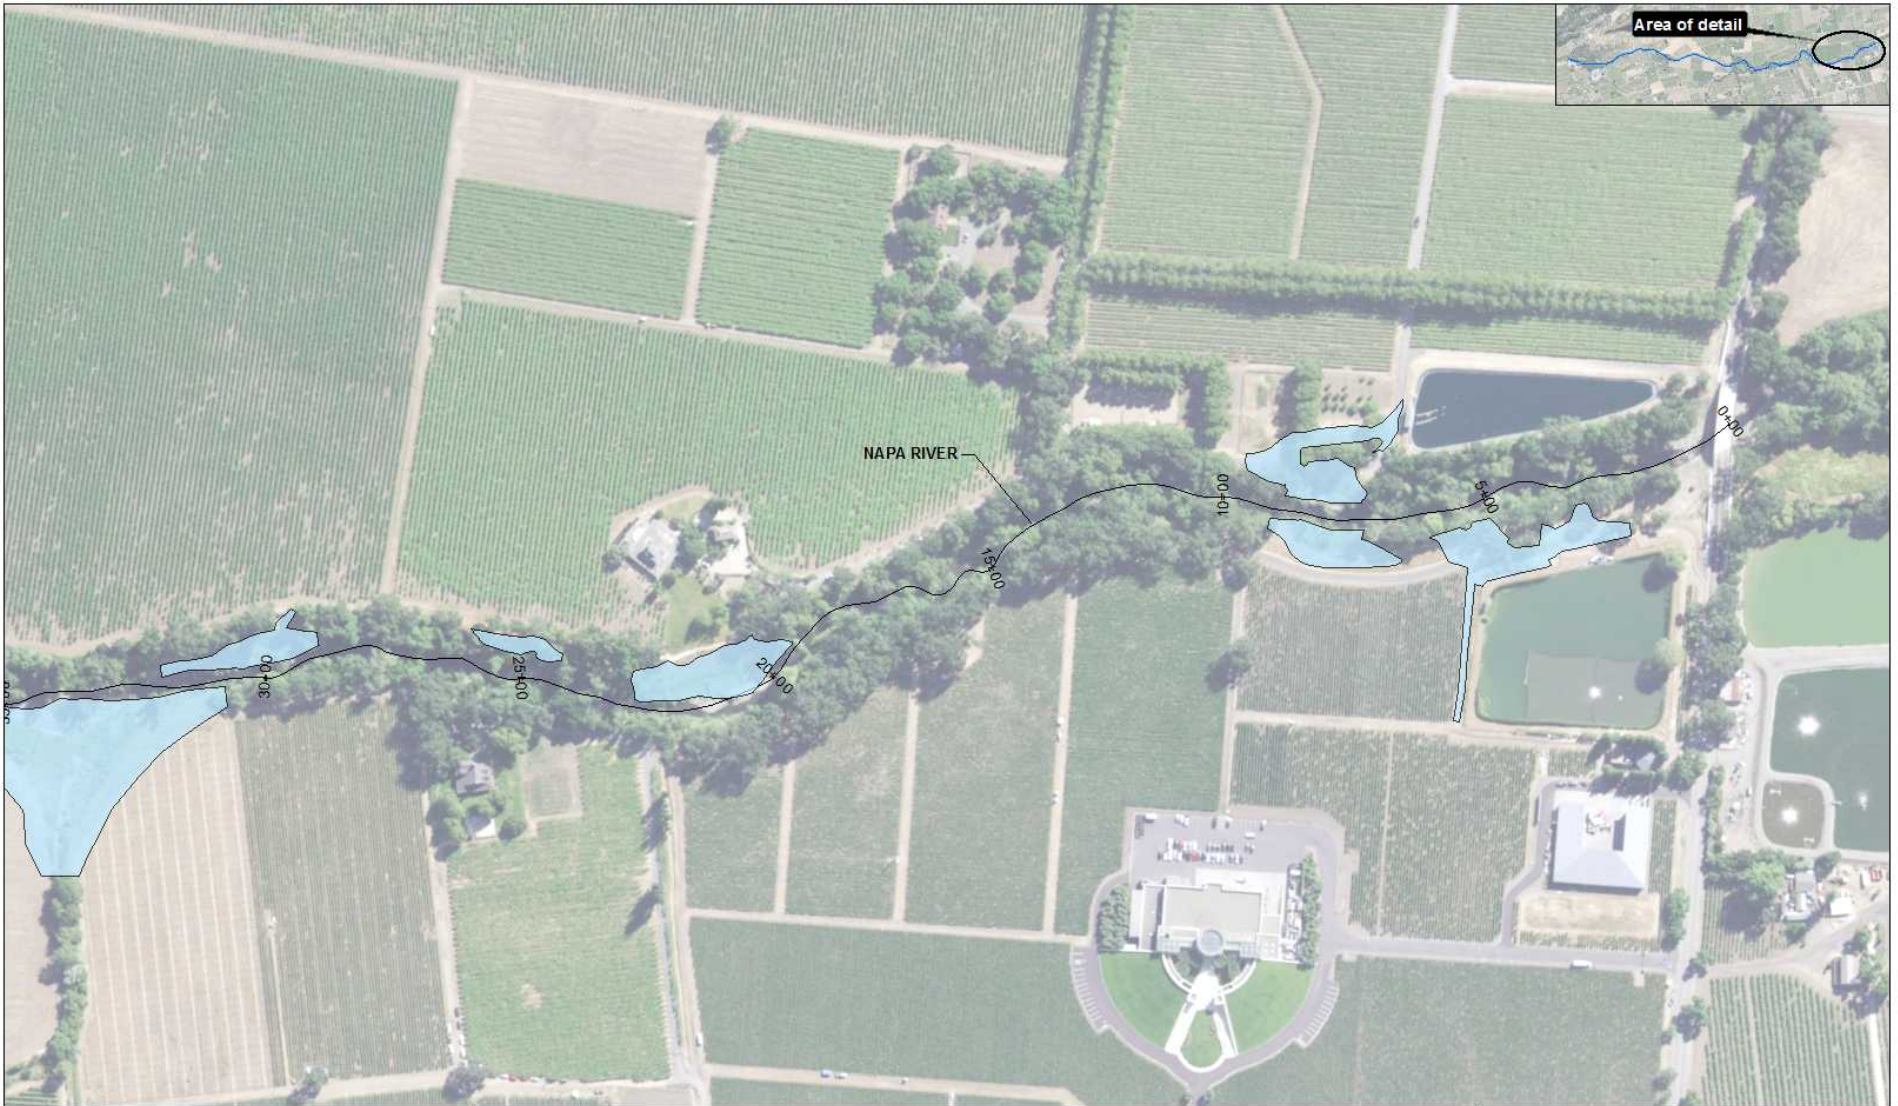
Napa River Rutherford Restoration Project Reach 8  
Eroding Stream Bank Survey

- Stream Bank Erosion
- Constructed Features

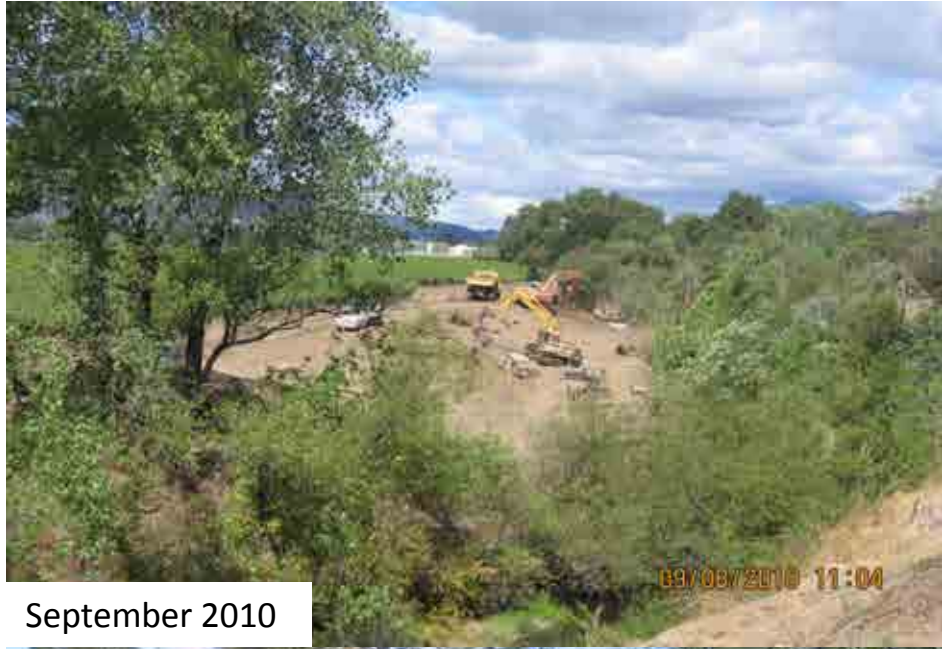
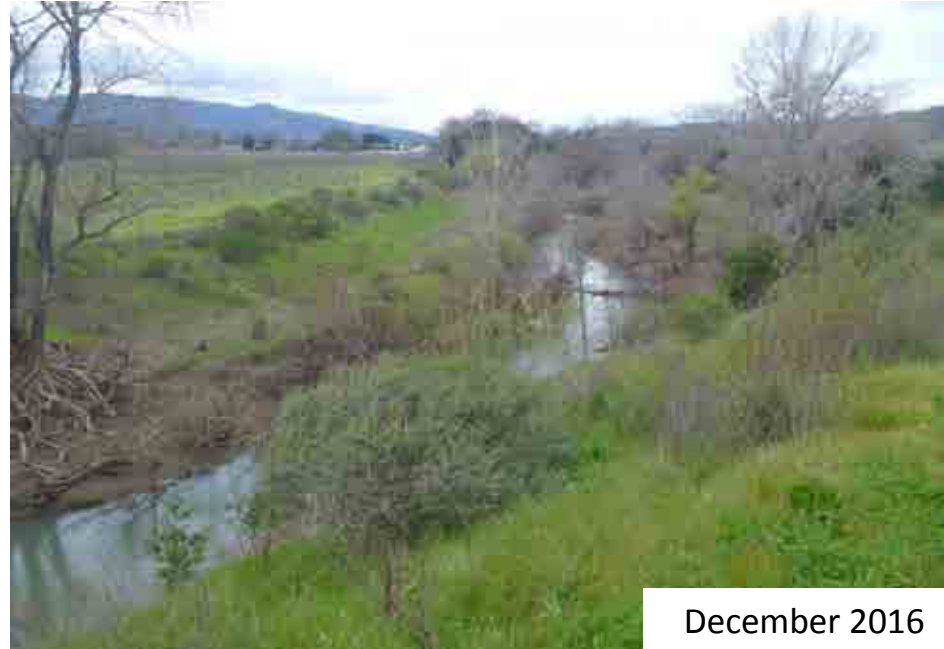
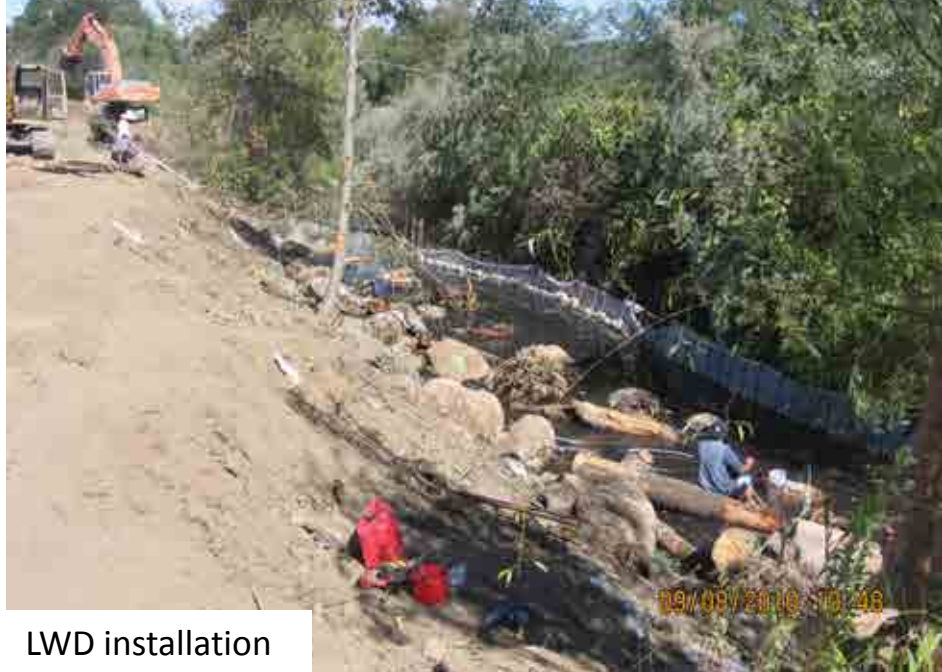
River Station 191+00  
Frog's Leap Bench from Quintessa Road, East Bank

LWD installation

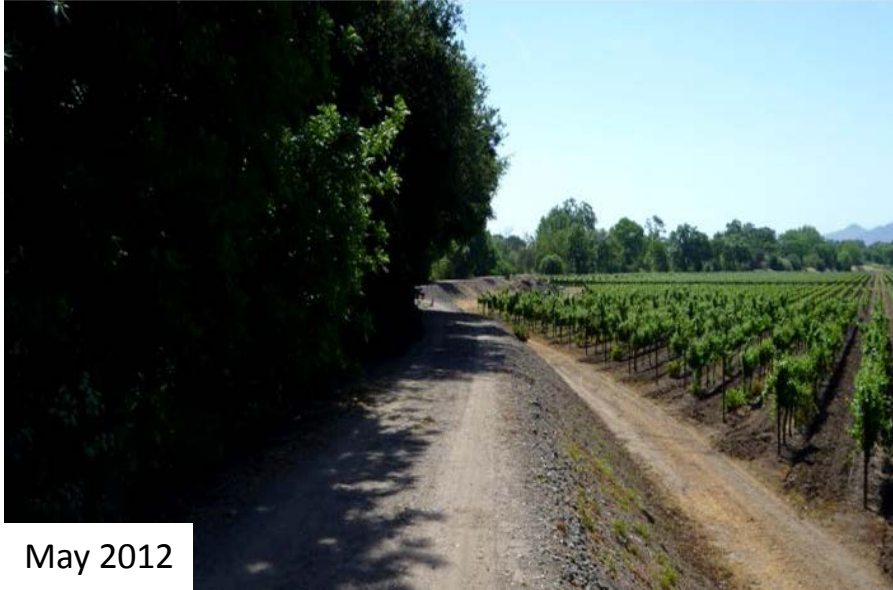
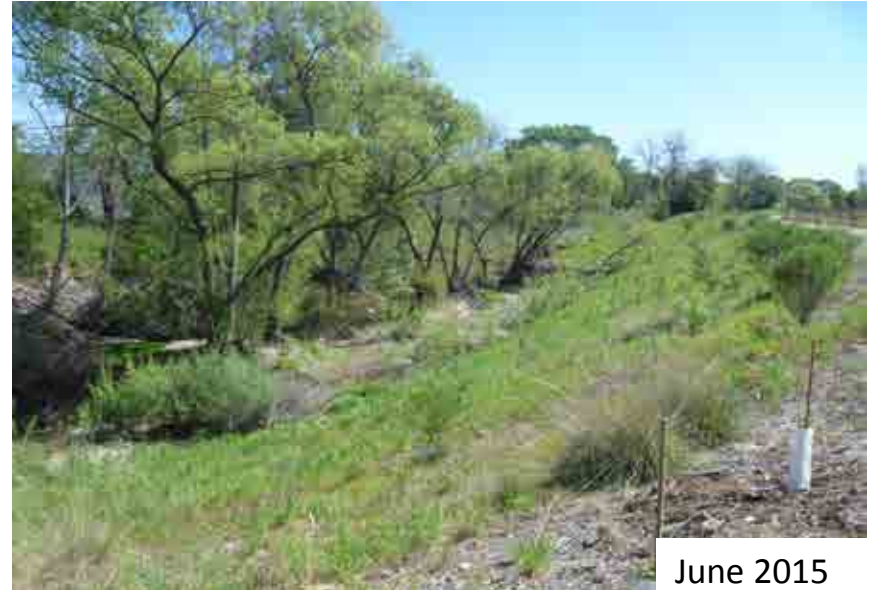
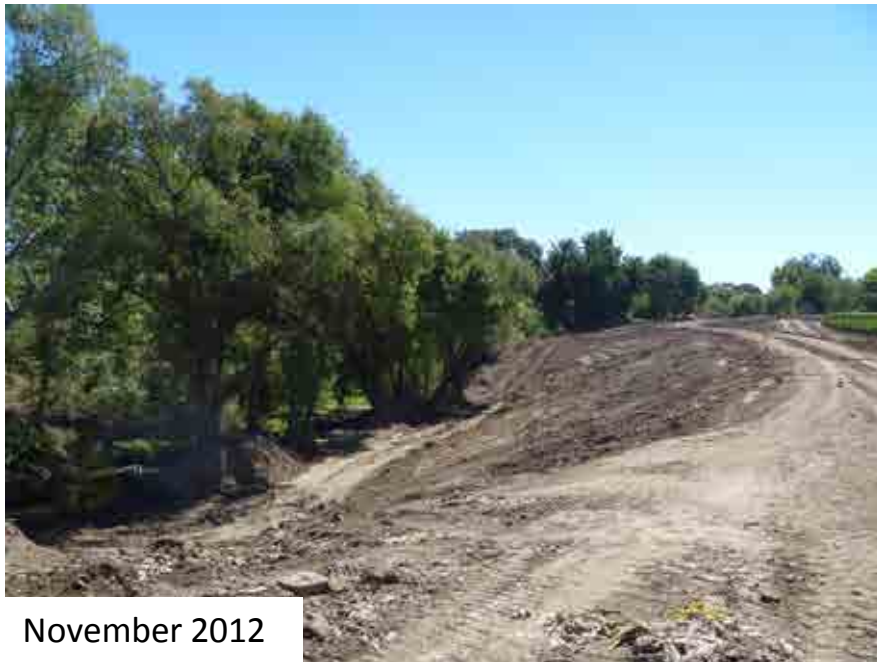
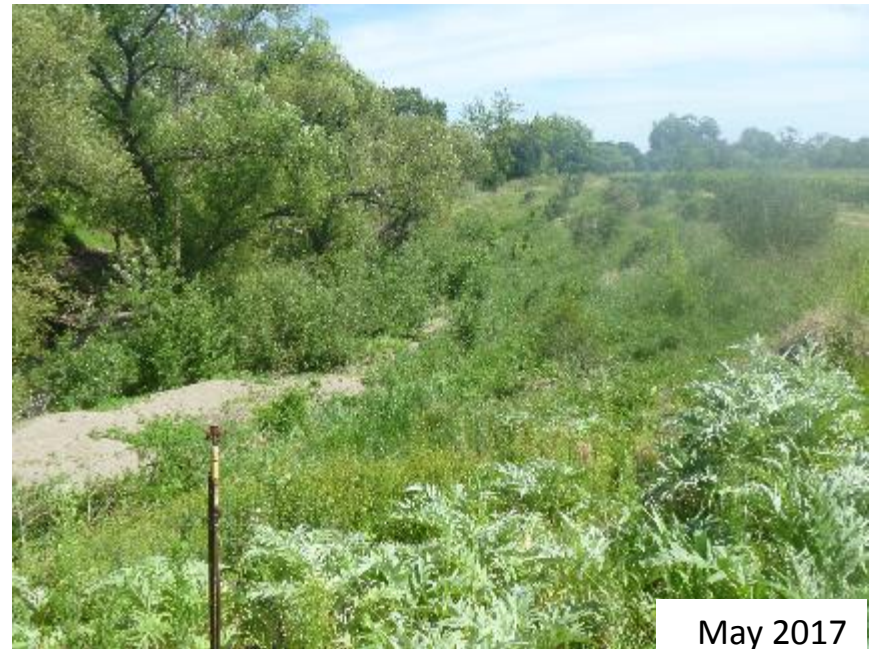
River Station 161+10  
Bench 6: Emmolo, West Bank

May 2012

June 2015

November 2012

May 2017

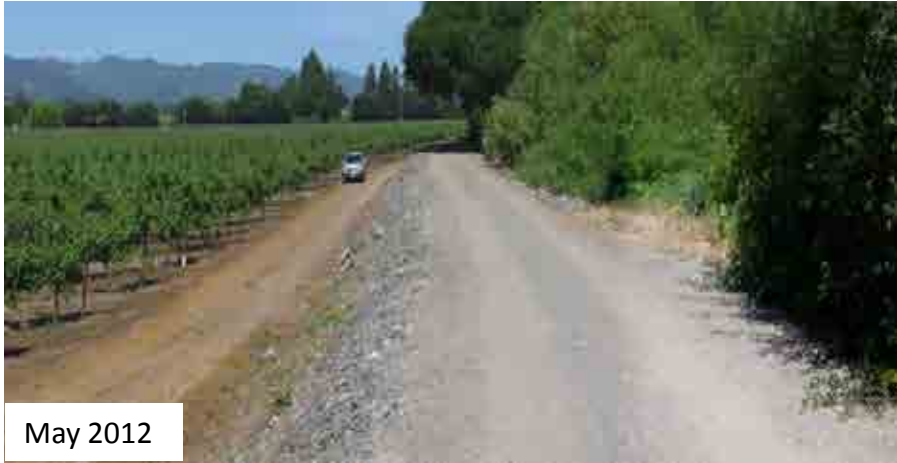
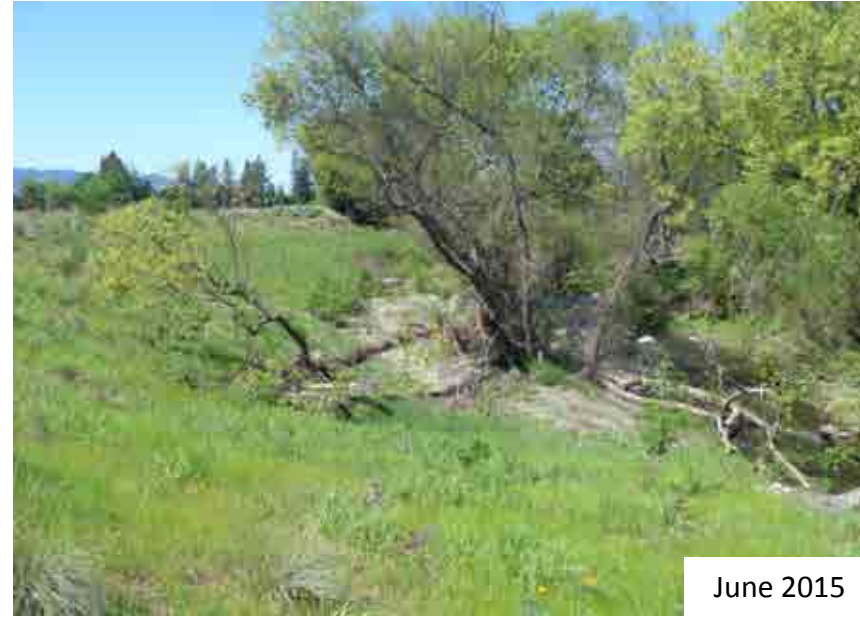
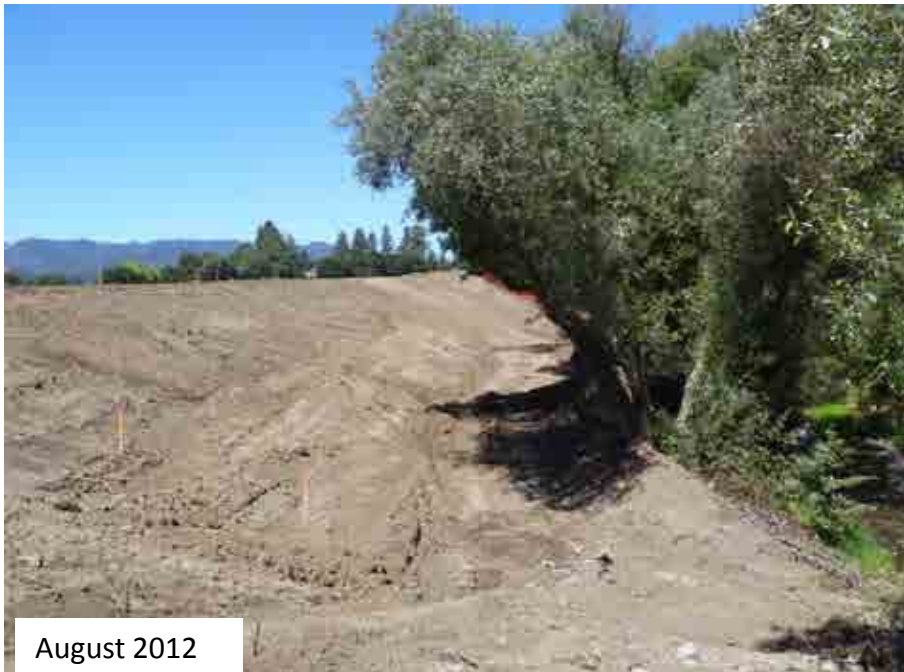
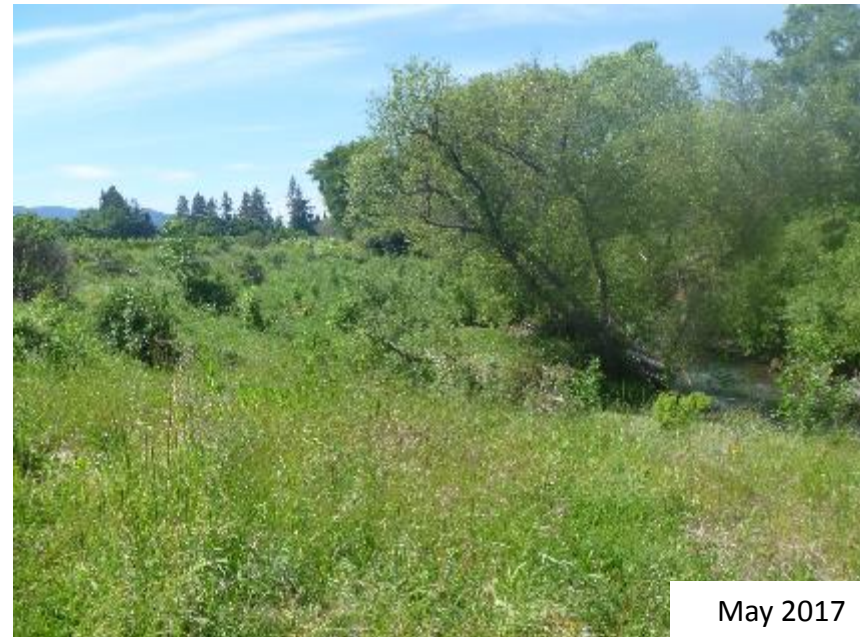
River Station 157+60  
Bench 6: Emmolo, West Bank to Upstream

May 2012

June 2015

August 2012

May 2017

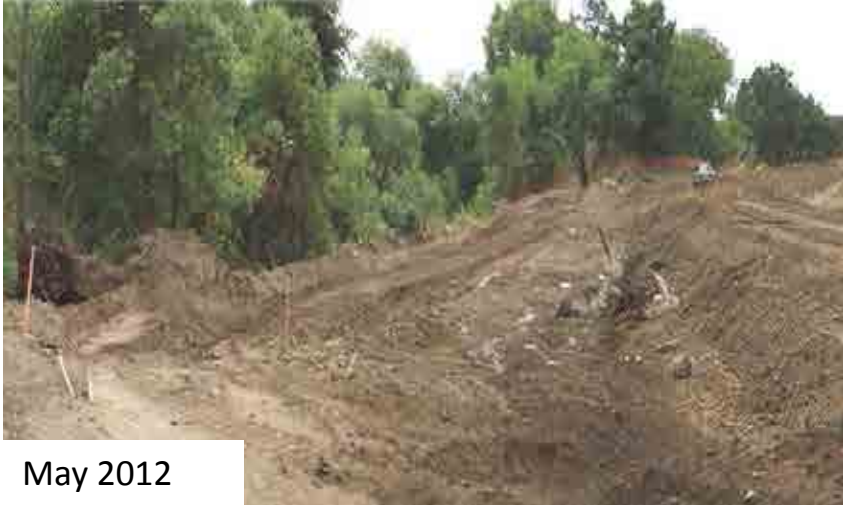
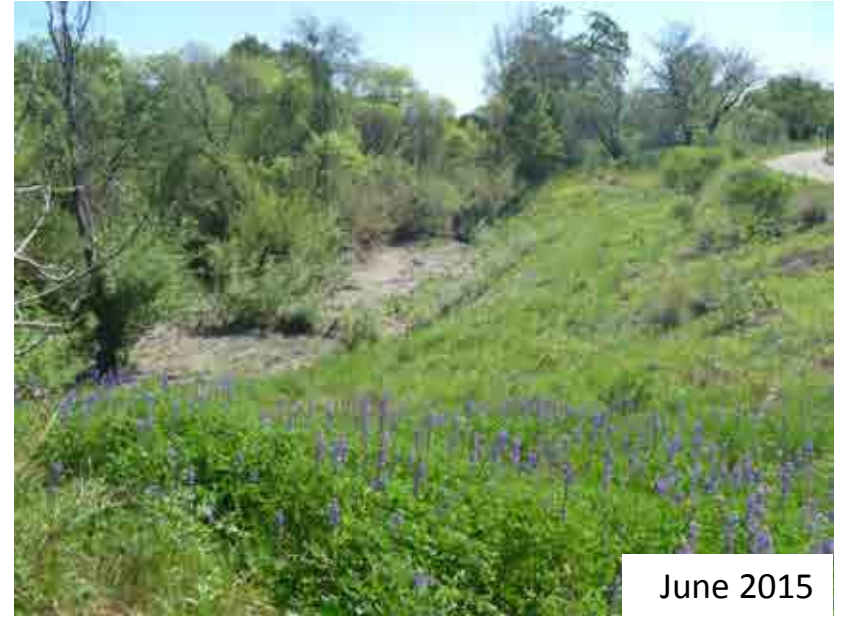
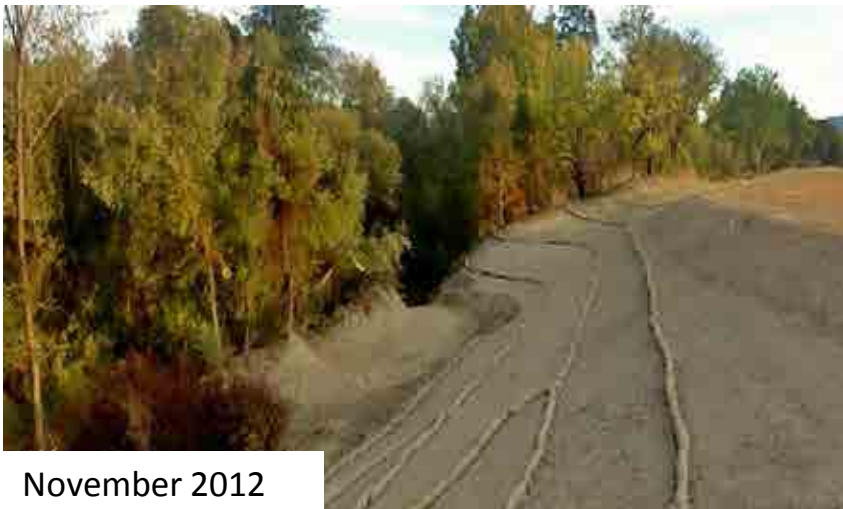
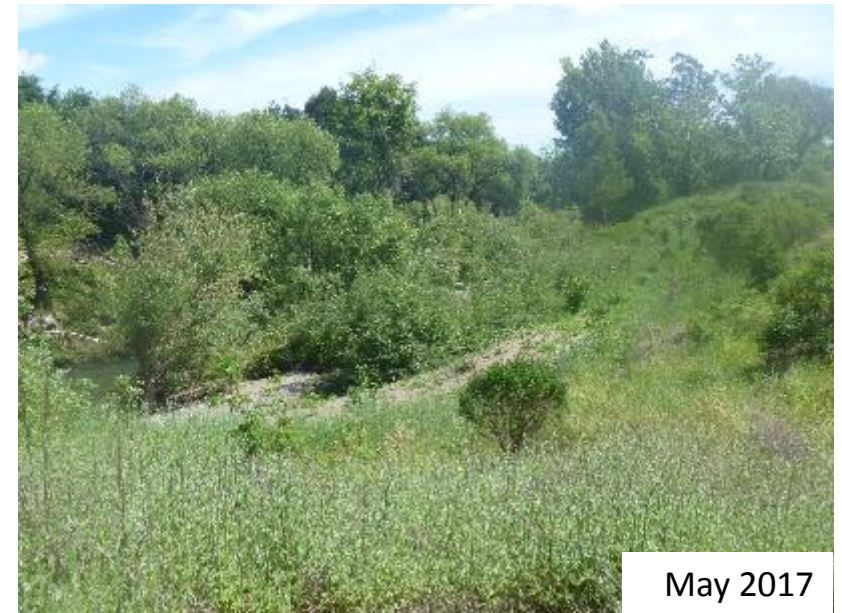
River Station 152+90  
Bench 8: Emmolo, West Bank to Downstream

May 2012

June 2015

November 2012

May 2017

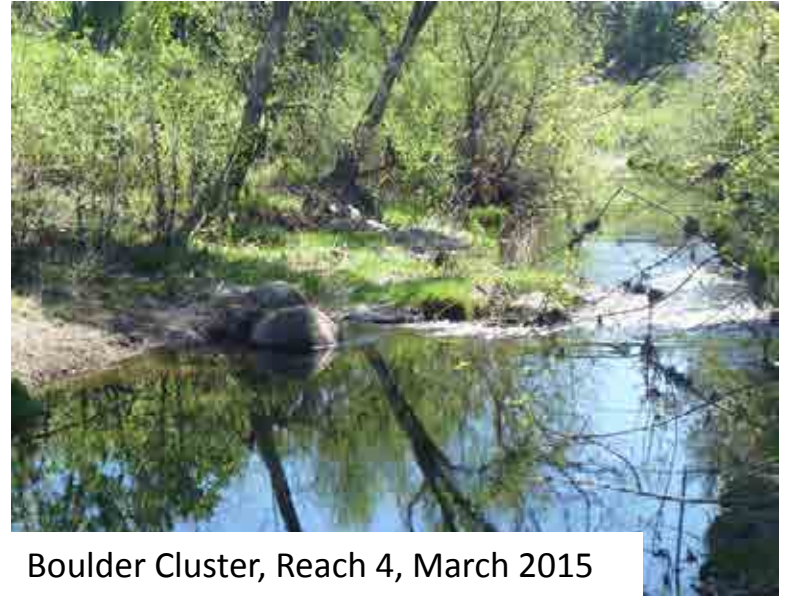
Boulder Cluster, Reach 4, March 2015

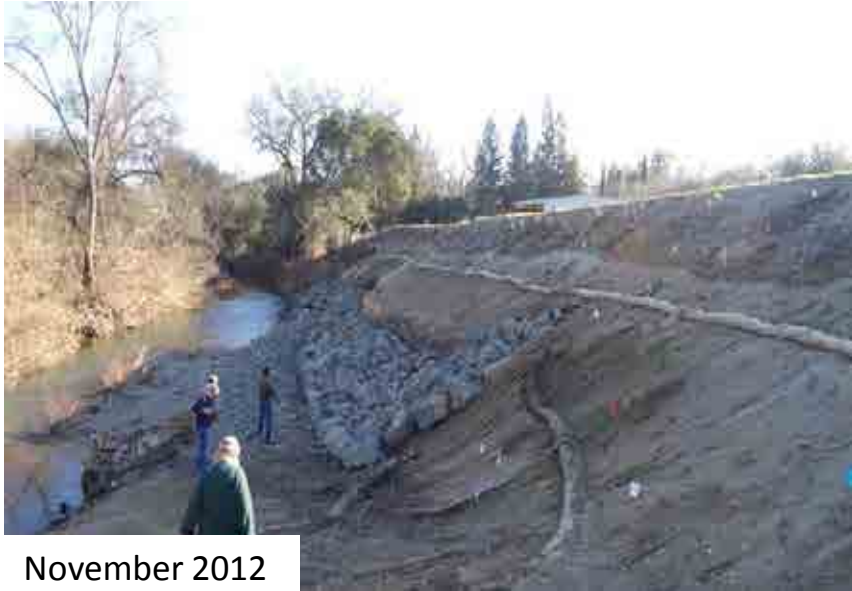
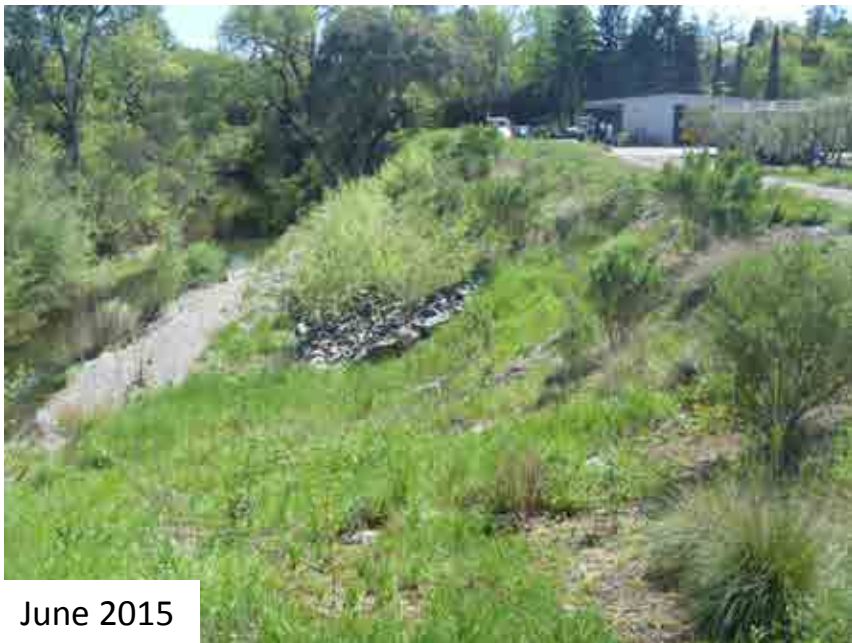
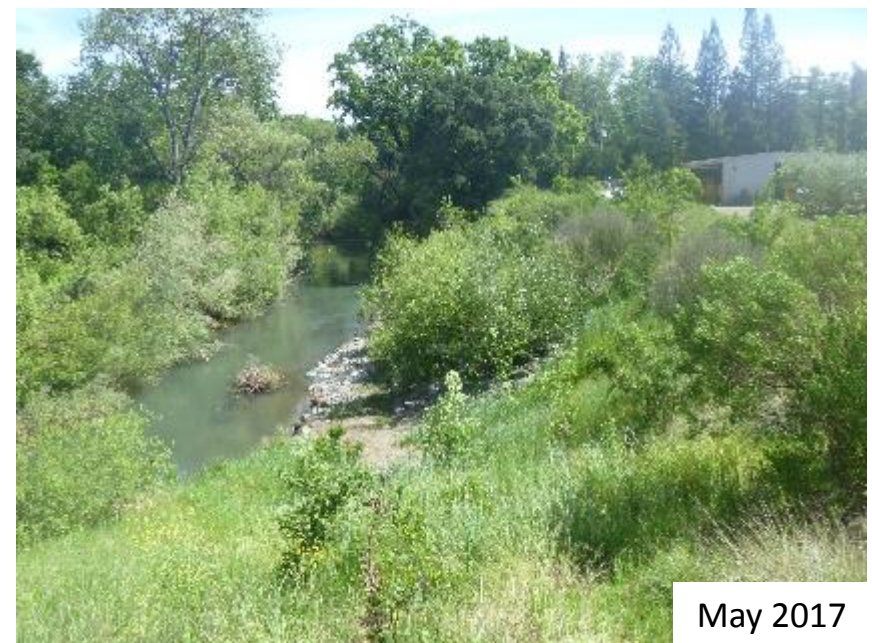
River Station 127+80  
Bank Stabilization 3: Round Pond West Bank Looking Downstream

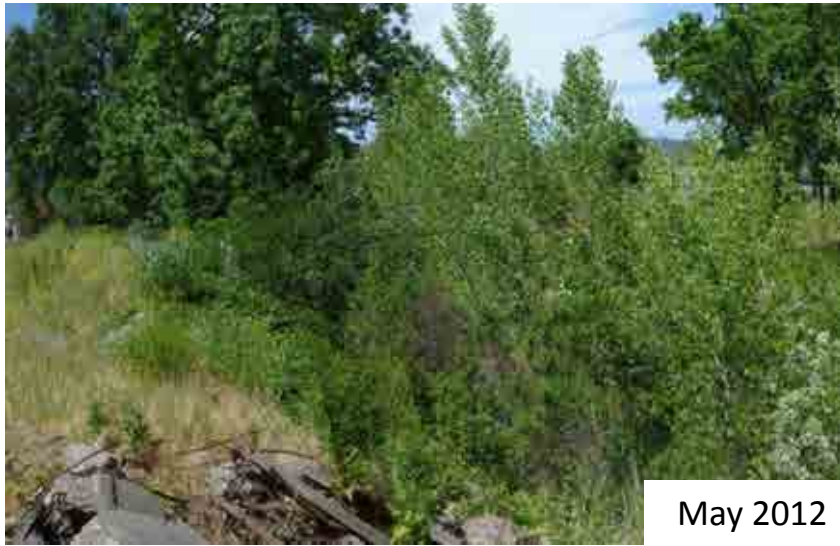
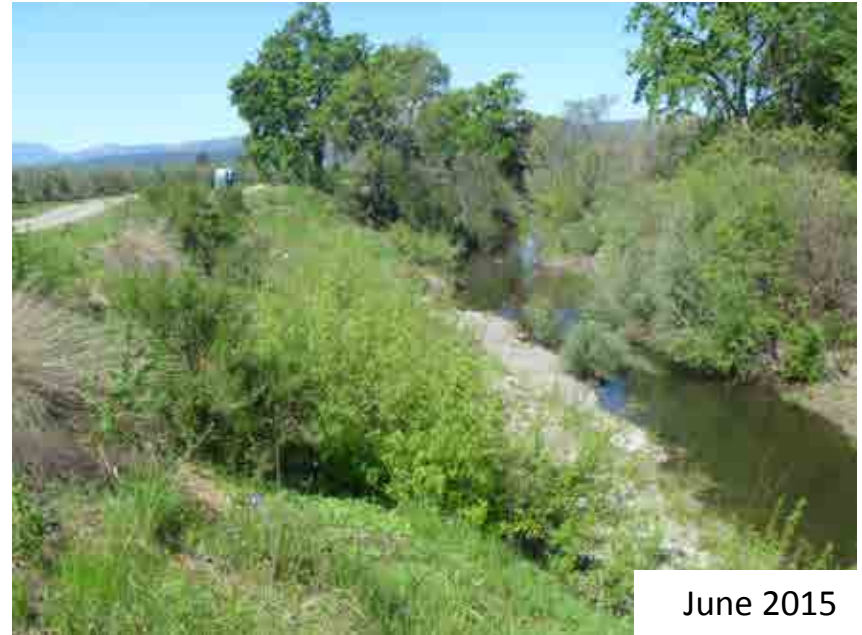
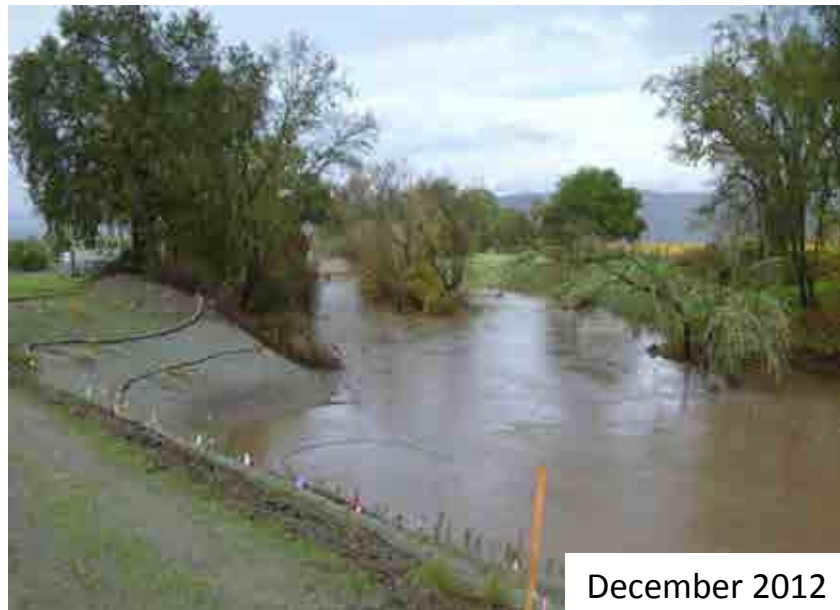
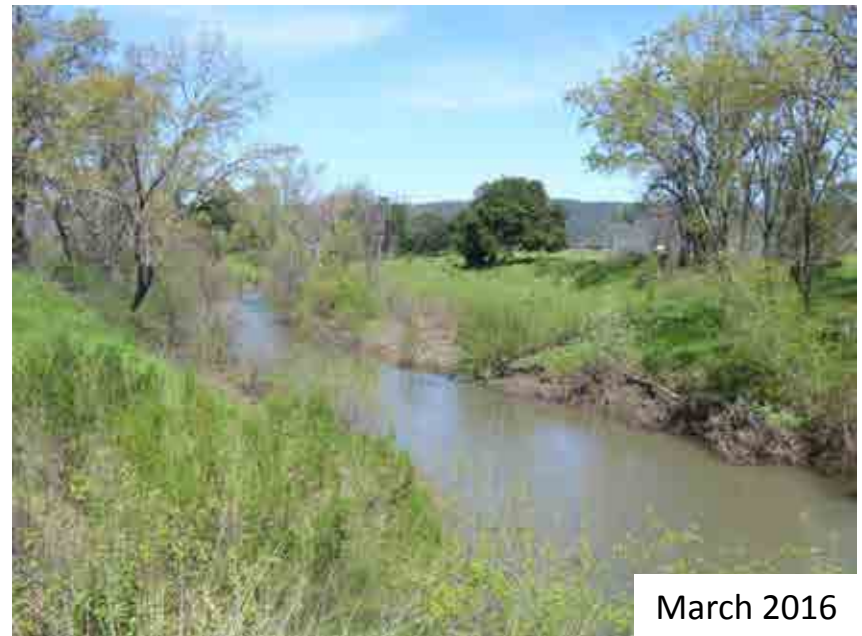
River Station 126+00  
Bank Stabilization 3: Round Pond West, West Bank to Upstream
