# NAPA RIVER RUTHERFORD REACH RESTORATION PROJECT ANNUAL MONITORING REPORT - 2017

Napa County Flood Control and Water Conservation District  
804 First Street  
Napa, California, 94559  
Contact: Jeremy Sarrow  
(707) 259-8204

Napa County Resource Conservation District  
1303 Jefferson Street, Suite 500 B  
Napa, California, 94558  
Contact: Paul Blank/Jonathan Koehler  
(707) 252-4189

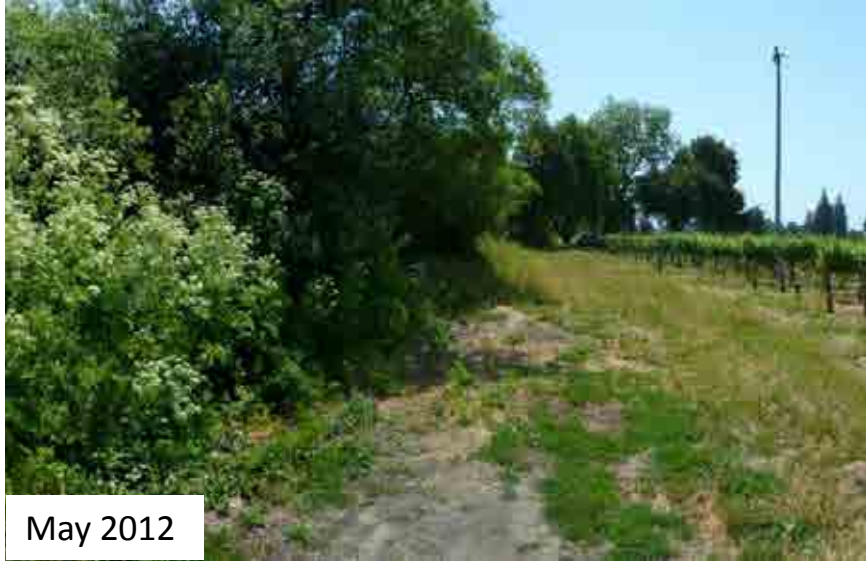
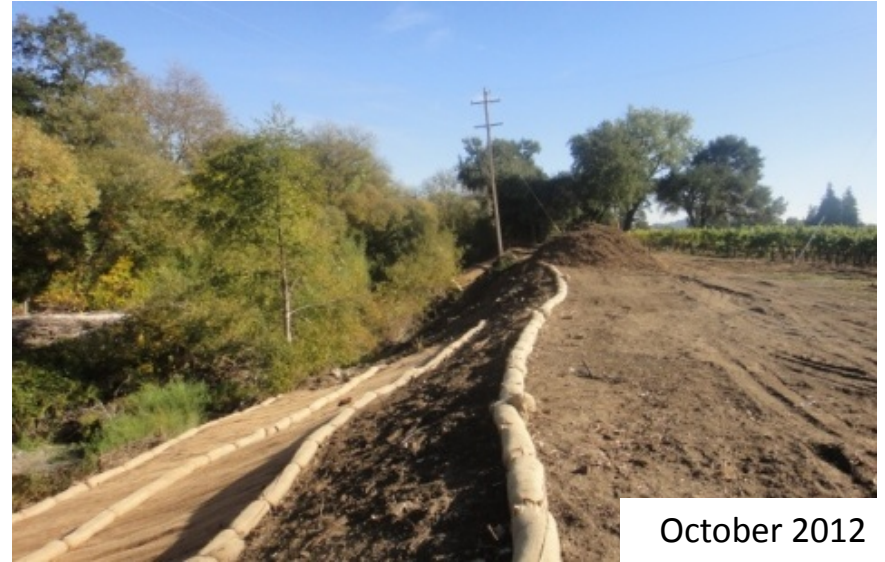
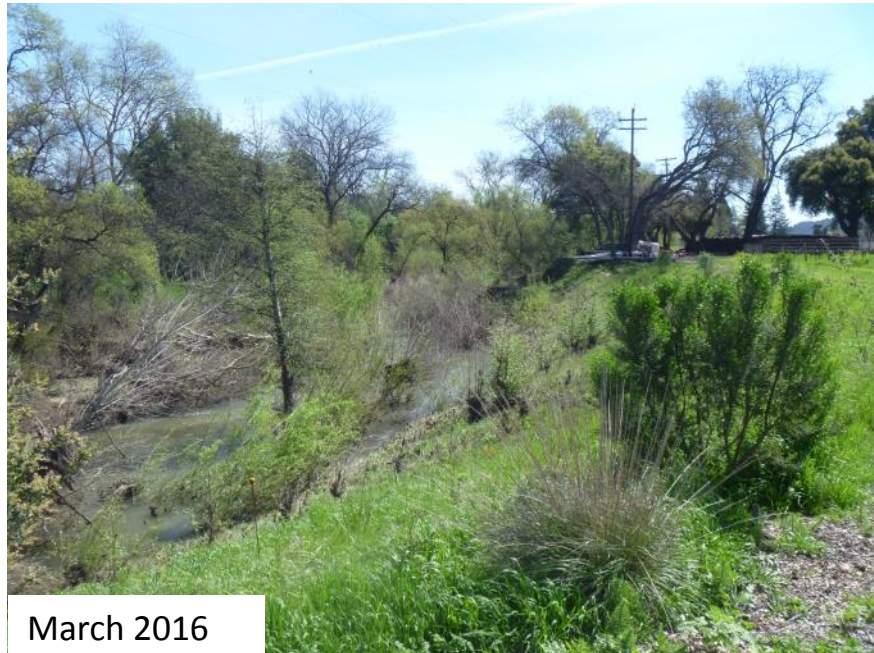
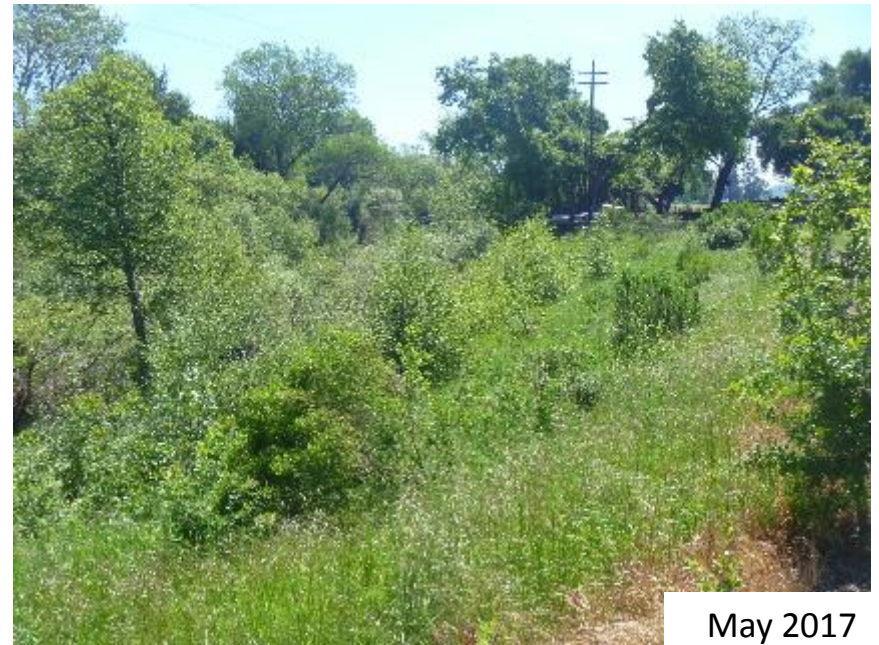
Station 73+30  
Reach 8 North, West Bank, Foley Johnson (Sawyer) West Bank

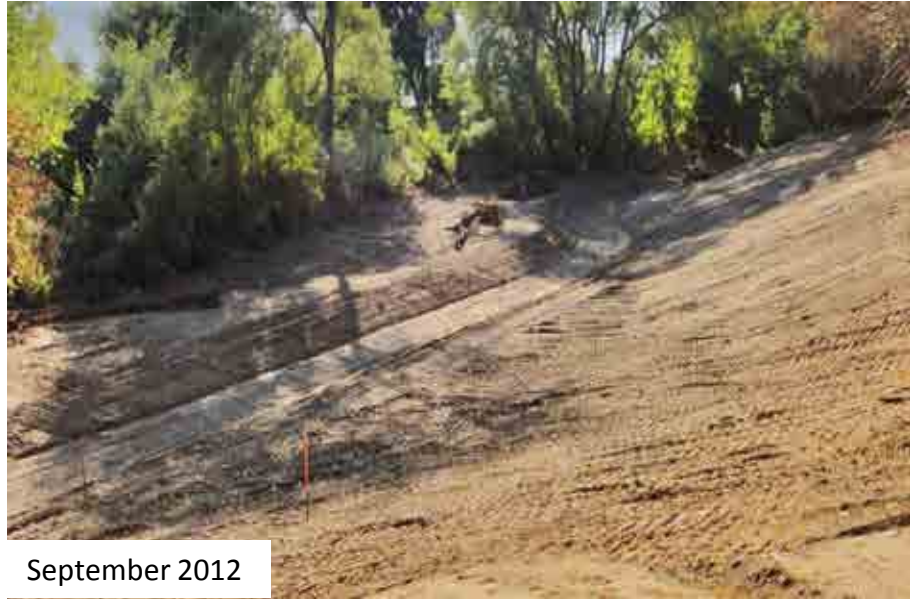
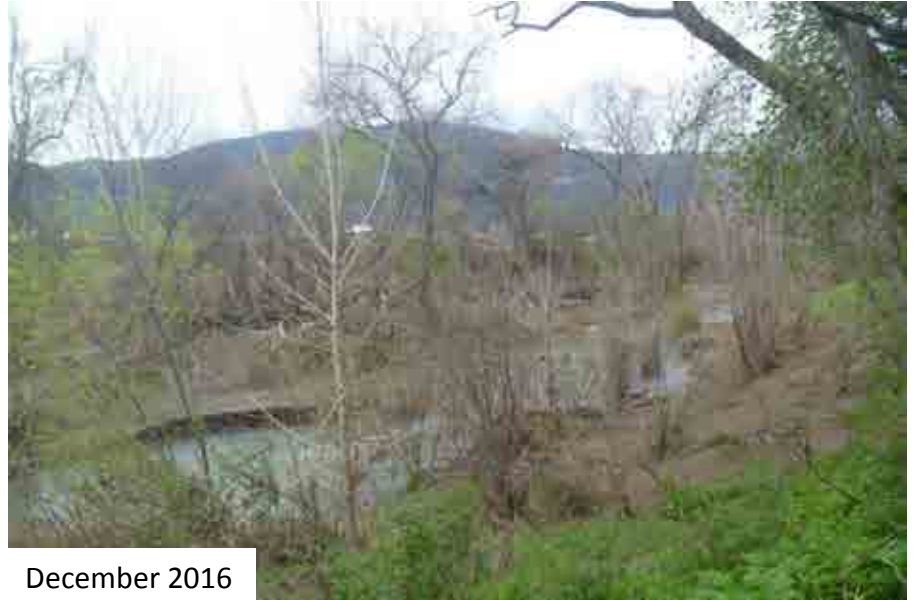
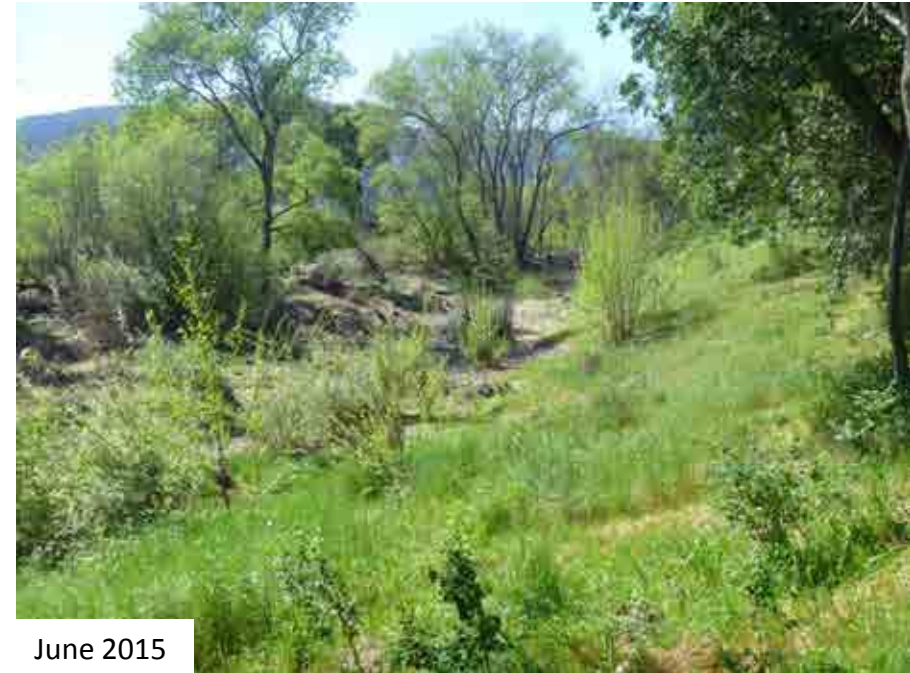
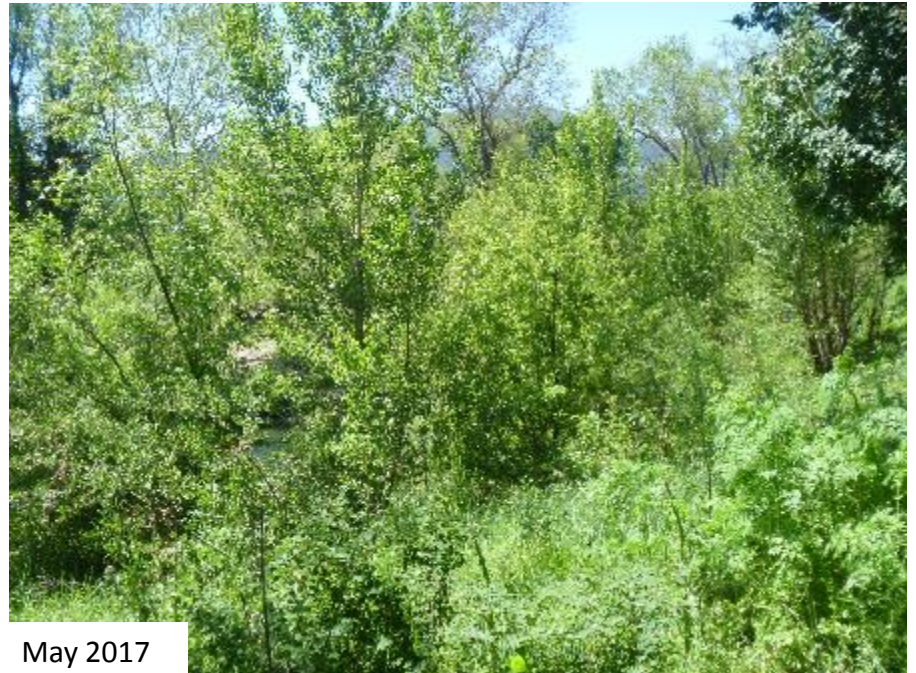
River Station 65+50  
Bench 1: Wilsey, Secondary Channel Looking Upstream

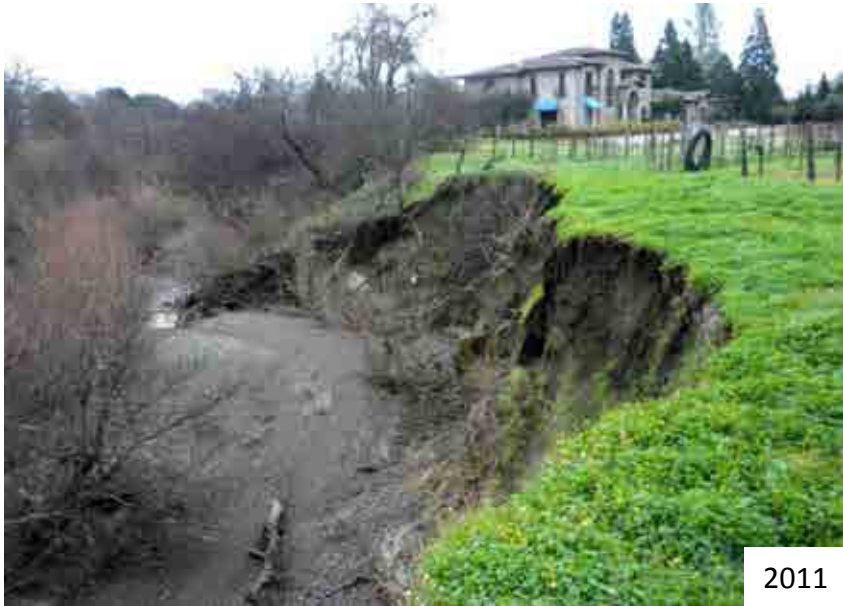
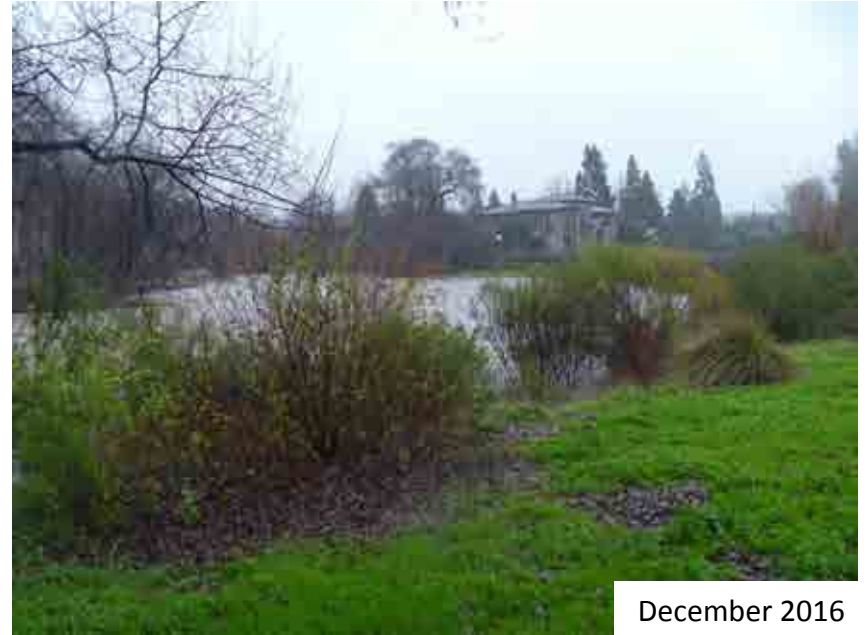
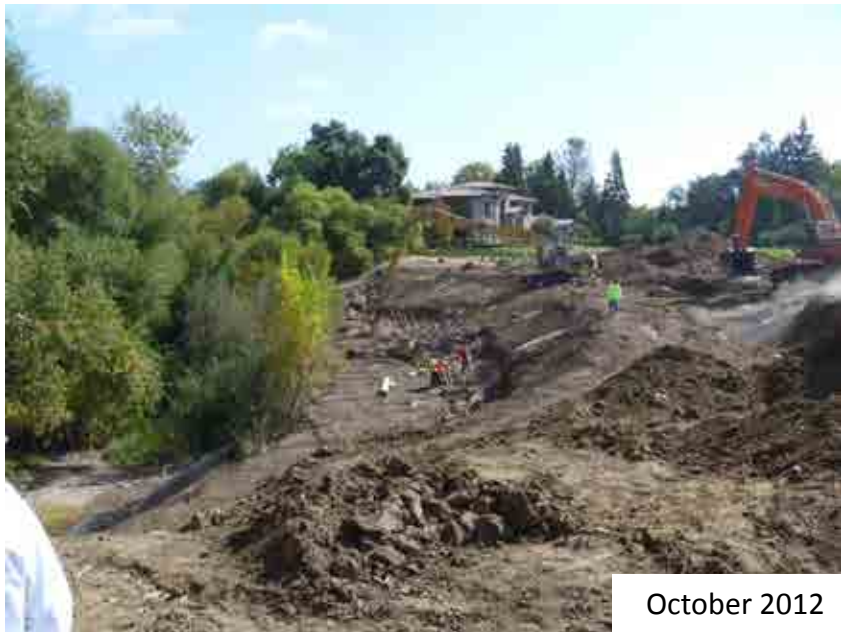
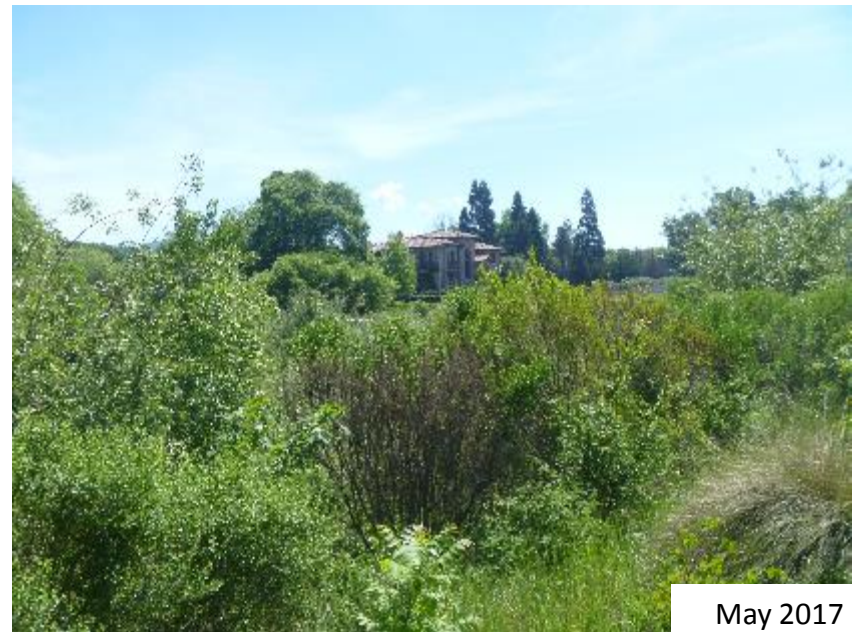
River Station 66+30  
Bank Stabilization 2: Sequoia Grove, West Bank

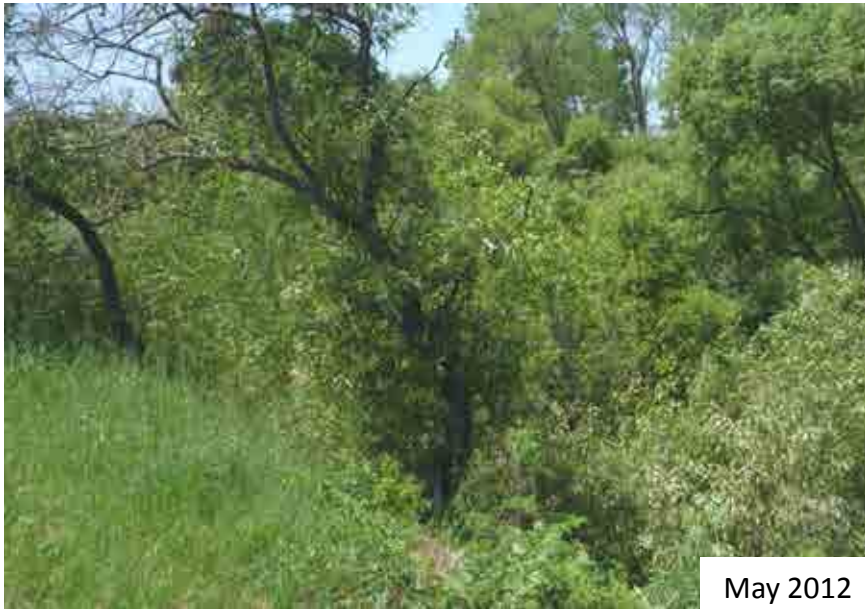
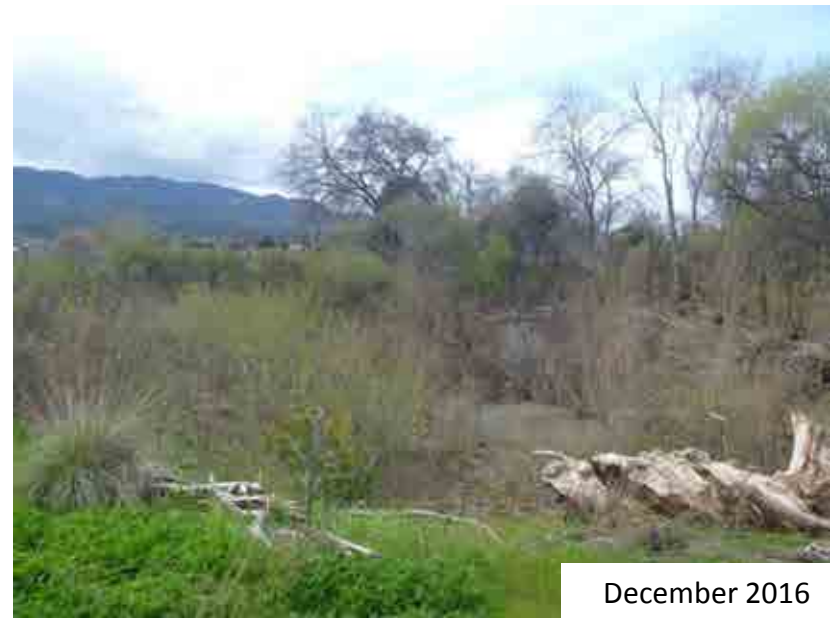
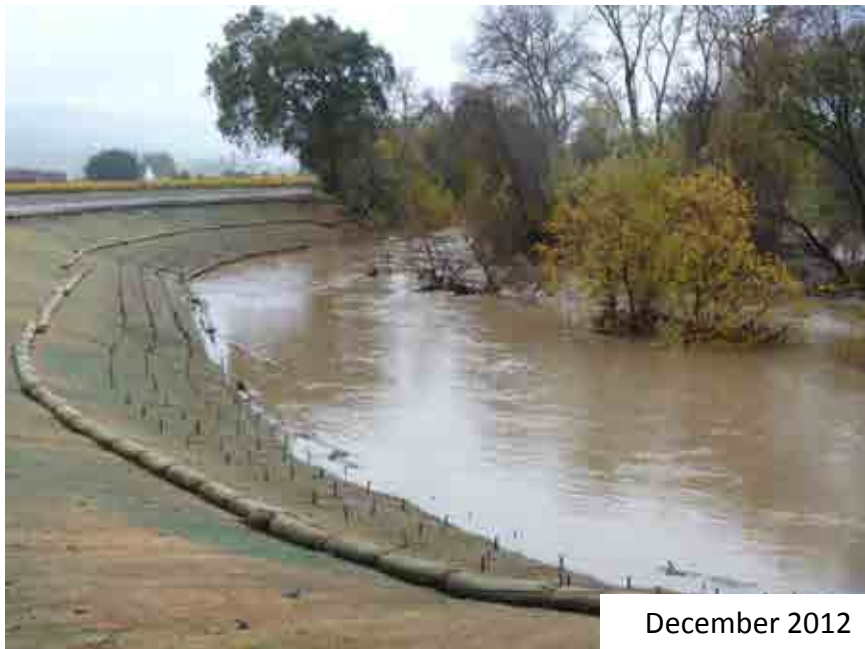
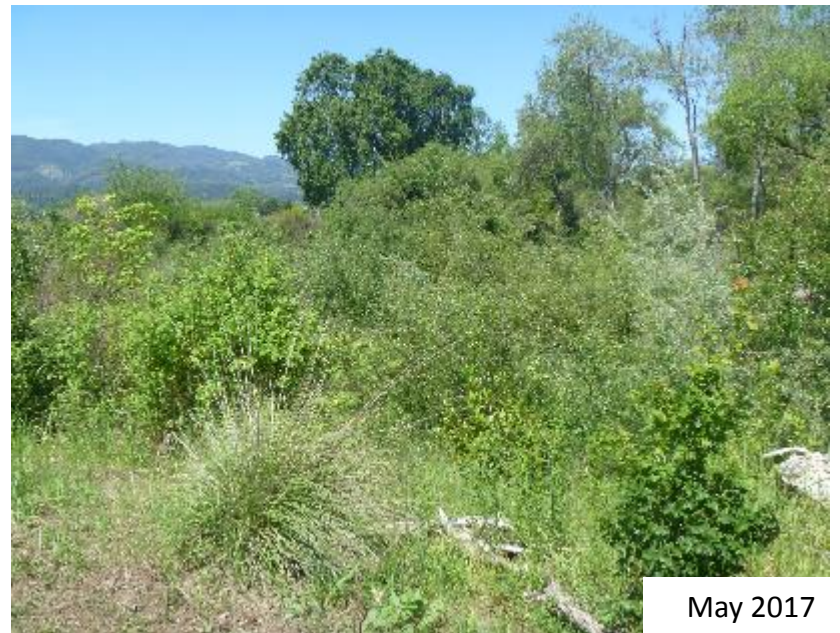
River Station 66+30  
Bank Stabilization 2: Sequoia Grove, West Bank to Upstream

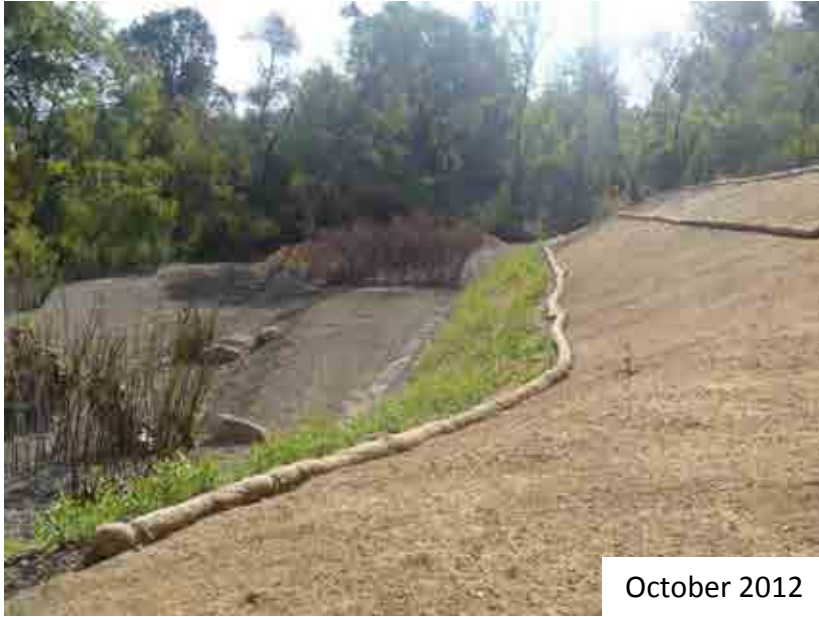
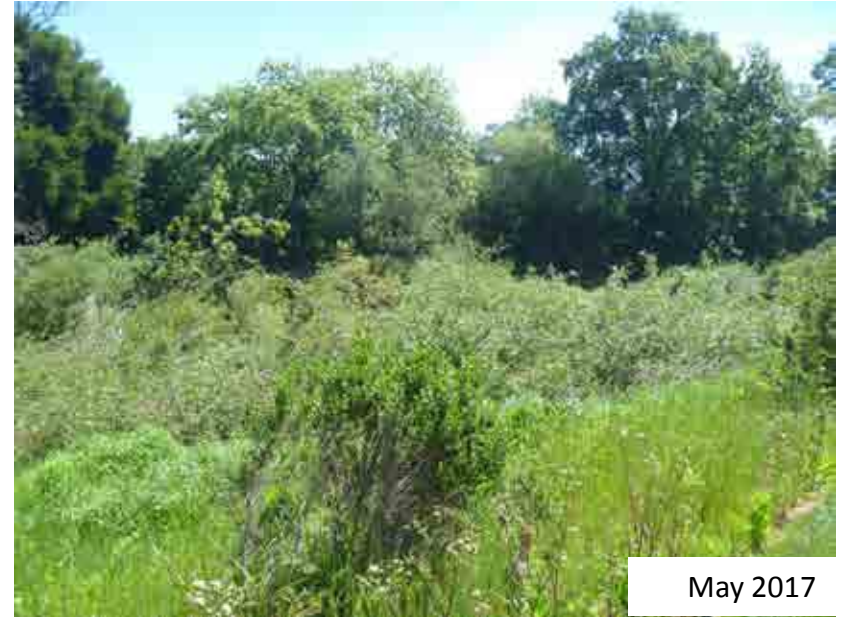
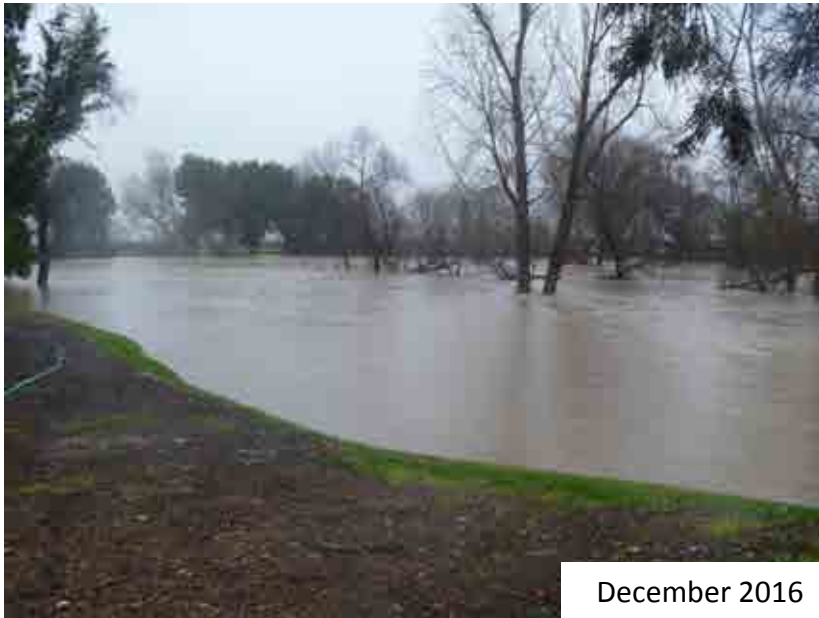
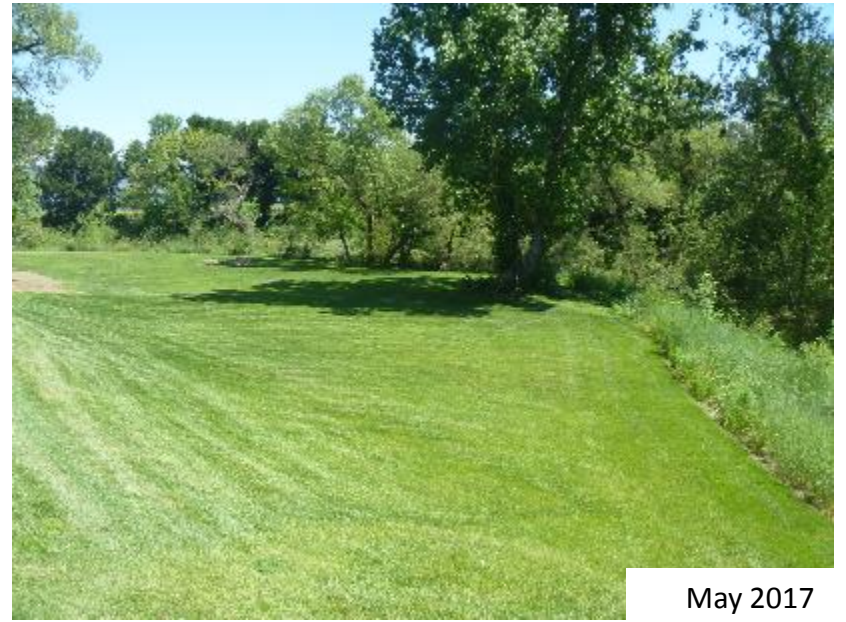
River Station 61 +00  
Reach 8 South, Bench 1: Upstream to Downstream

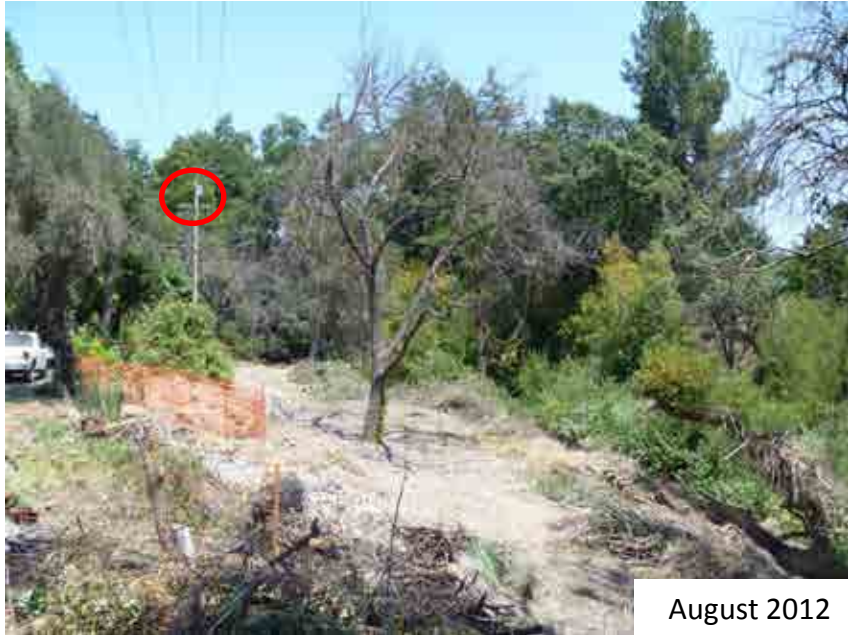
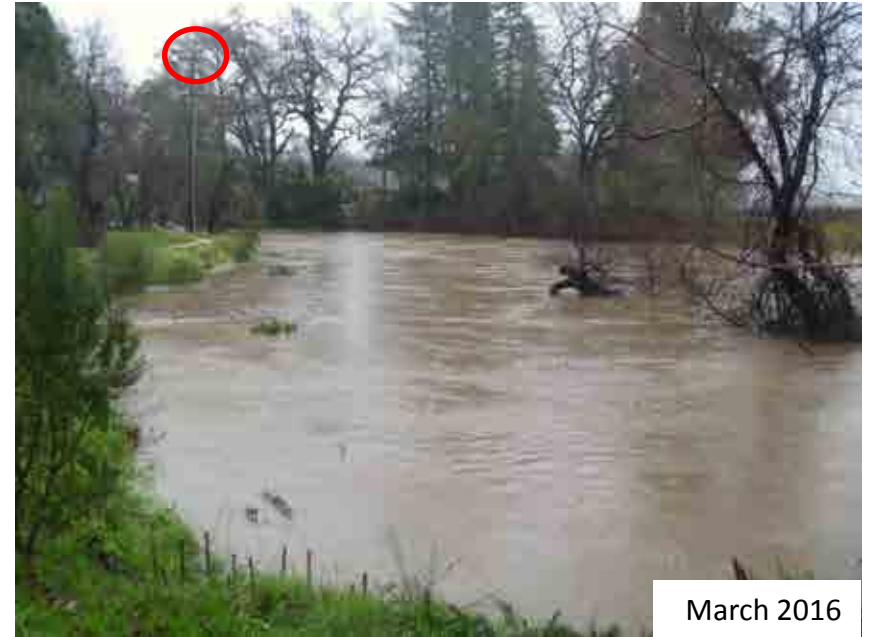
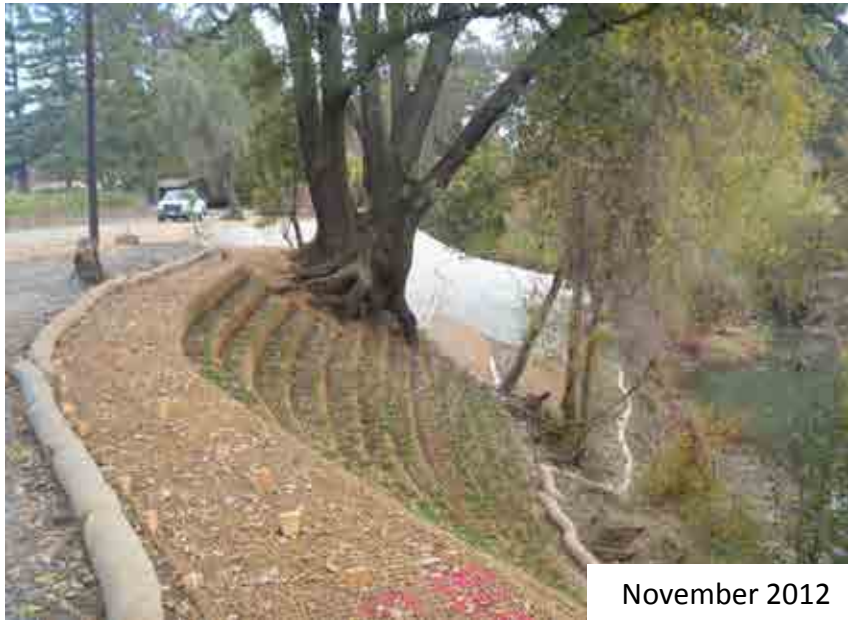
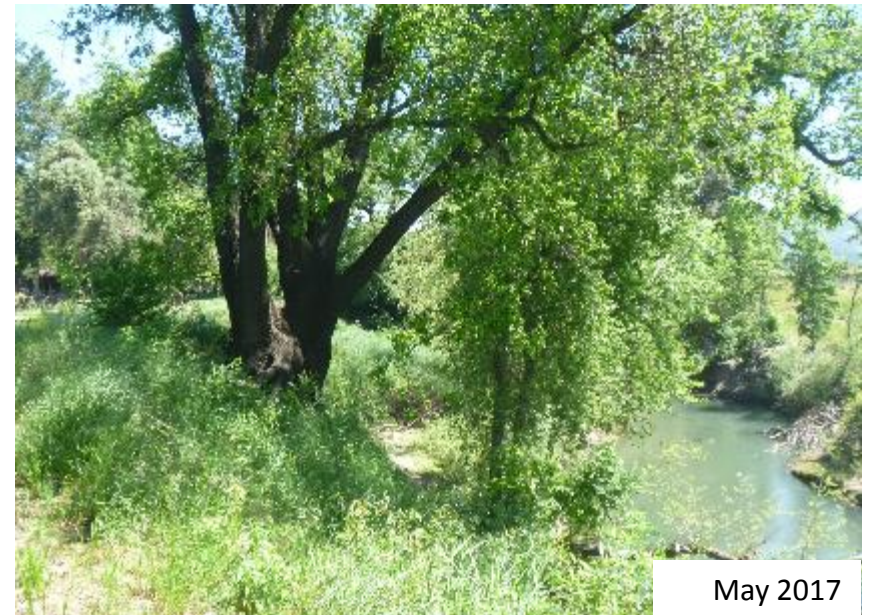
River Station 53+00  
Reach 8 South, Bank Stabilization 1: Downstream to Upstream

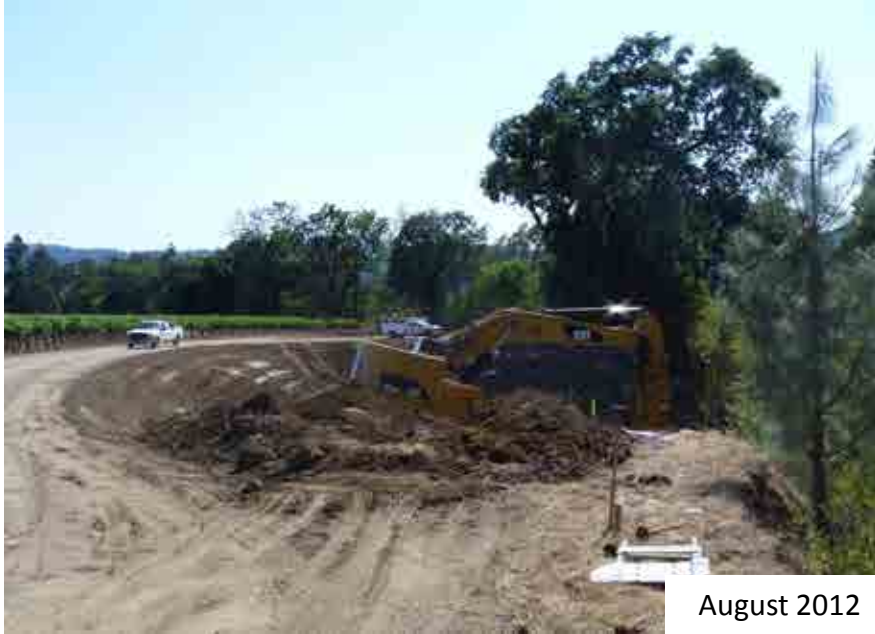
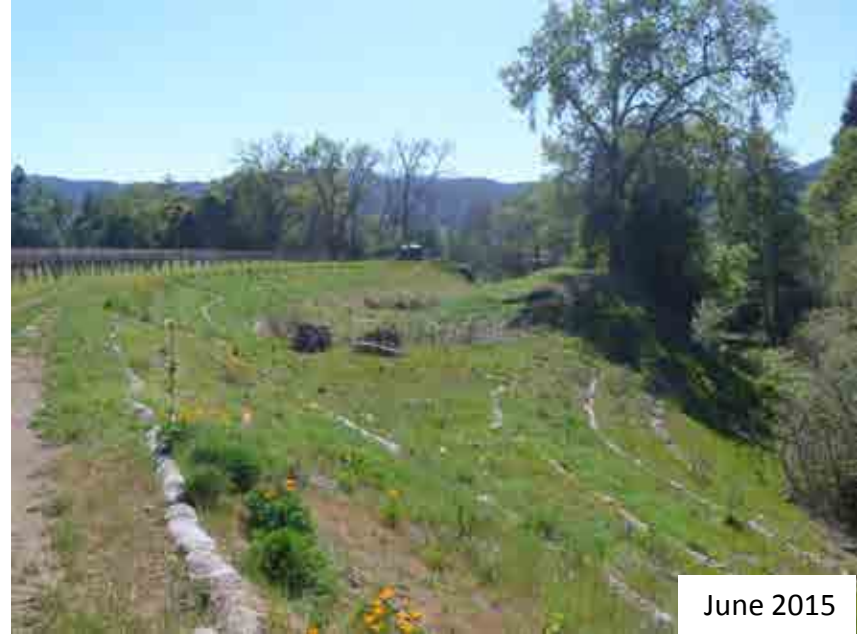
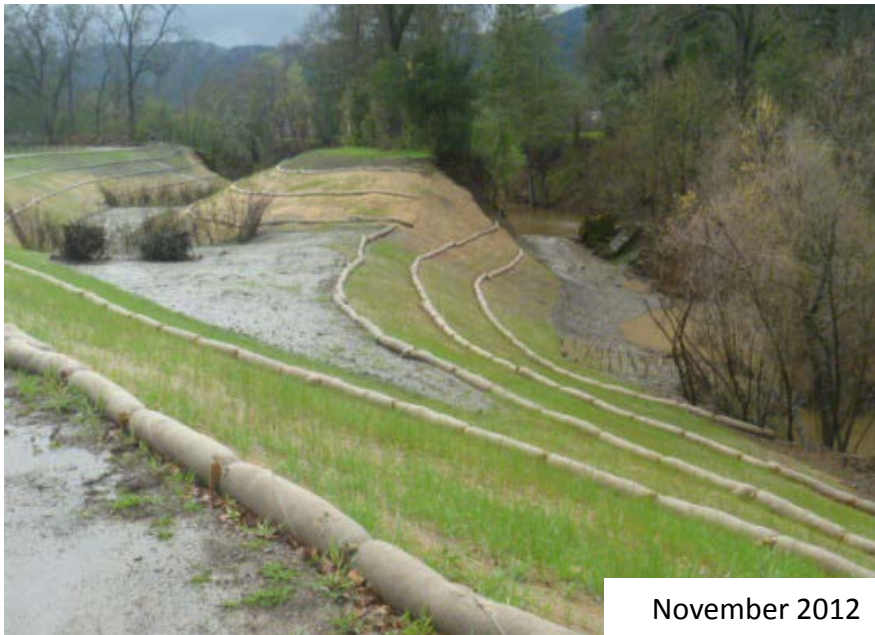
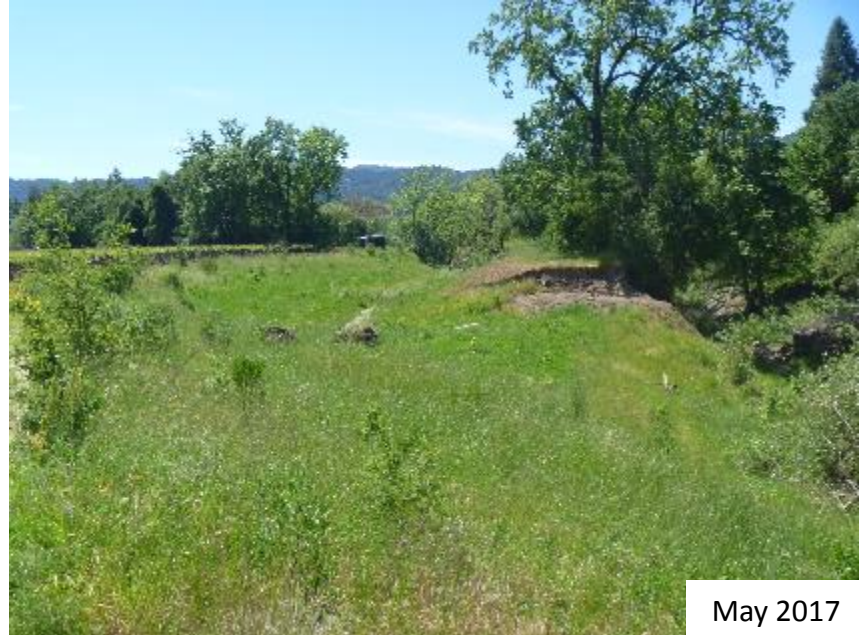
River Station 53+00  
Reach 8 South, Bench 2: Upstream to Downstream

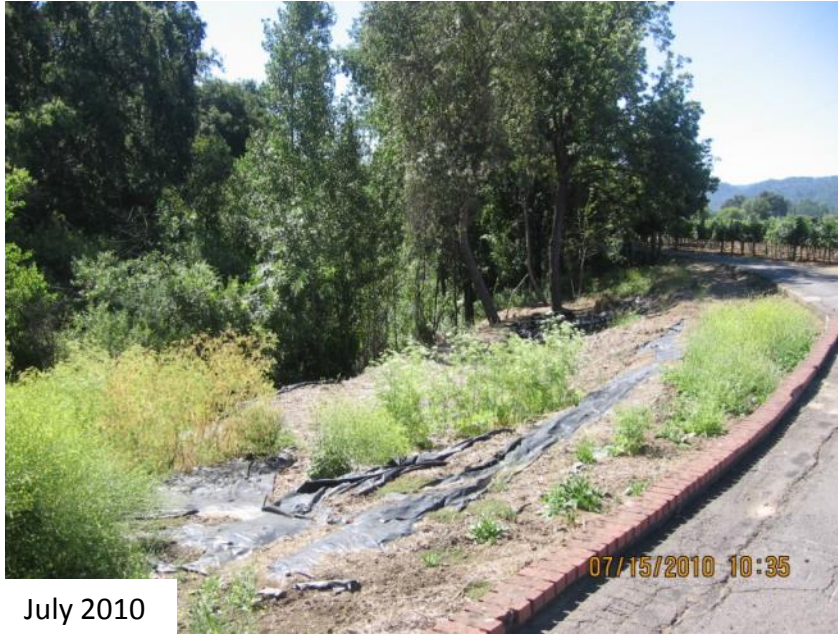
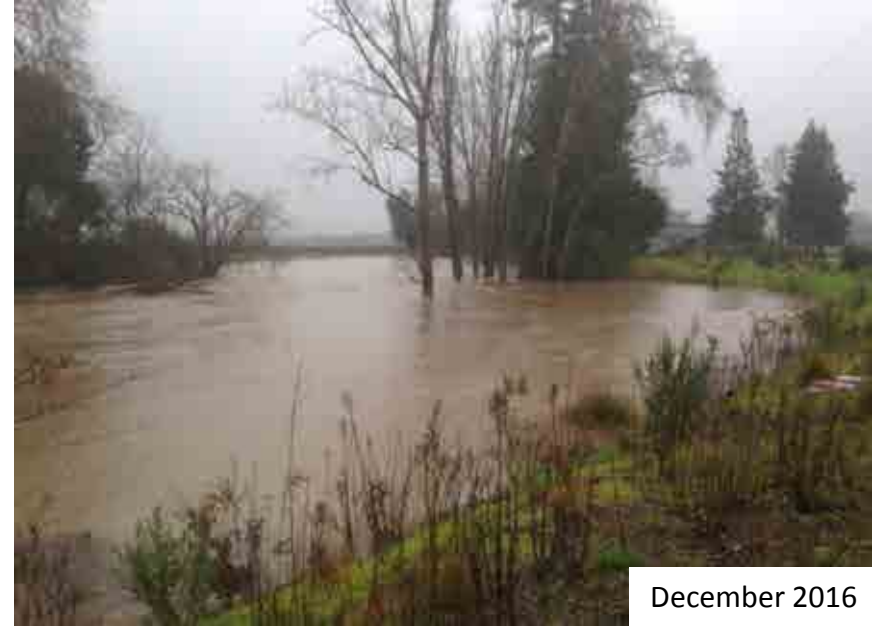
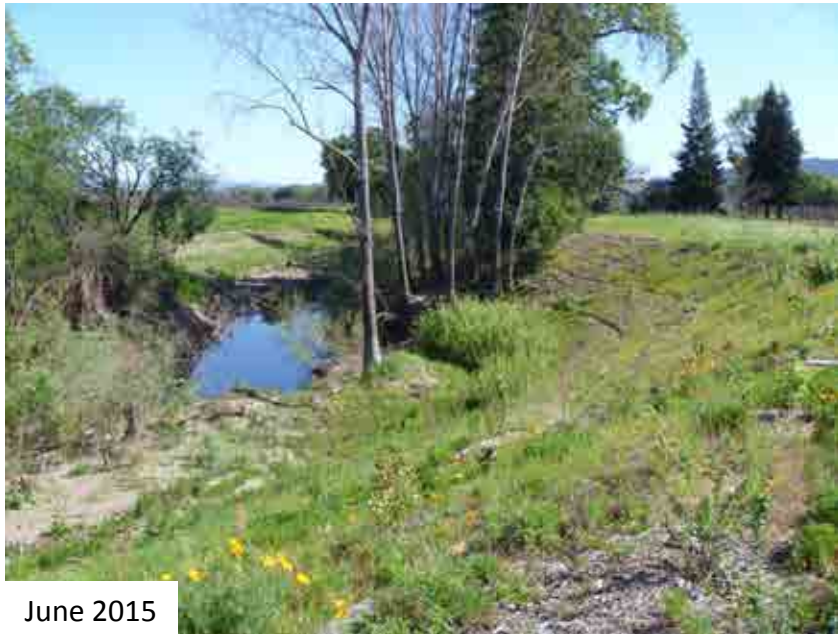
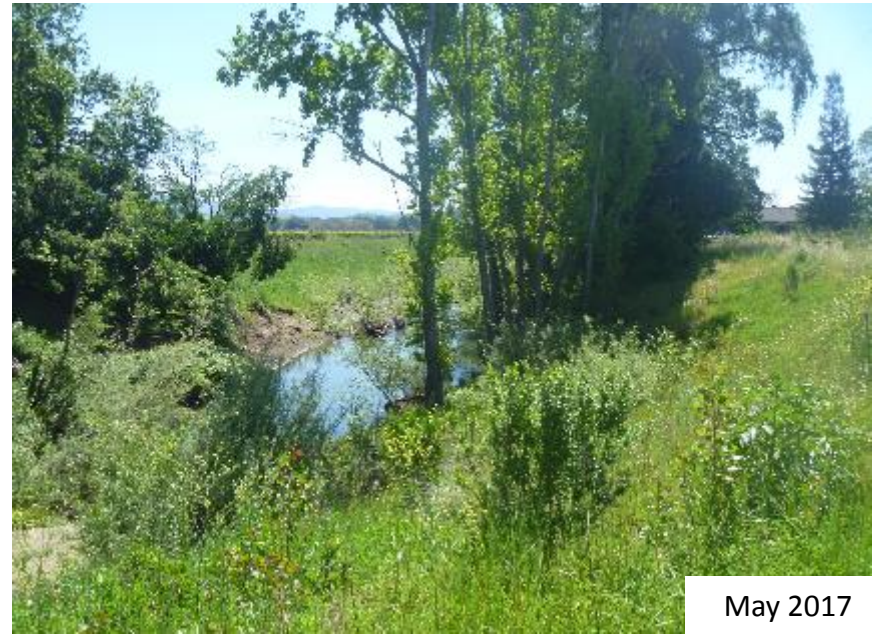
River Station 44+00

Reach 8 South, Bank Stabilization 3 to Bench 3: Upstream to Downstream

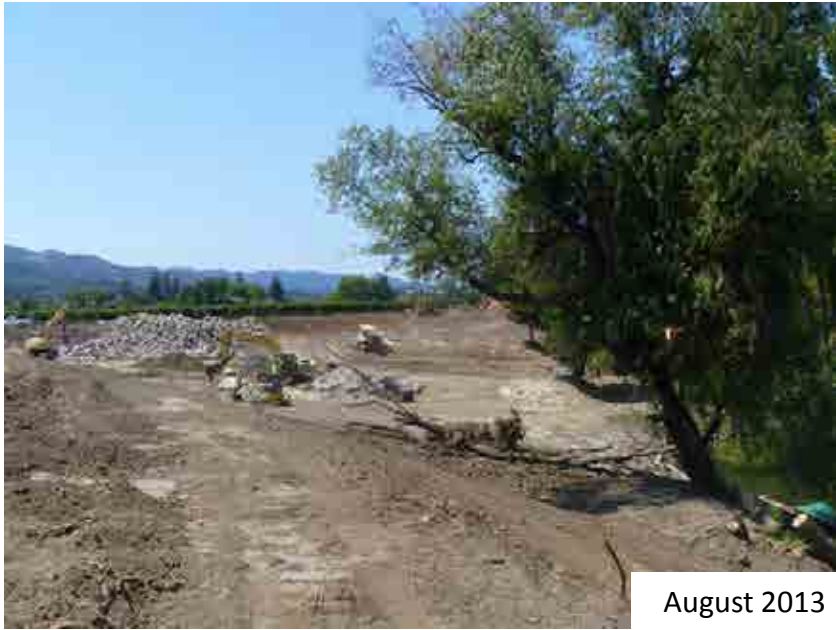
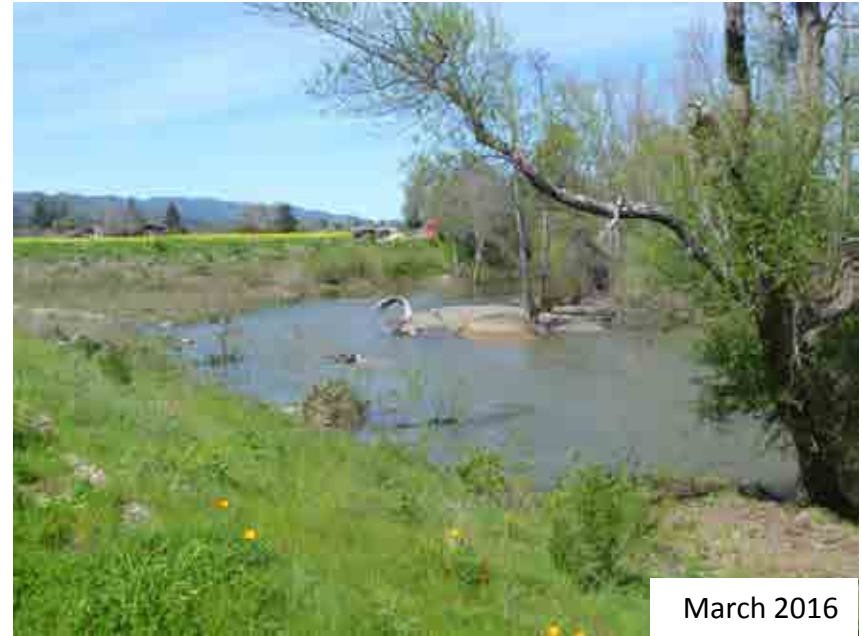
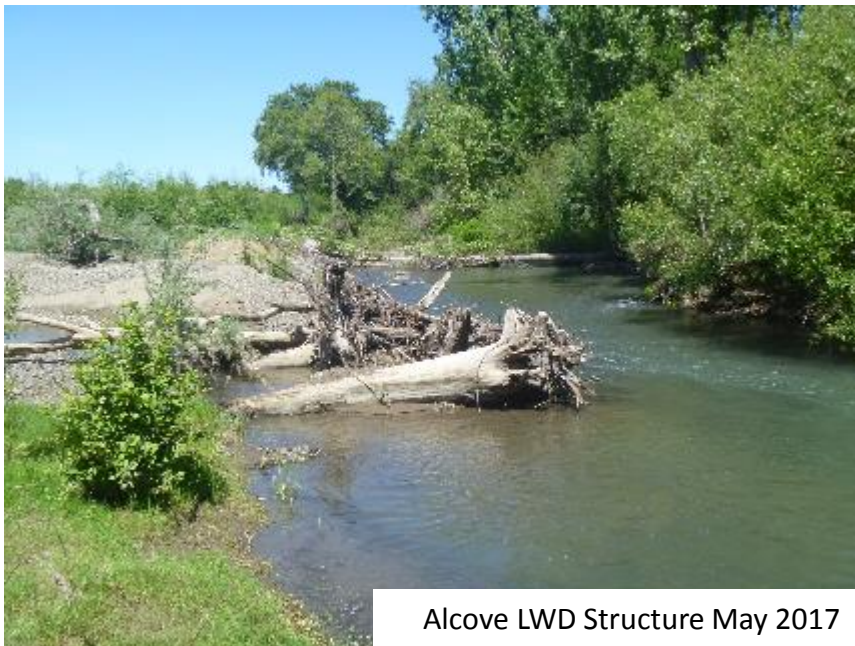
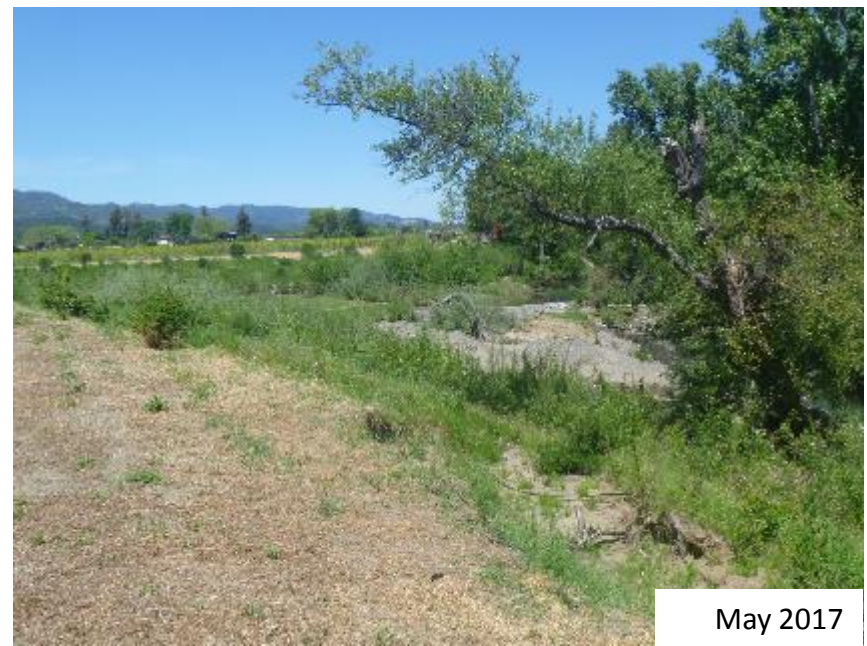
River Station 31+00, Reach 8 South, Cakebread Alcove: Downstream to Upstream

Alcove LWD Structure May 2017

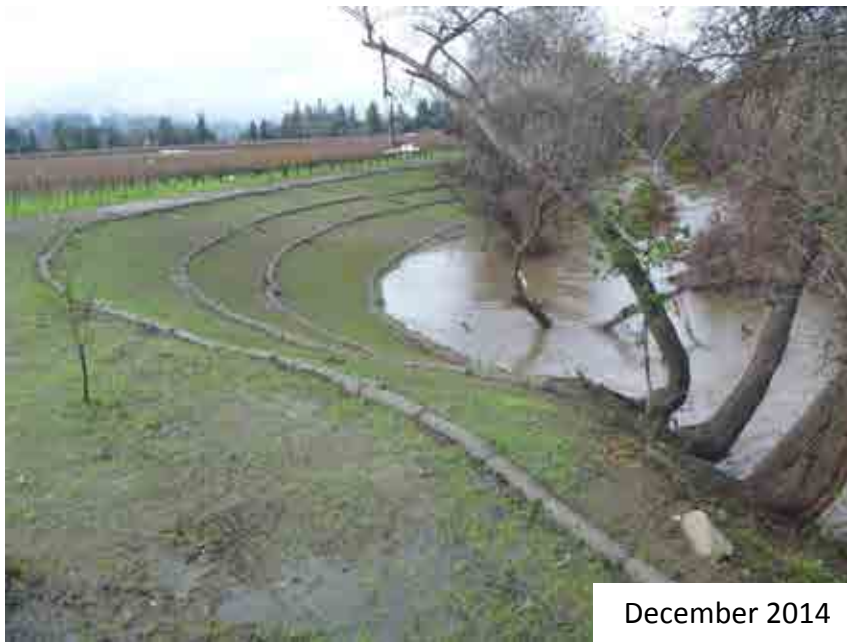
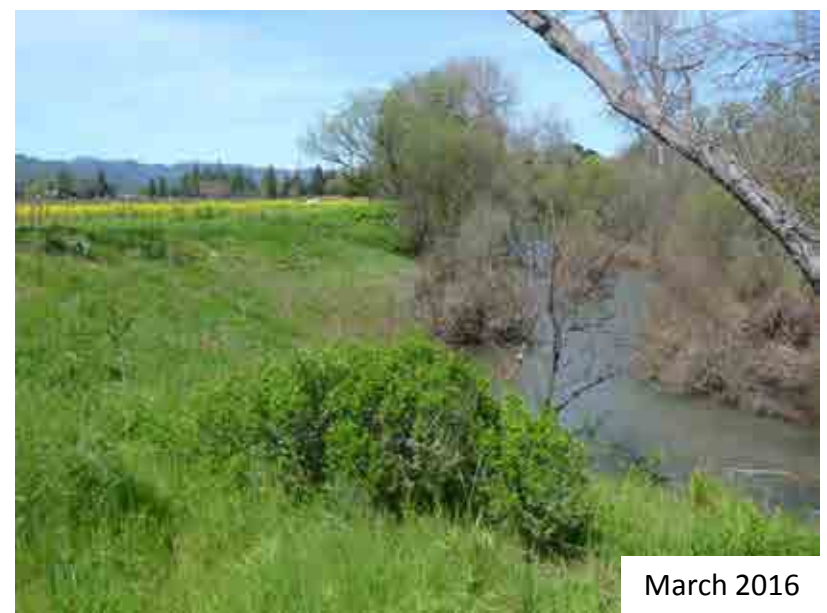
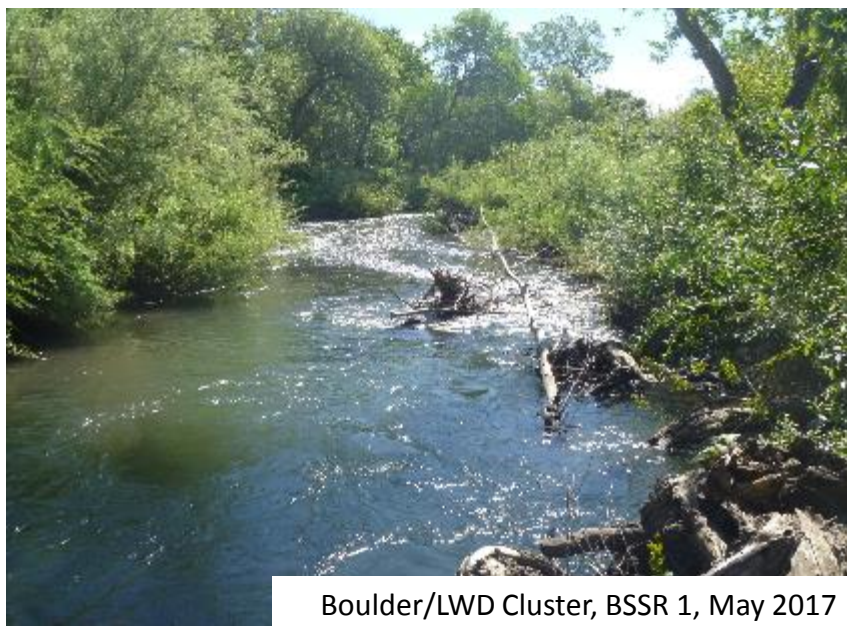
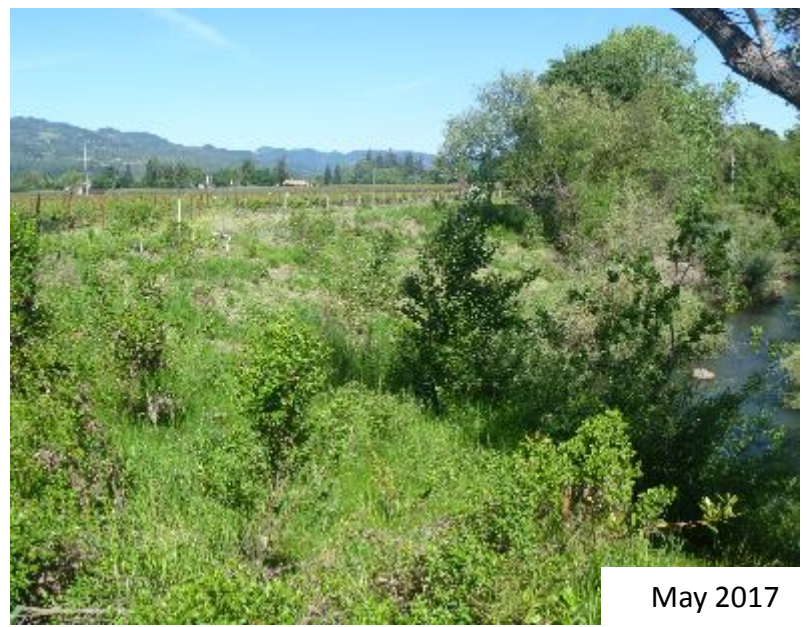
River Station 92+00, Reach 6, Peju-St. Supery Bank Stabilization Area 1, West Bank

Boulder/LWD Cluster, BSSR 1, May 2017
