# NAPA RIVER RUTHERFORD REACH RESTORATION PROJECT ANNUAL MONITORING REPORT - 2017

Napa County Flood Control and Water Conservation District  
804 First Street  
Napa, California, 94559  
Contact: Jeremy Sarrow  
(707) 259-8204

Napa County Resource Conservation District  
1303 Jefferson Street, Suite 500 B  
Napa, California, 94558  
Contact: Paul Blank/Jonathan Koehler  
(707) 252-4189

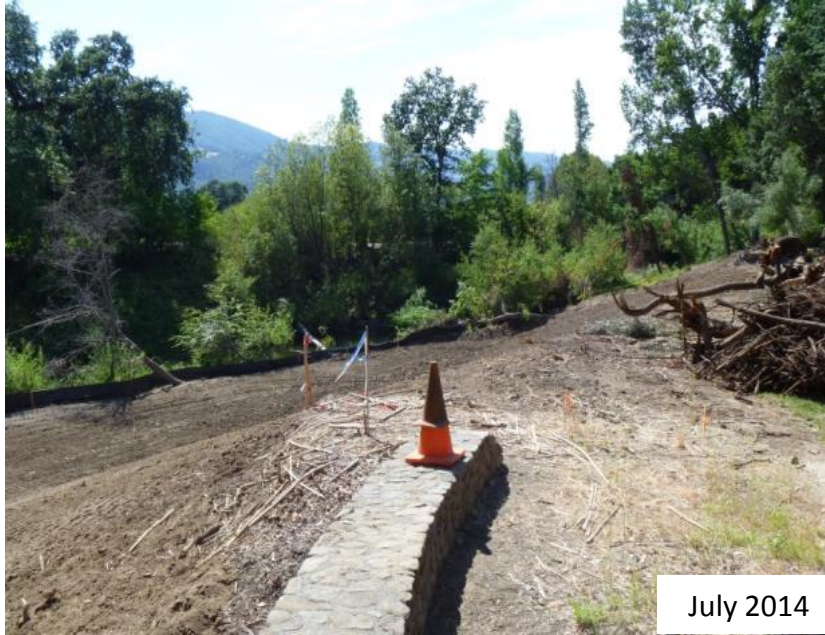
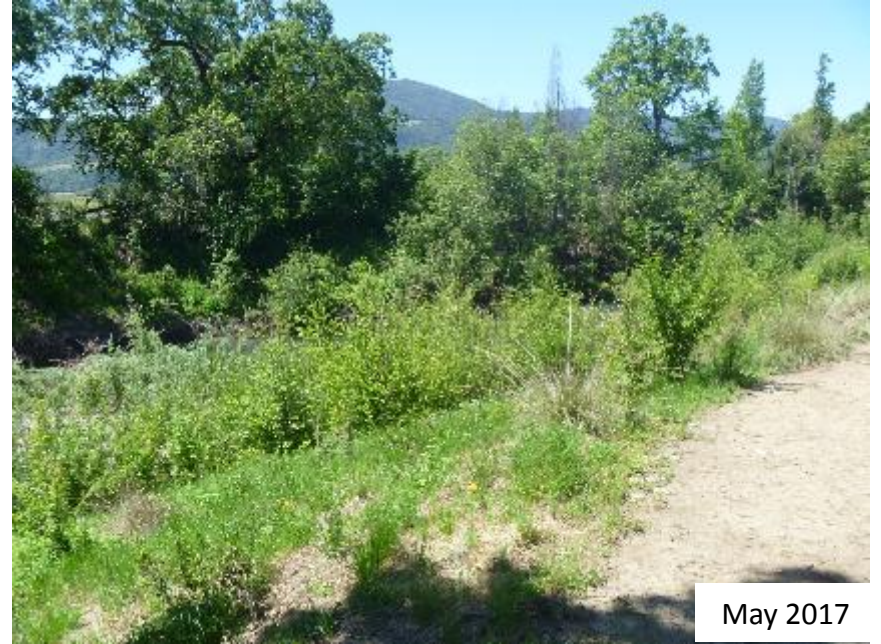
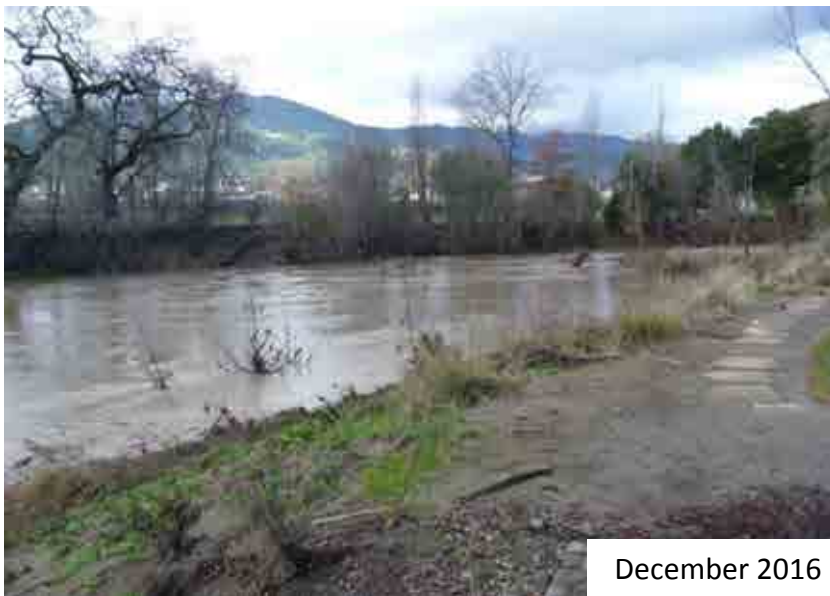
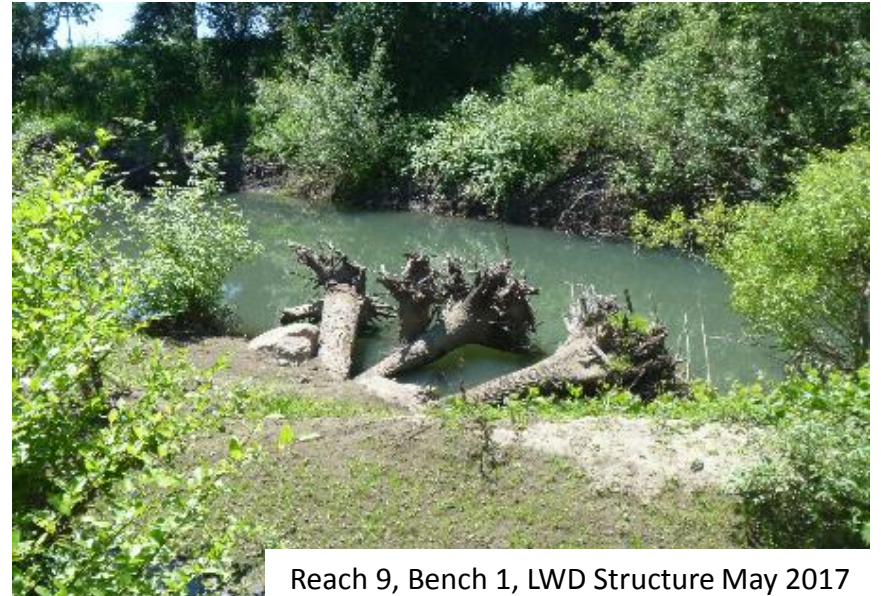
River Station 20+00, Reach 9, United Bench 1, Downstream to Upstream, East Bank

Reach 9, Bench 1, LWD Structure May 2017

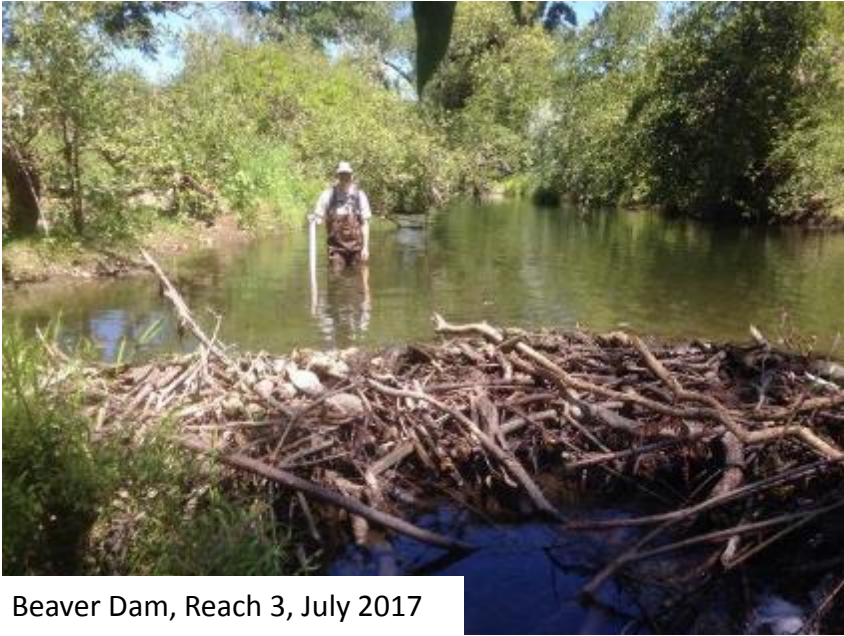
Beaver Dam, Reach 3, July 2017

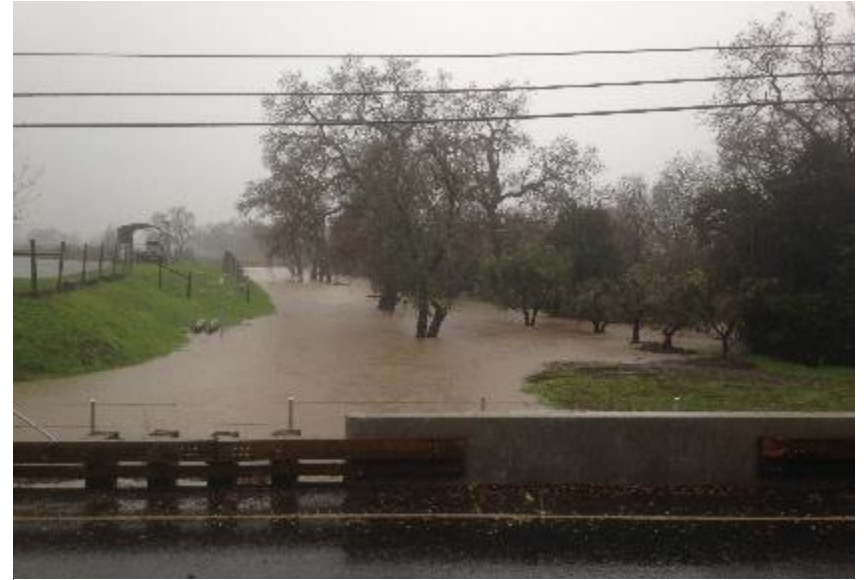
High Flow/Out of Channel, Reach 9, Opus One, January 2017

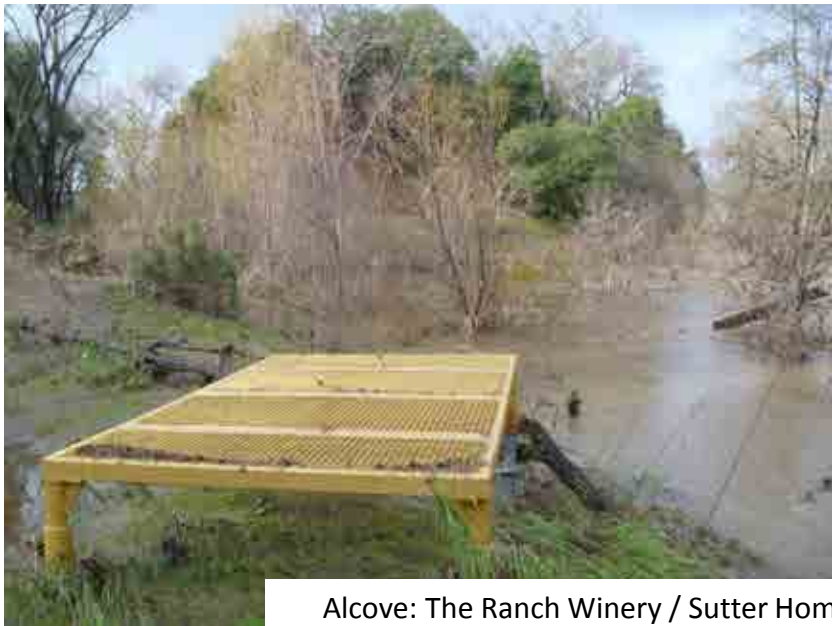
Alcove: The Ranch Winery / Sutter Home, West Bank, January 2016 and May 2016
